FLAG STATE INSPECTIONS AND COMMON DEFICIENCIES

Captain Sascha Marcel Dyker

Fleet Operations Manager (Hong Kong)

March 2025

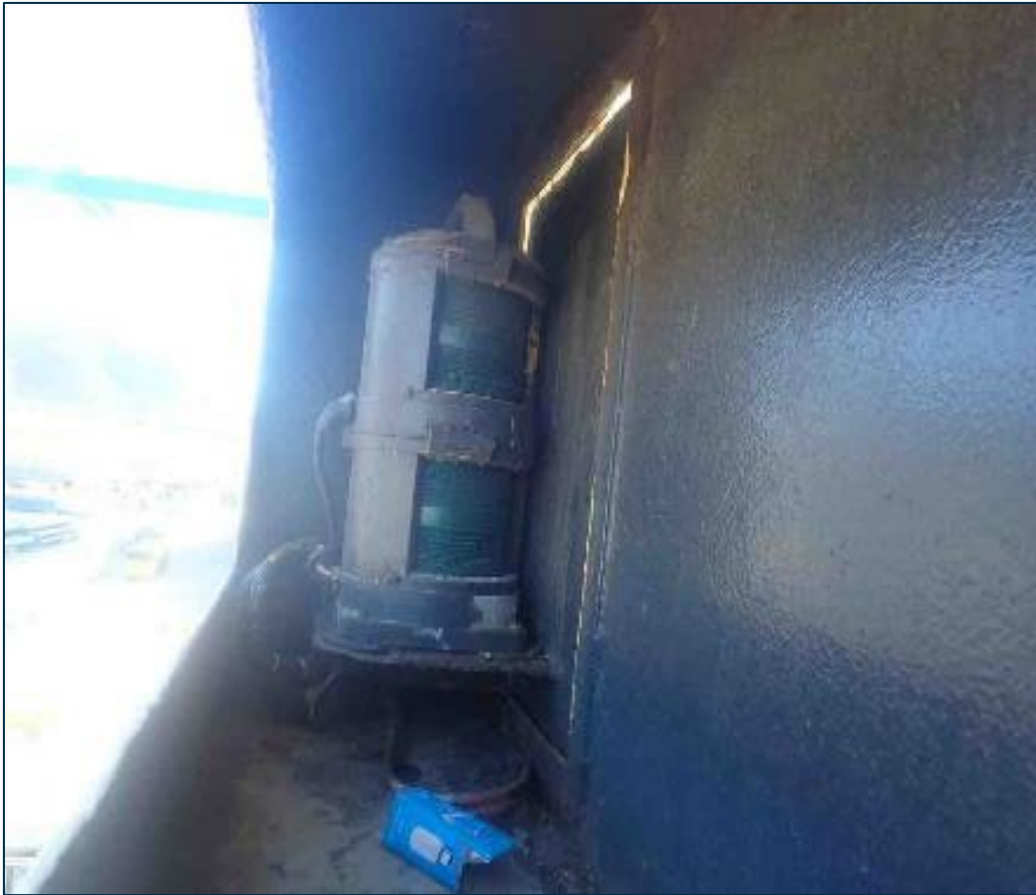
Starboard side light is mounted in the opposite way

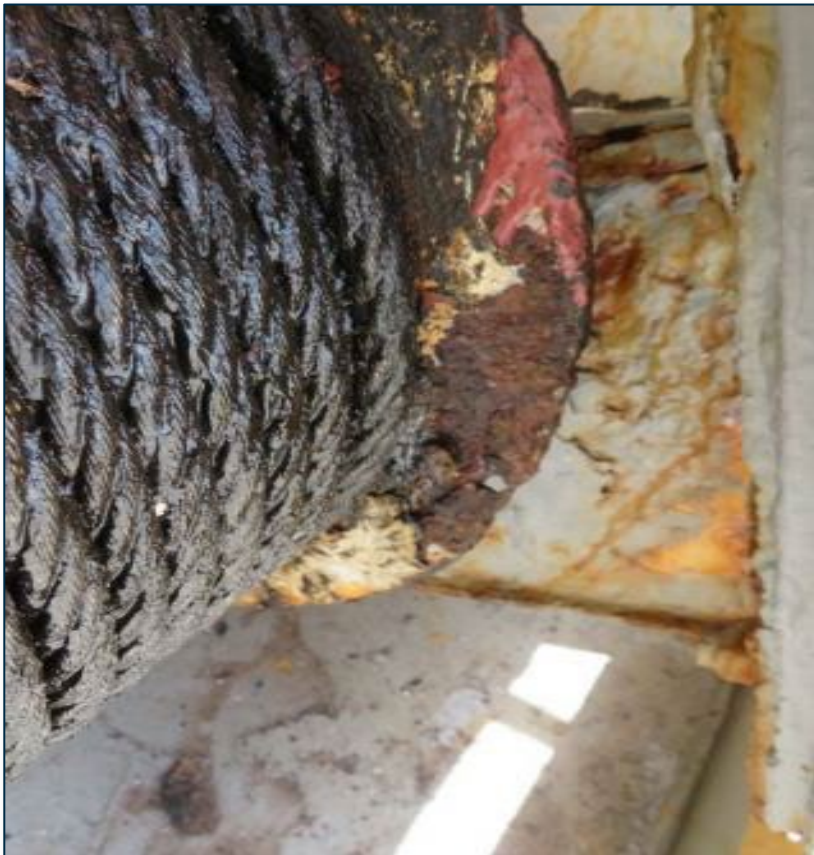
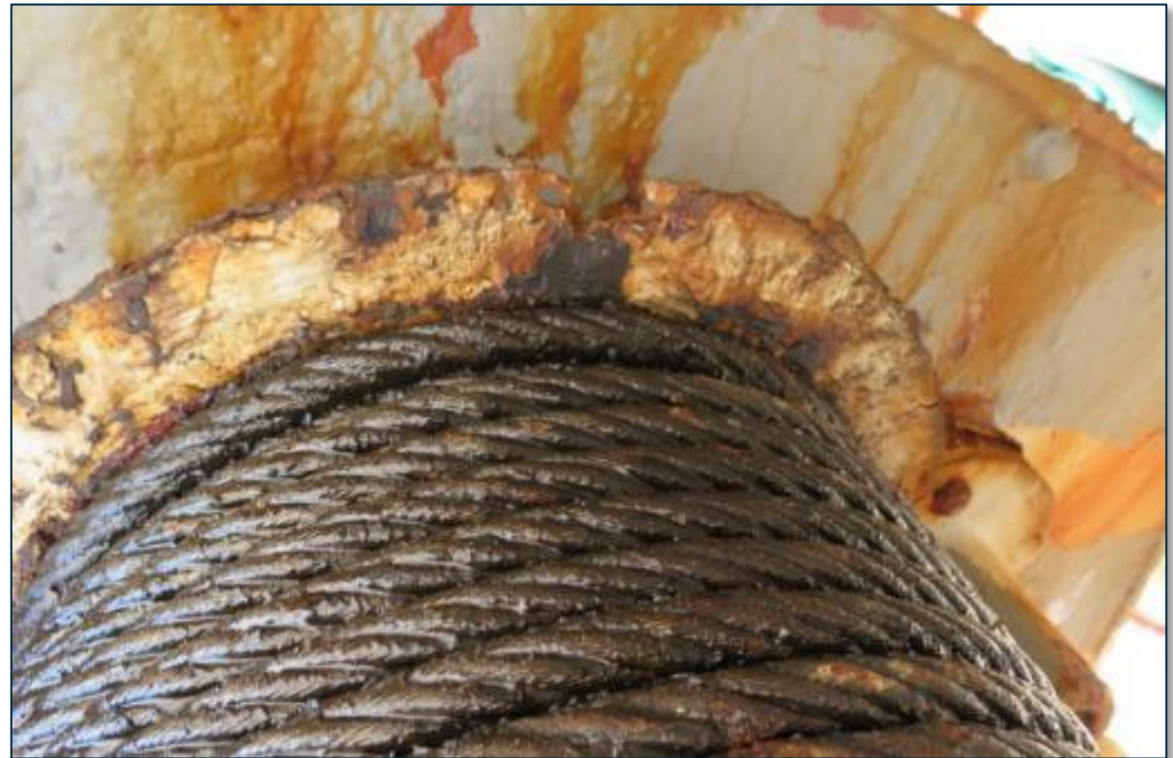
Lifeboat winch drums corroded

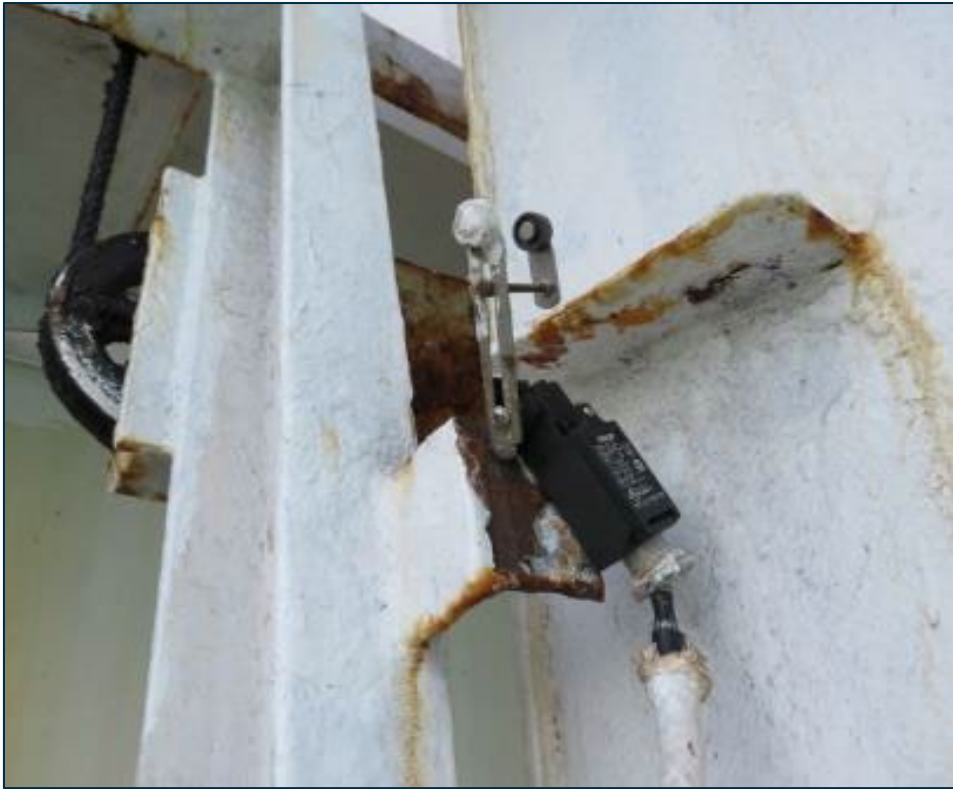
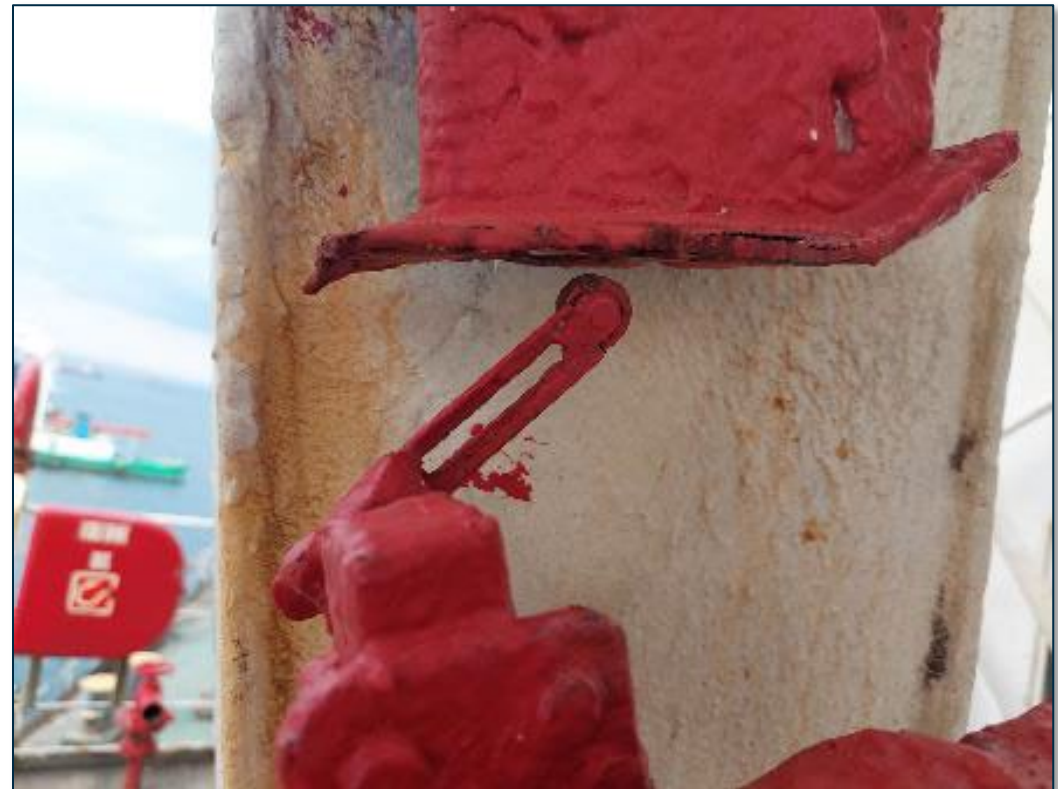
Defective / seized limit switches

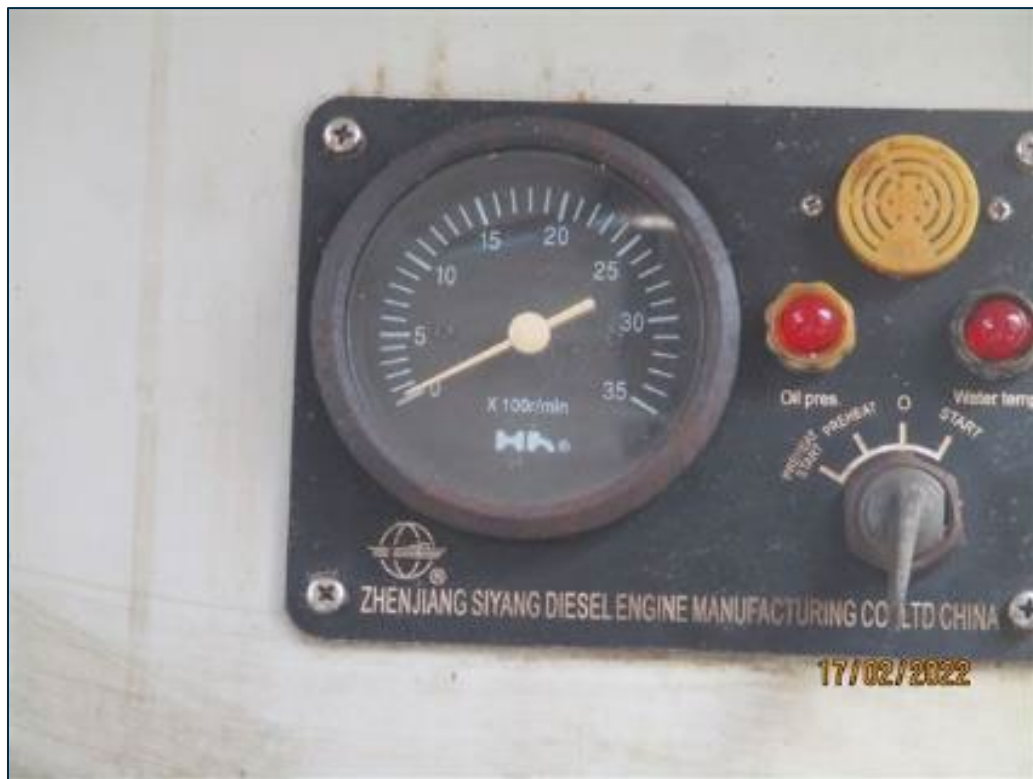
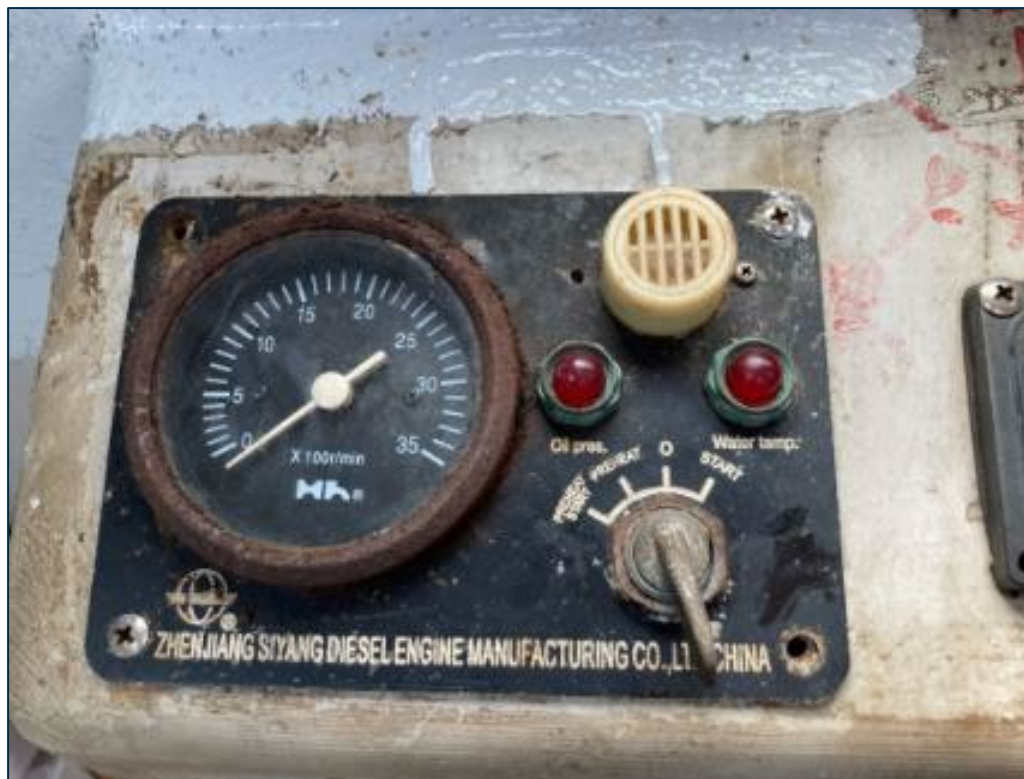
Defective tachometer

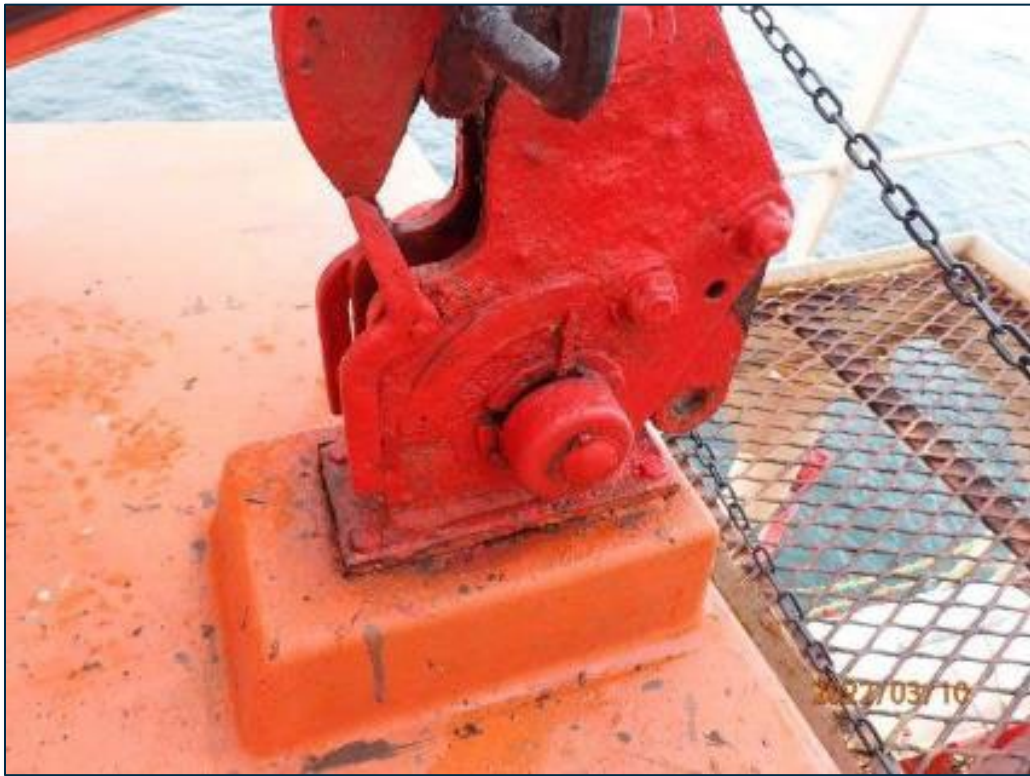
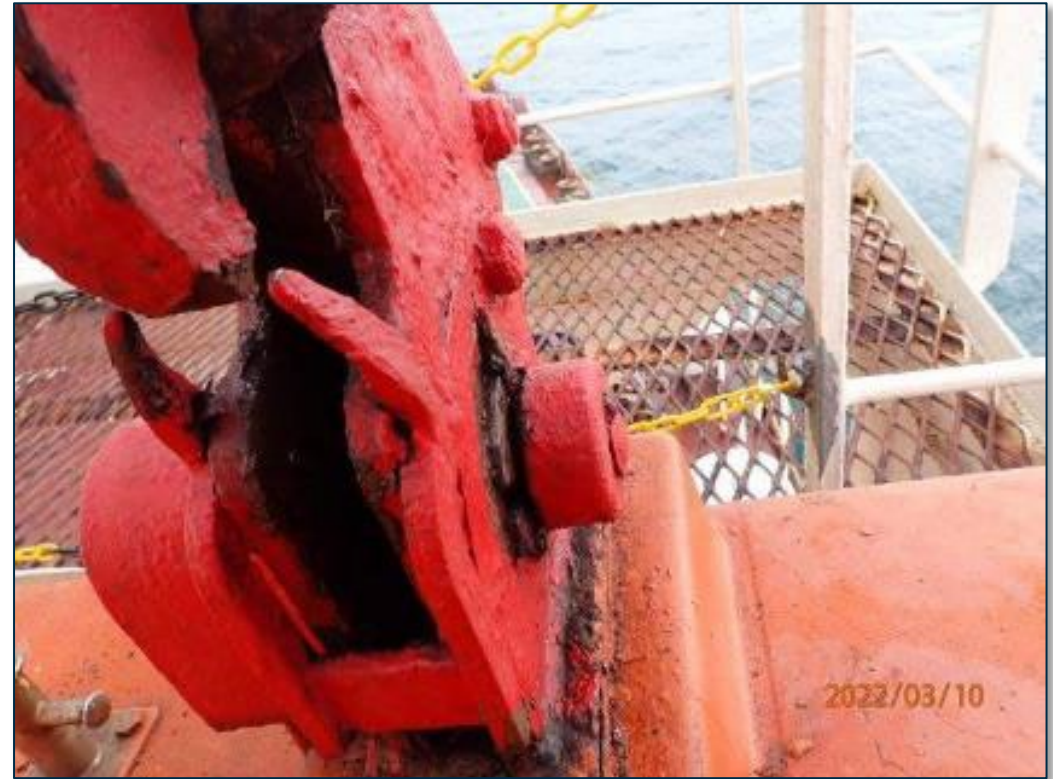
Lifeboat hooks painted covering lock indicators

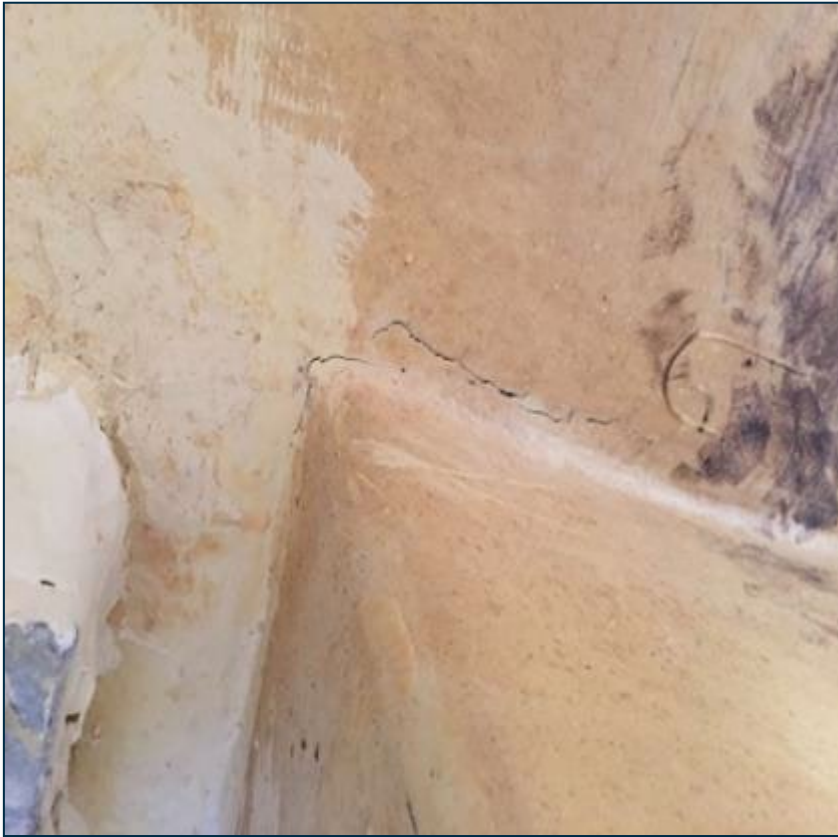
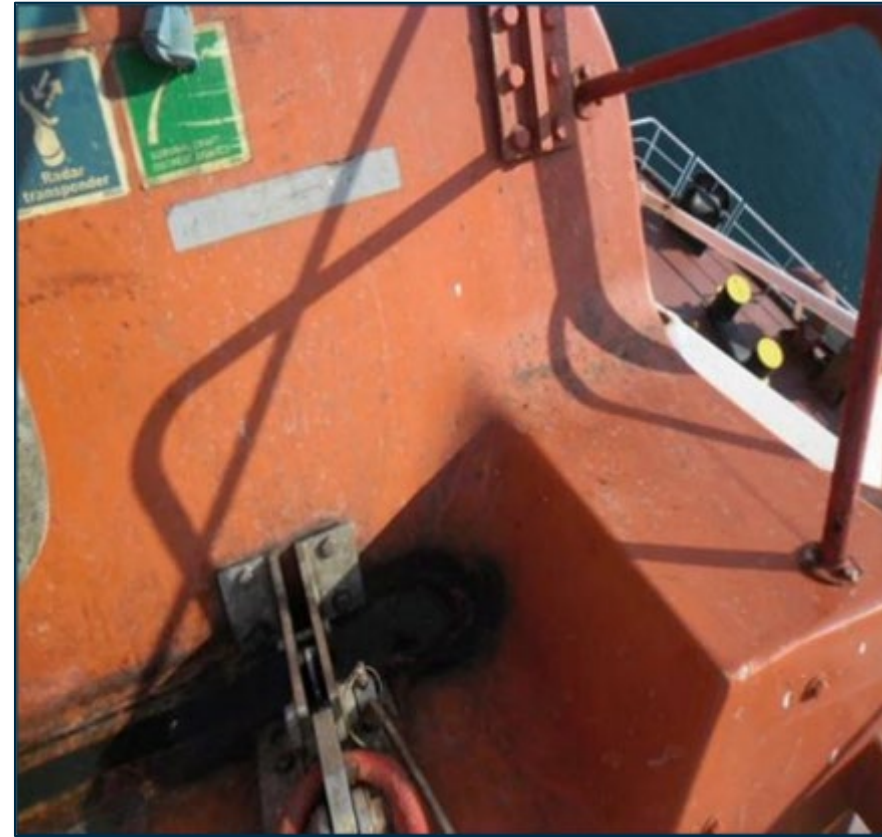
FF lifeboat cracks (internal)

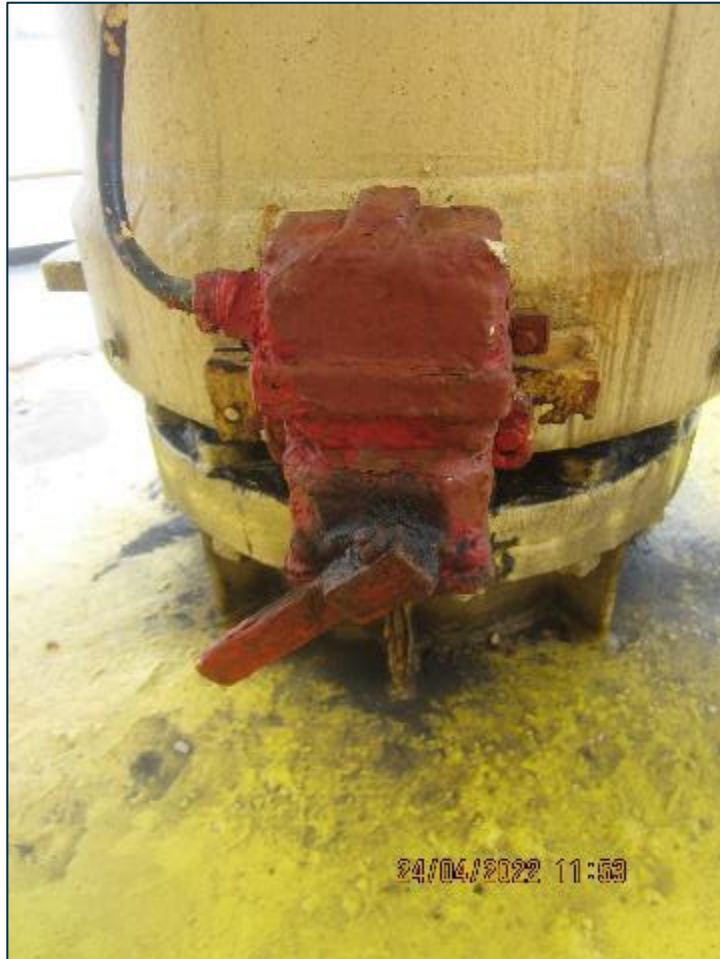
- Limit switches were found out of order during the swinging test of davit

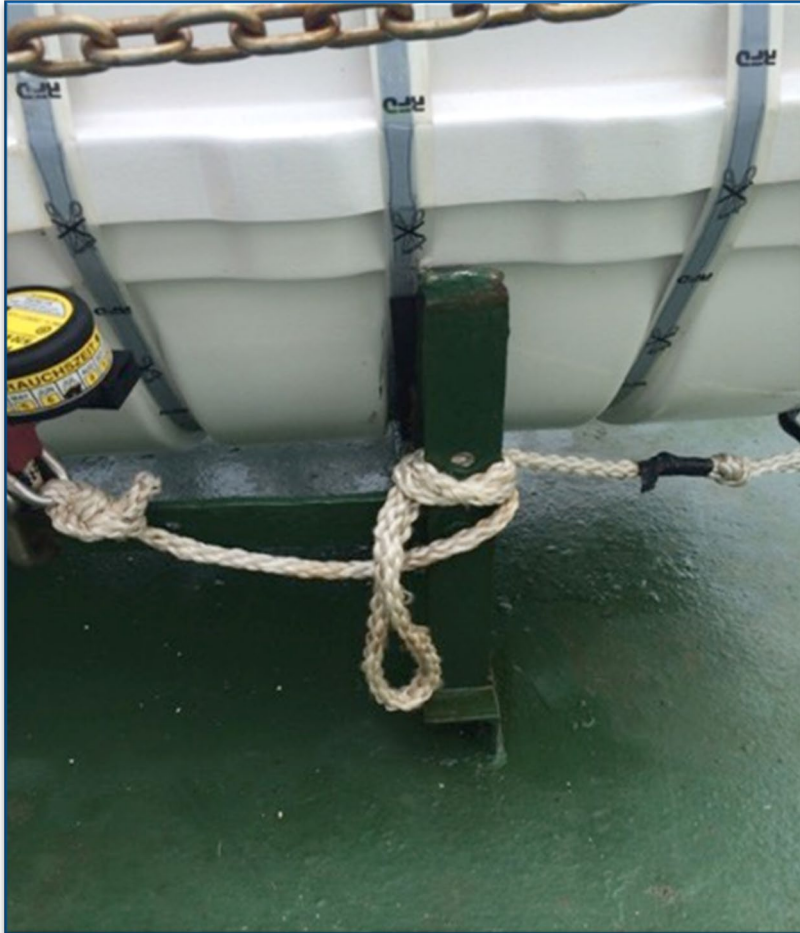
- Life raft's hydrostatic release units (HRUs) / painters' wrong connection and/or extra securing ropes

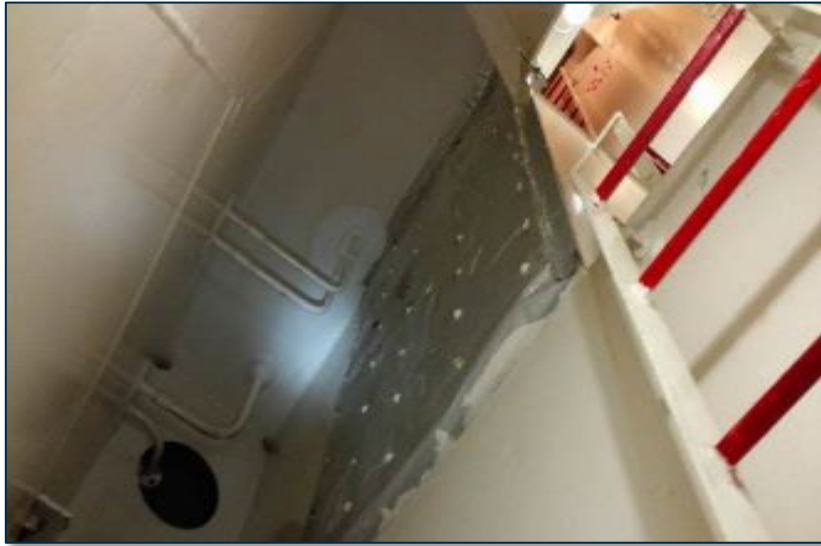
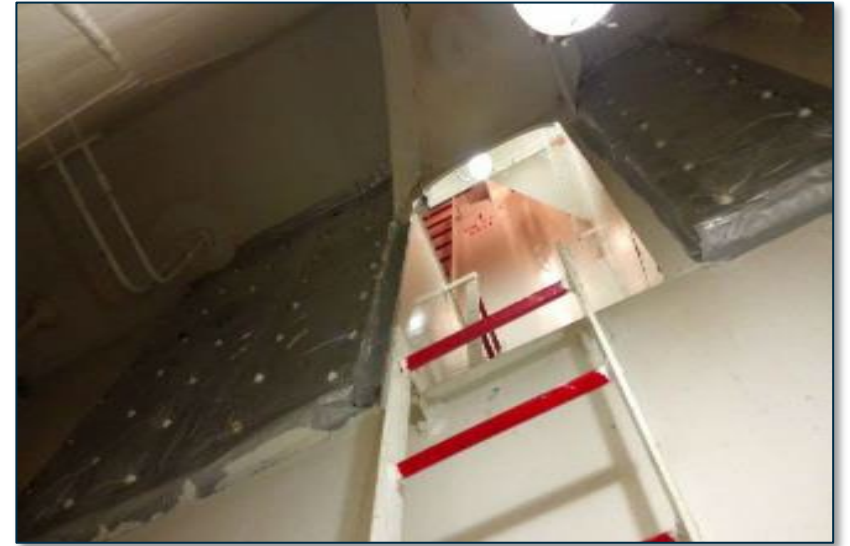
Escape trunk insulation missing

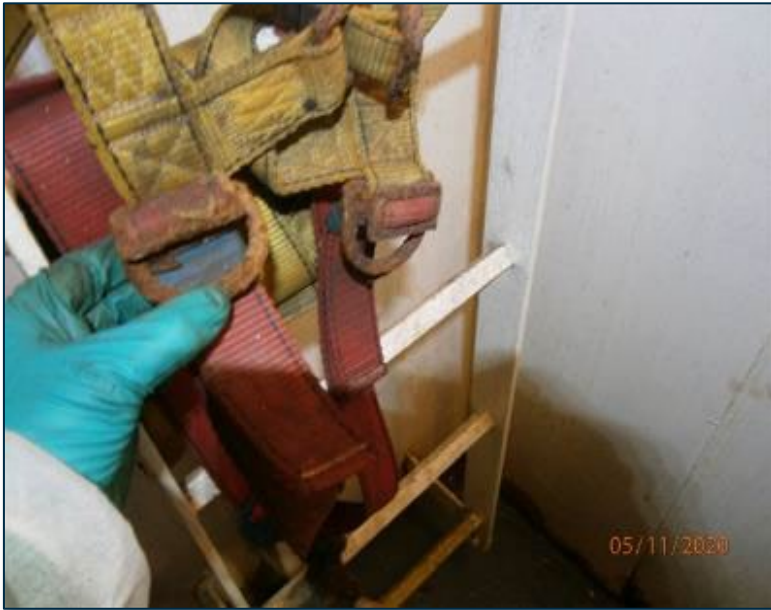
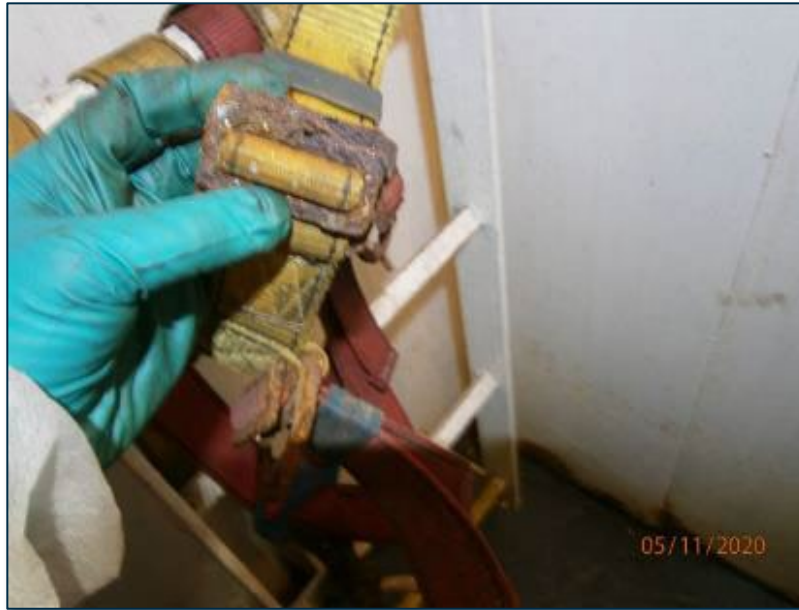
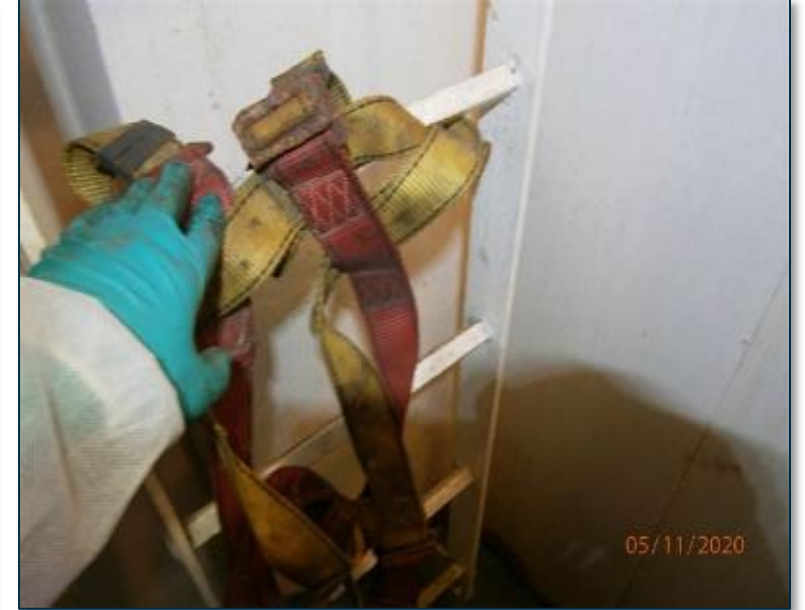
Condition of rescue harness / rope / pulley

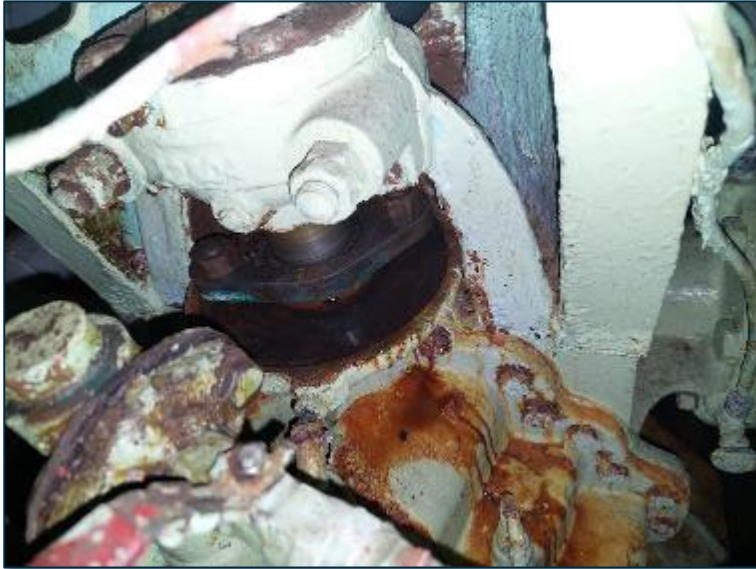
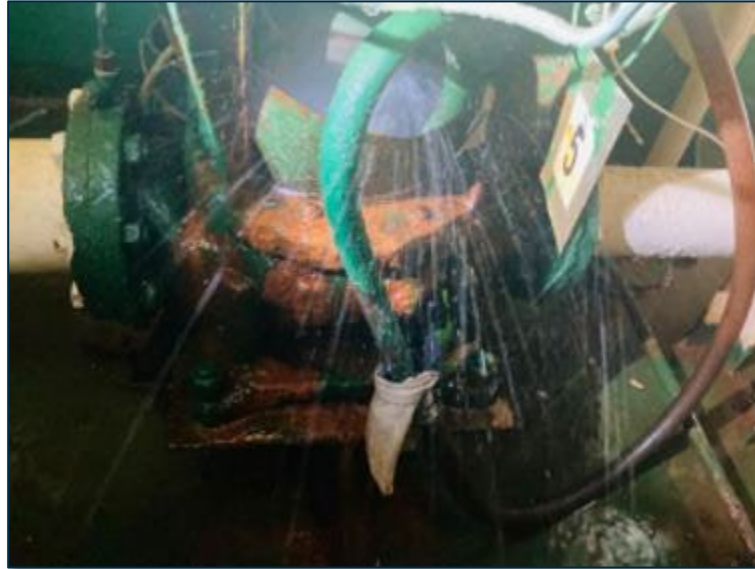
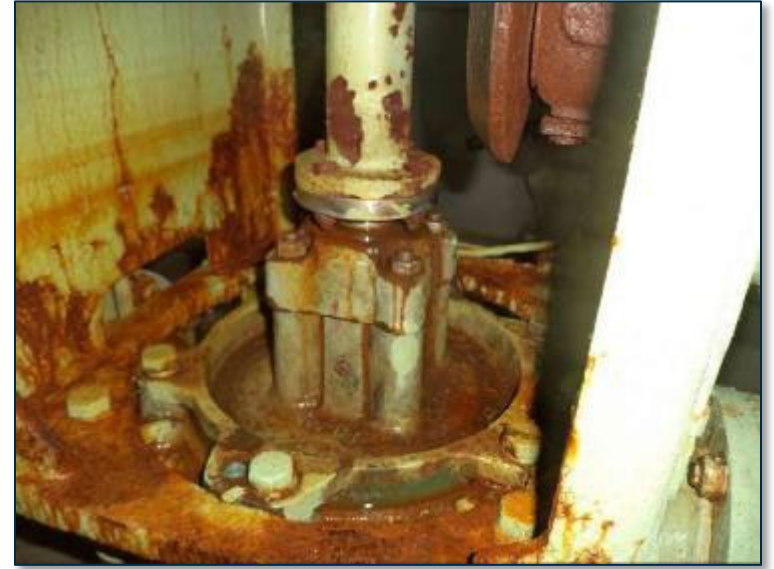
Leaking EFP gland packing / mechanical seal

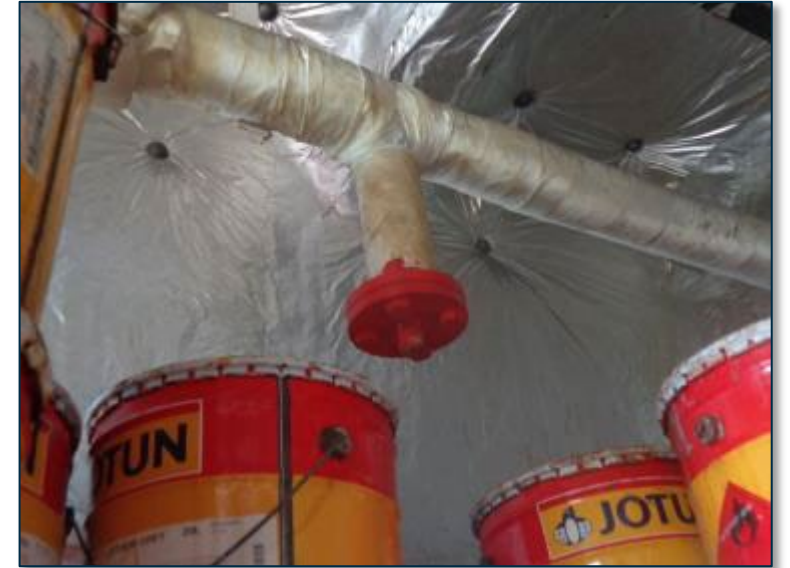
Sprinklers are choked

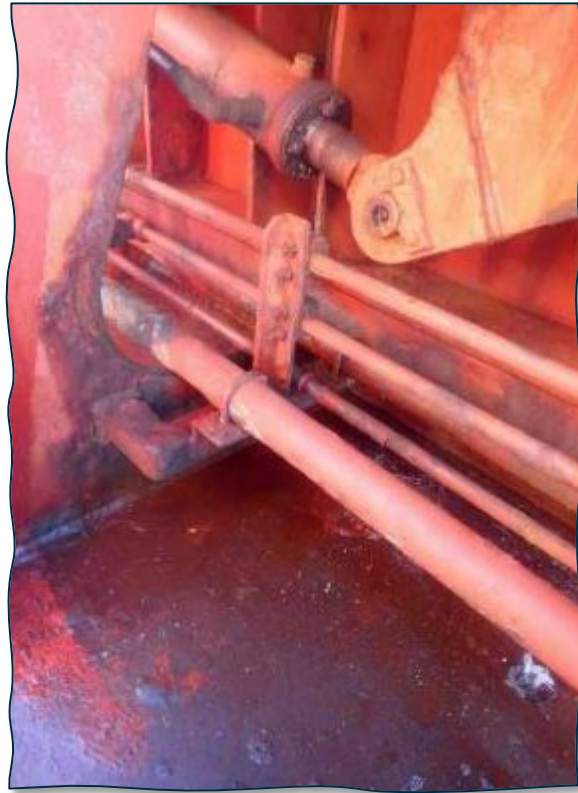
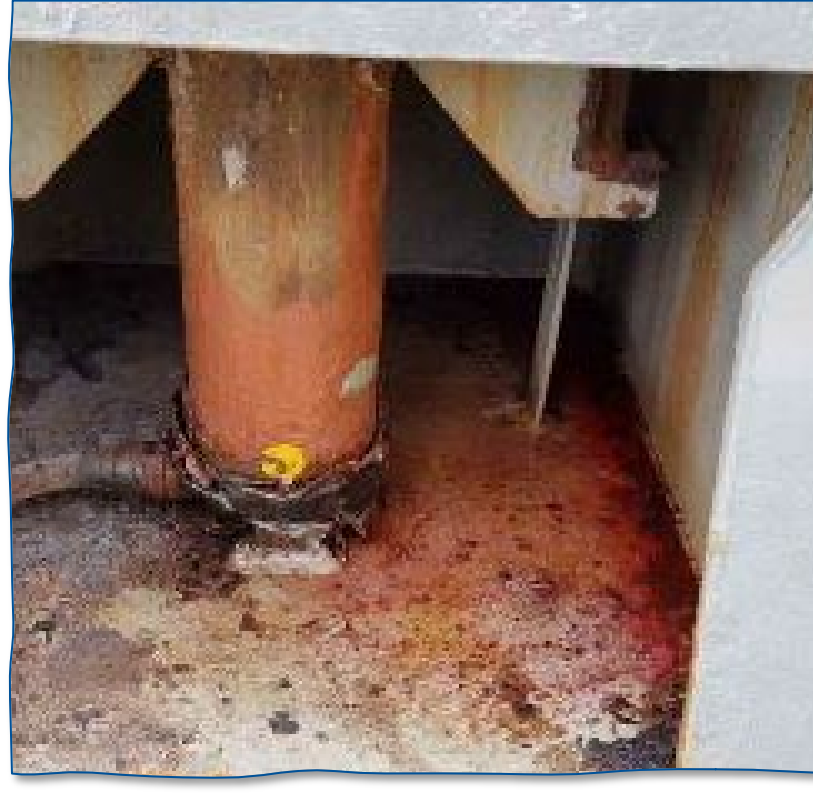
Hydraulic leaks

Second most common deficiency related to hatch covers from January to June 2022.

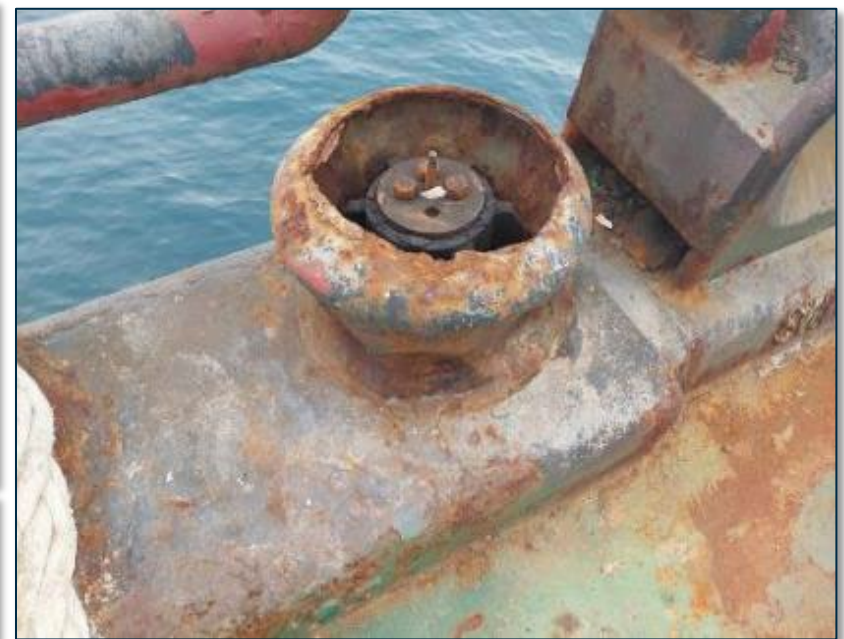
Roller fairleads seized / damaged

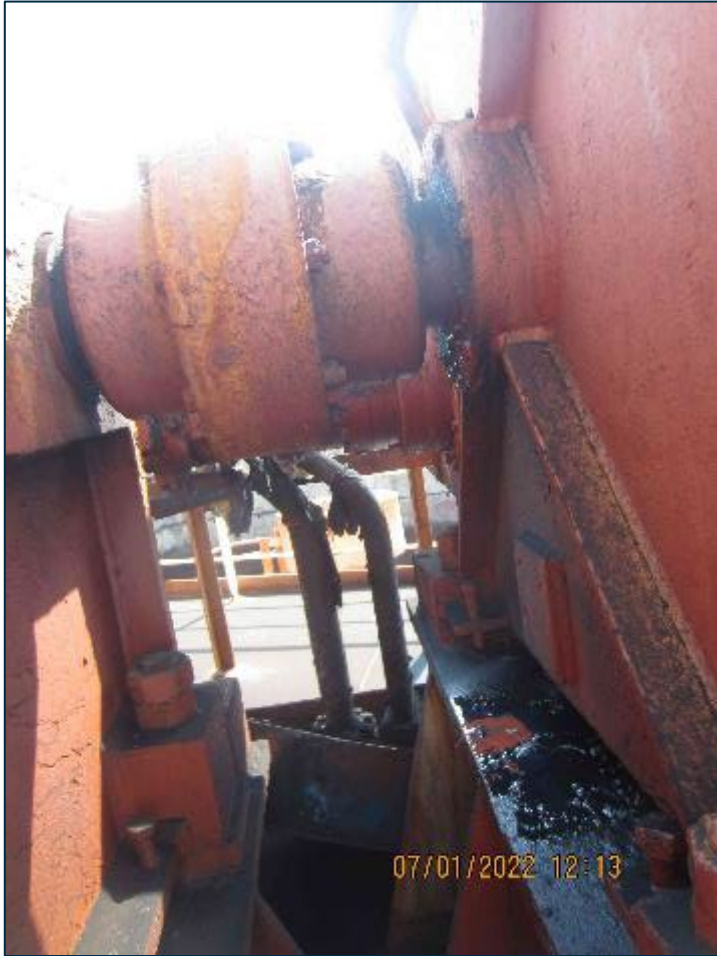
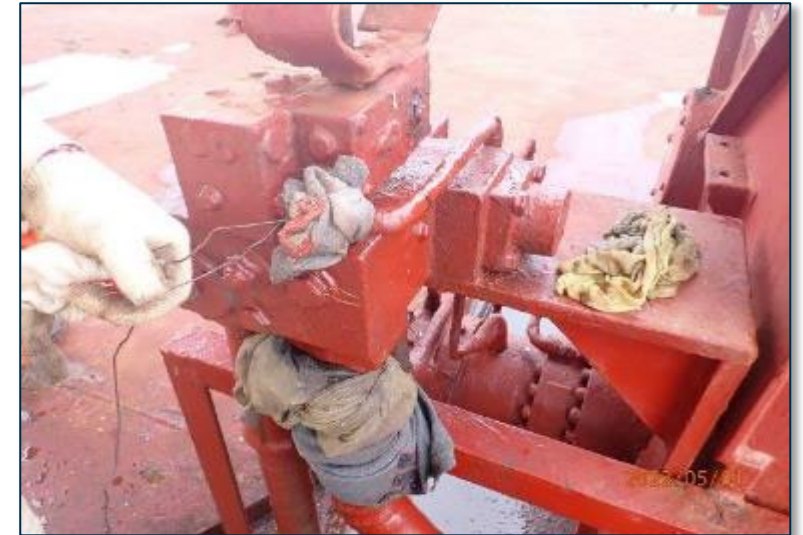
Hydraulic leaks from winches and windlasses

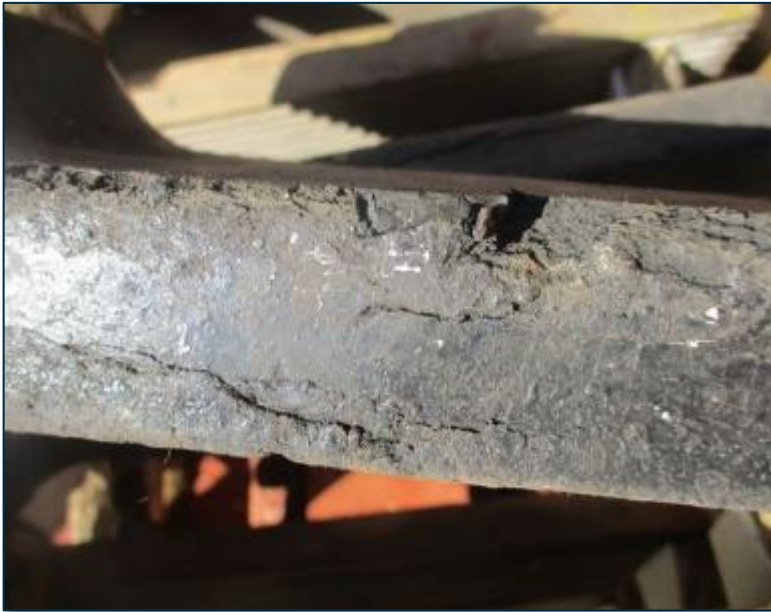
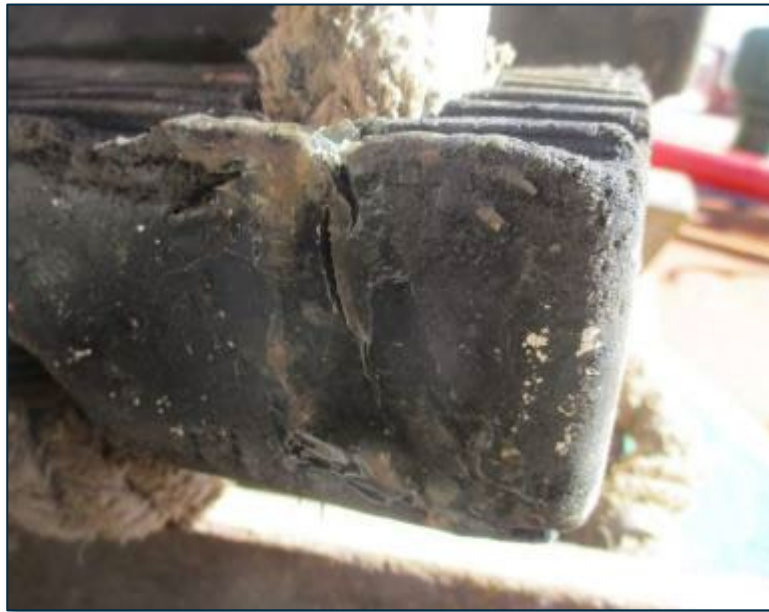
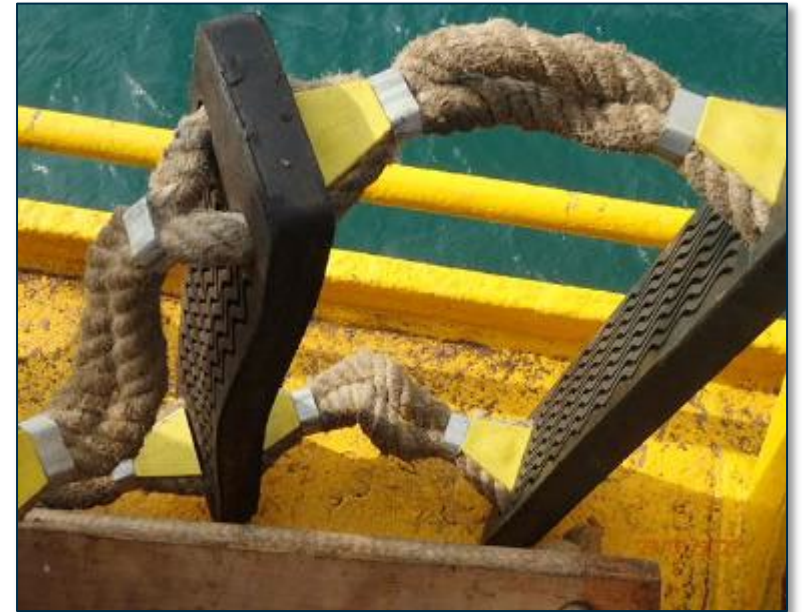
Pilot ladder rubber steps damaged

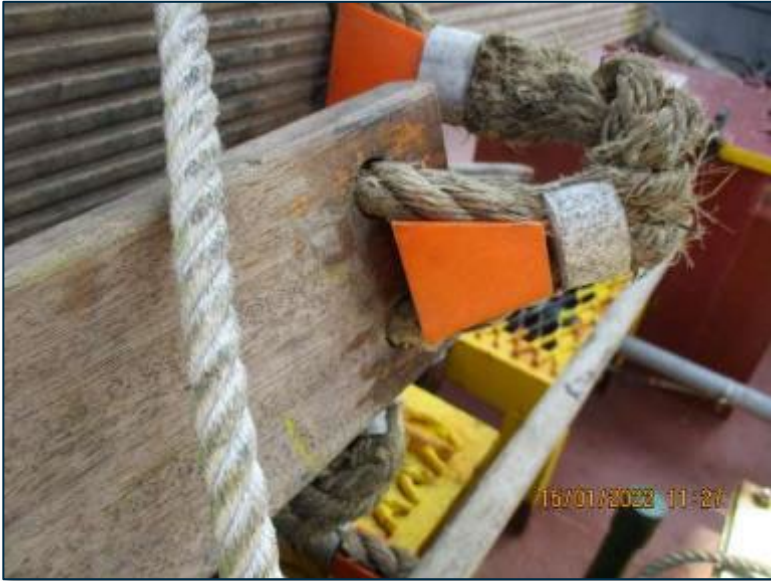
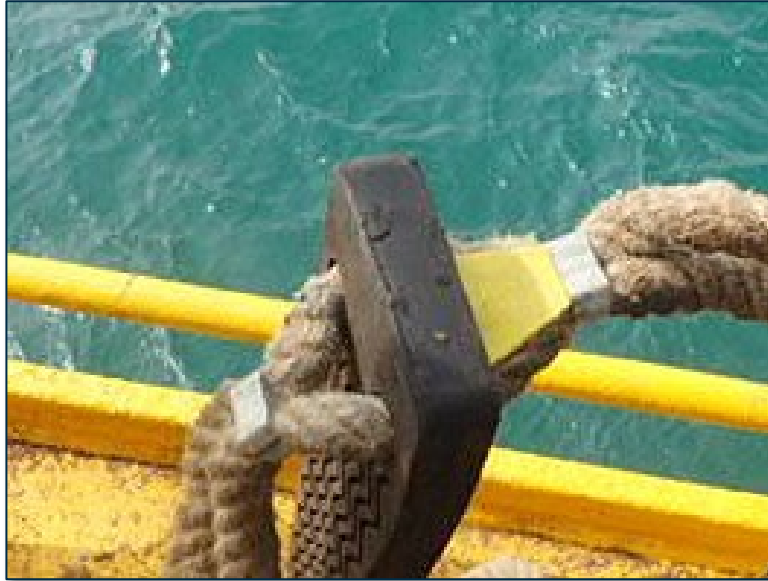
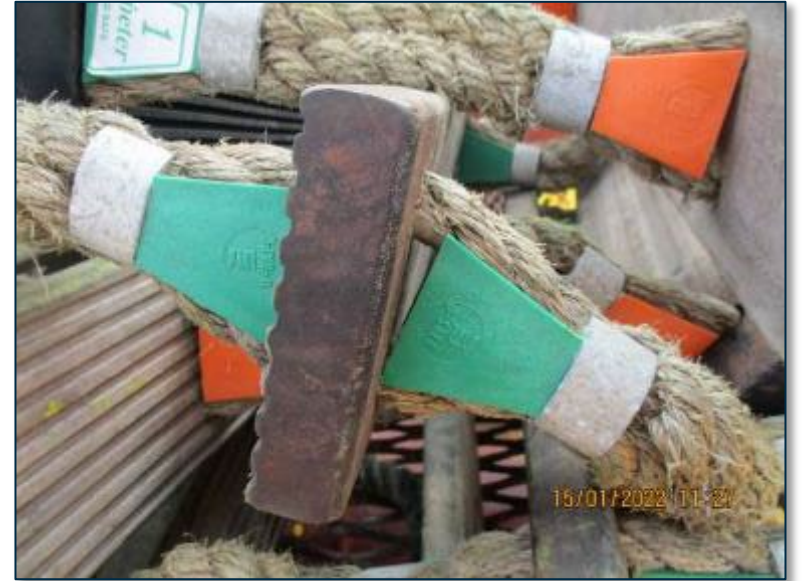
Pilot ladder chocks loosened / missing
(It does not ensure that the steps are prevented from moving)

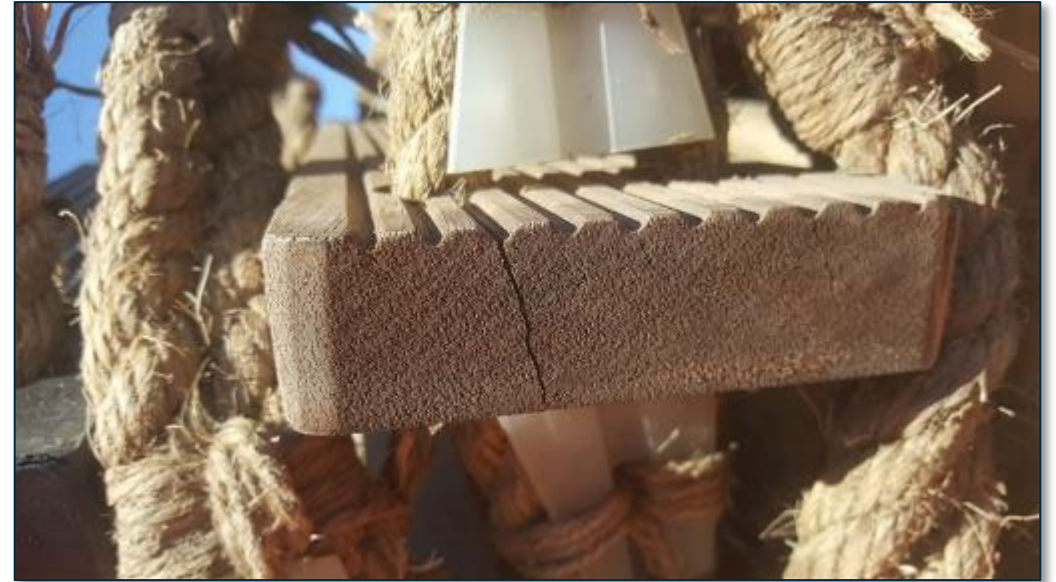
Pilot ladder wastages and cracks

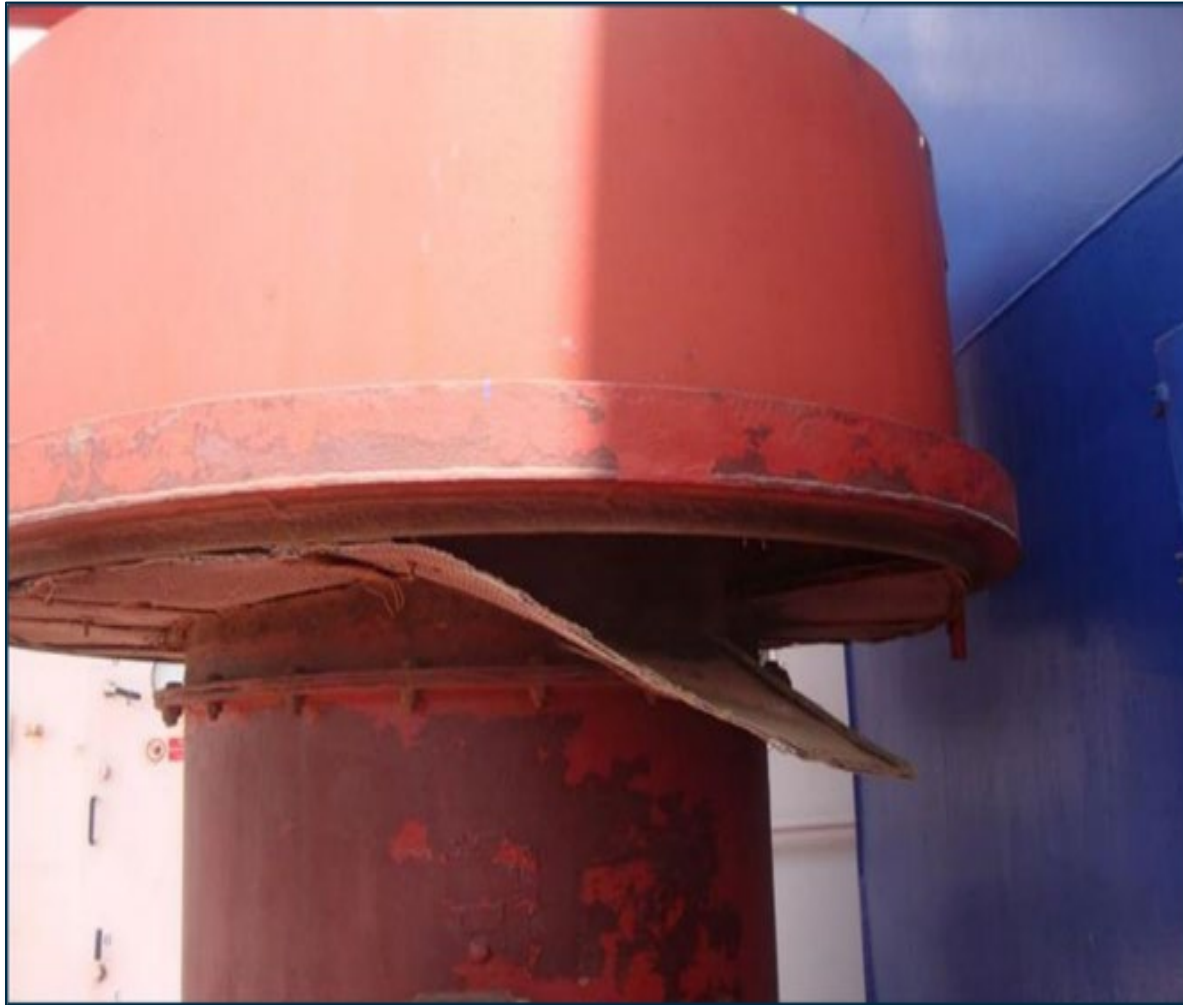
Main engine vent fan wire mesh in poor condition

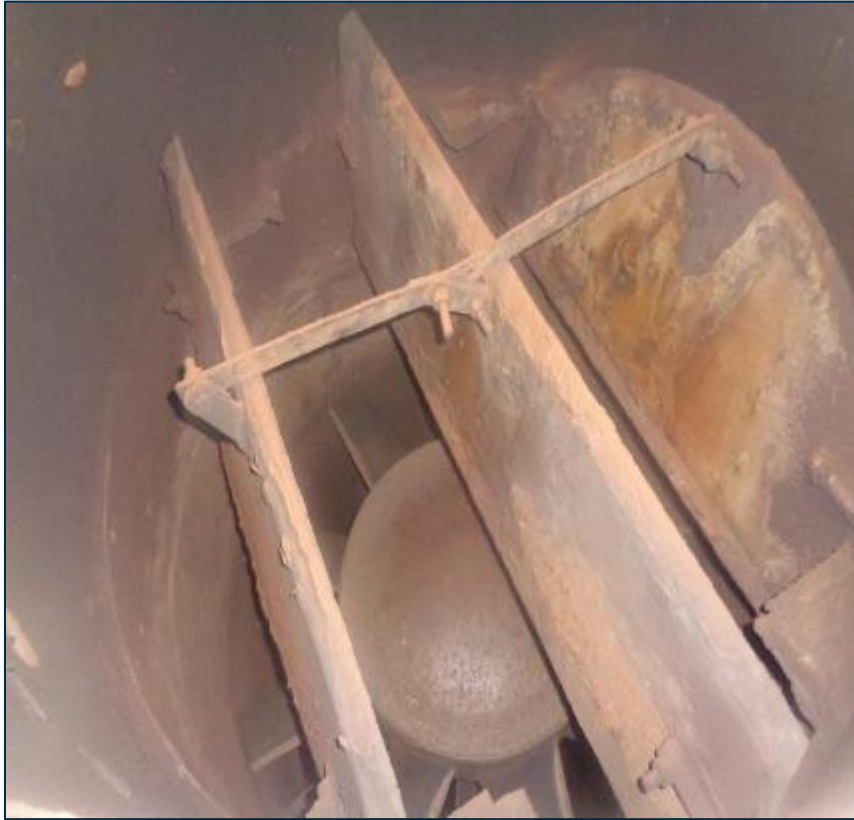
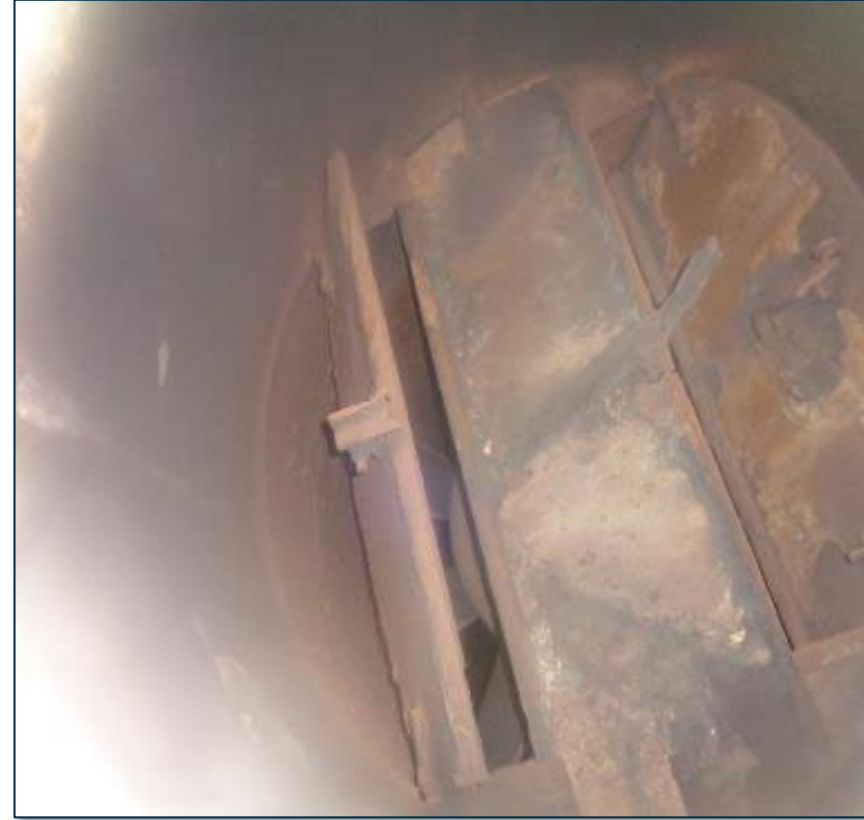
Engine louvers condition before
