FLAG STATE INSPECTIONS AND COMMON DEFICIENCIES

Captain Sascha Marcel Dyker

Fleet Operations Manager (Hong Kong)

March 2025

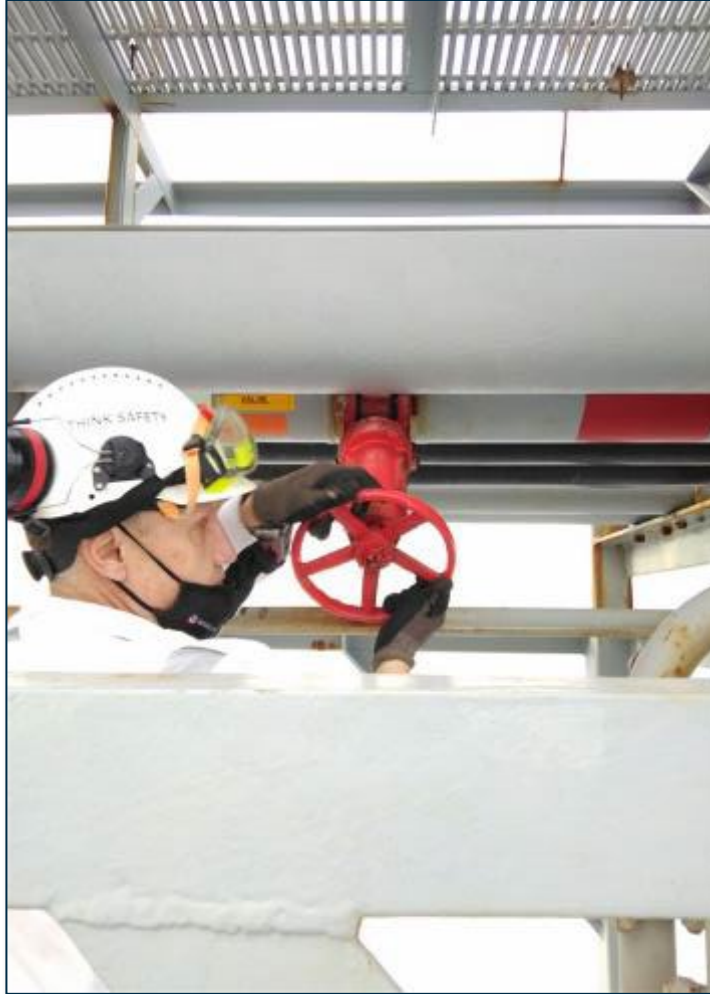
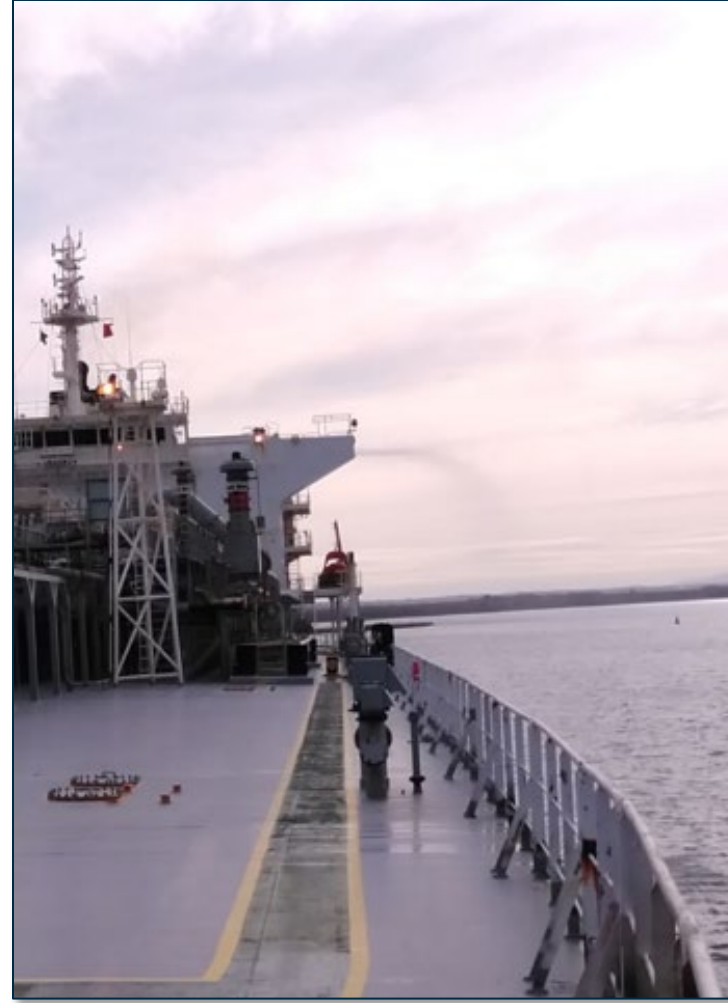
- Fire line main isolating valve frozen (foam room).
- Fire line main leak on deck.
- Lifeboat sprinkler line holed.

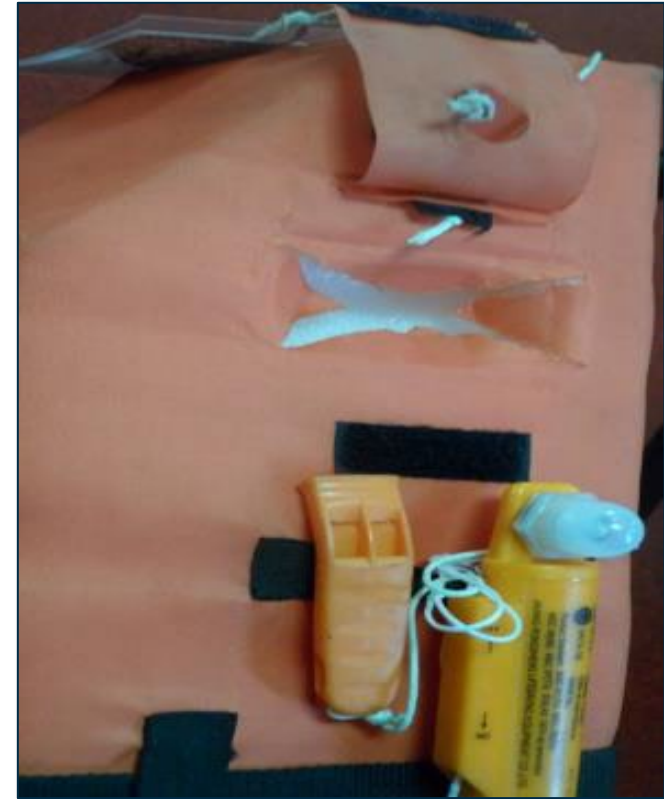
Life jacket as observed by PSC

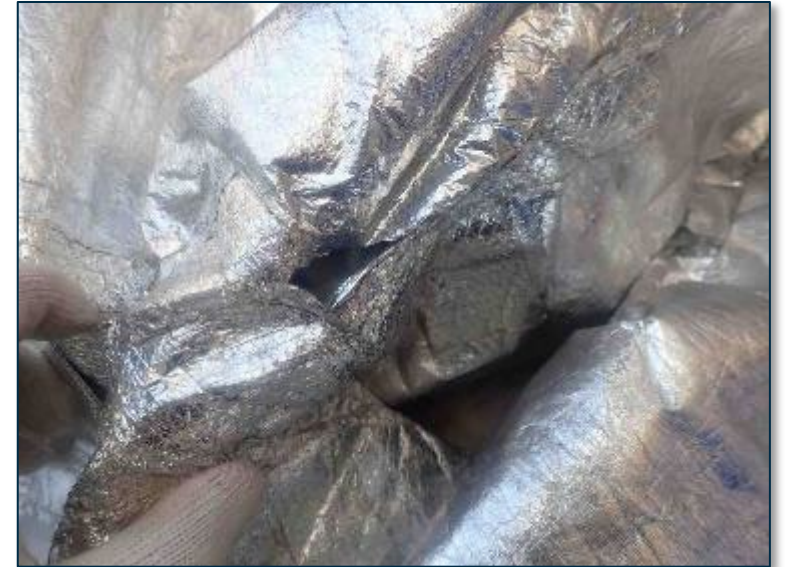
Damaged firefighter's outfit

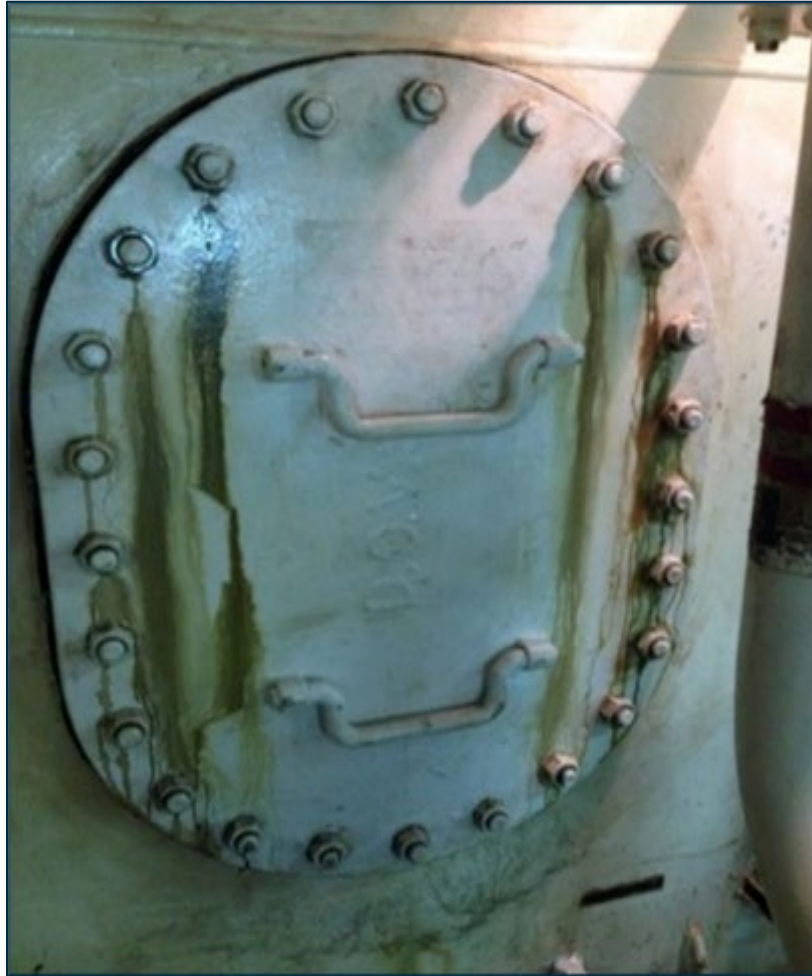
Leaking manhole cover
(diesel oil tank).
