FLAG STATE INSPECTIONS AND COMMON DEFICIENCIES

Captain Sascha Marcel Dyker

Fleet Operations Manager (Hong Kong)

March 2025

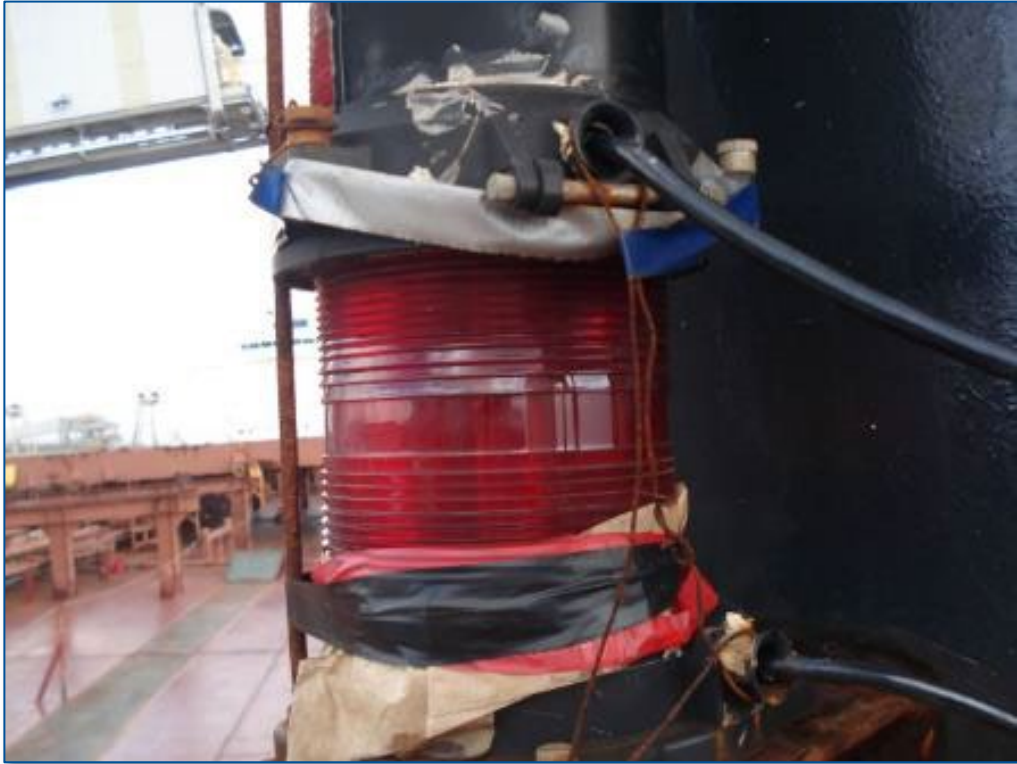
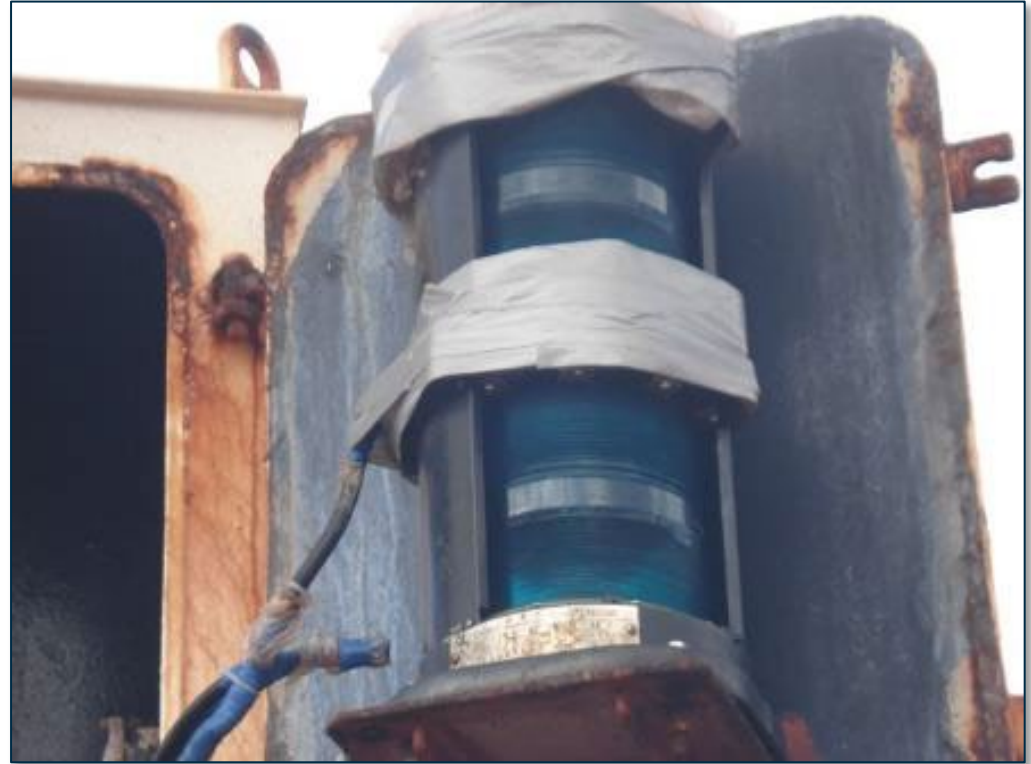
- Both sidelights are secured using duct tape
- Port sidelight installed without sector arc plate

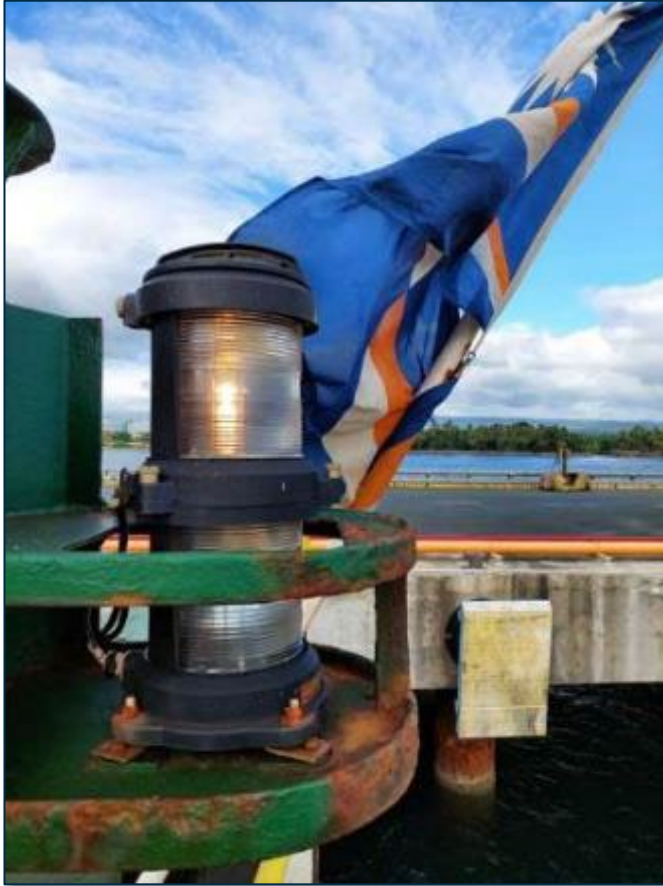
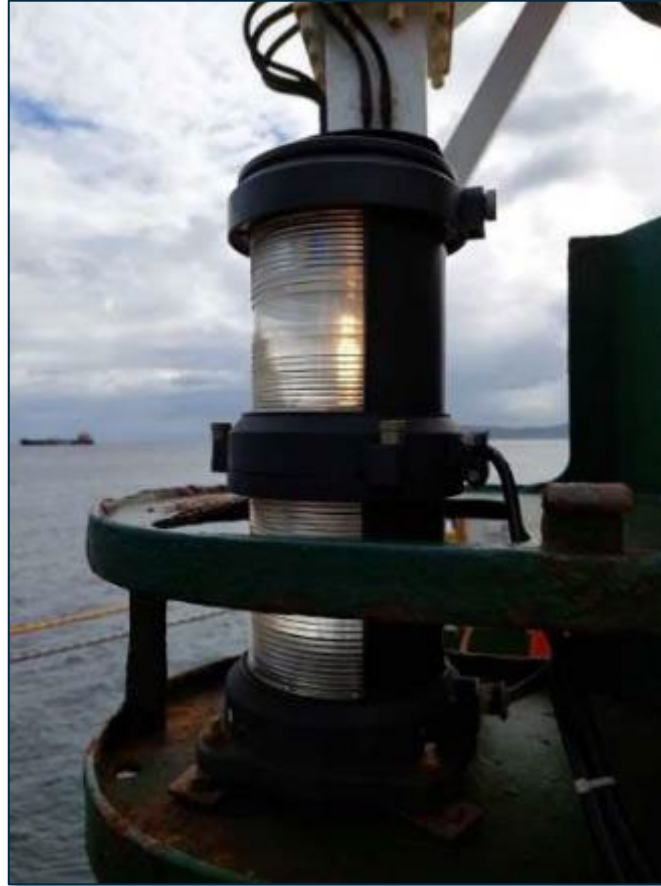
- Masthead light installed as a stern light giving a 225° arc of visibility instead of 135°

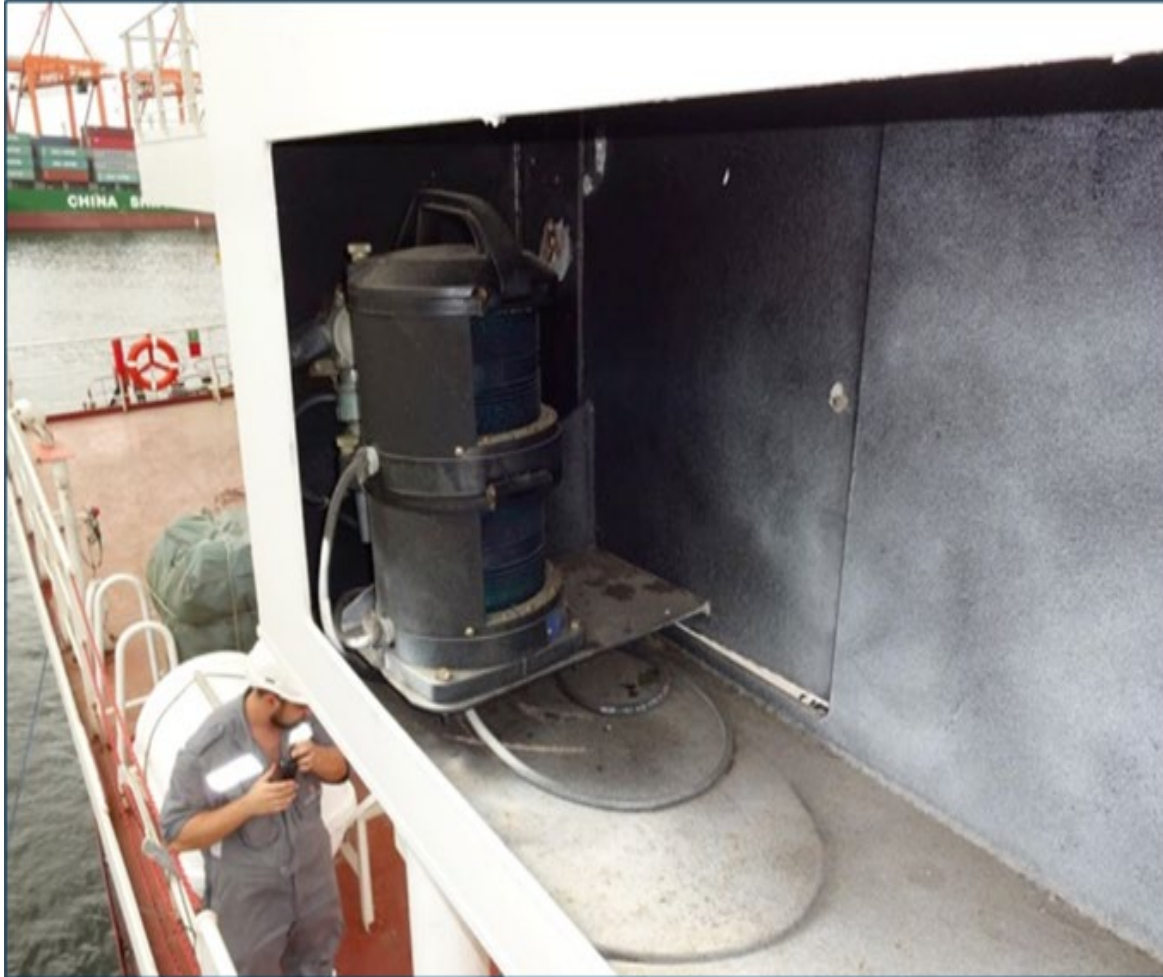
- Starboard side navigation light, newbuild vessel

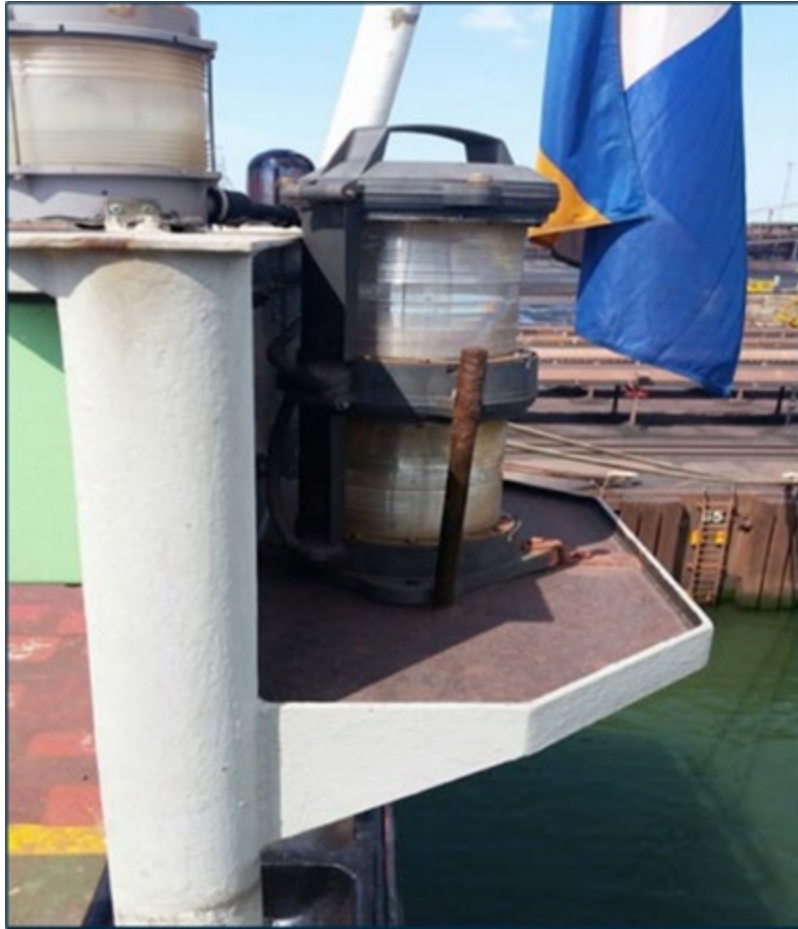
Stern light, before (10-year-old vessel)

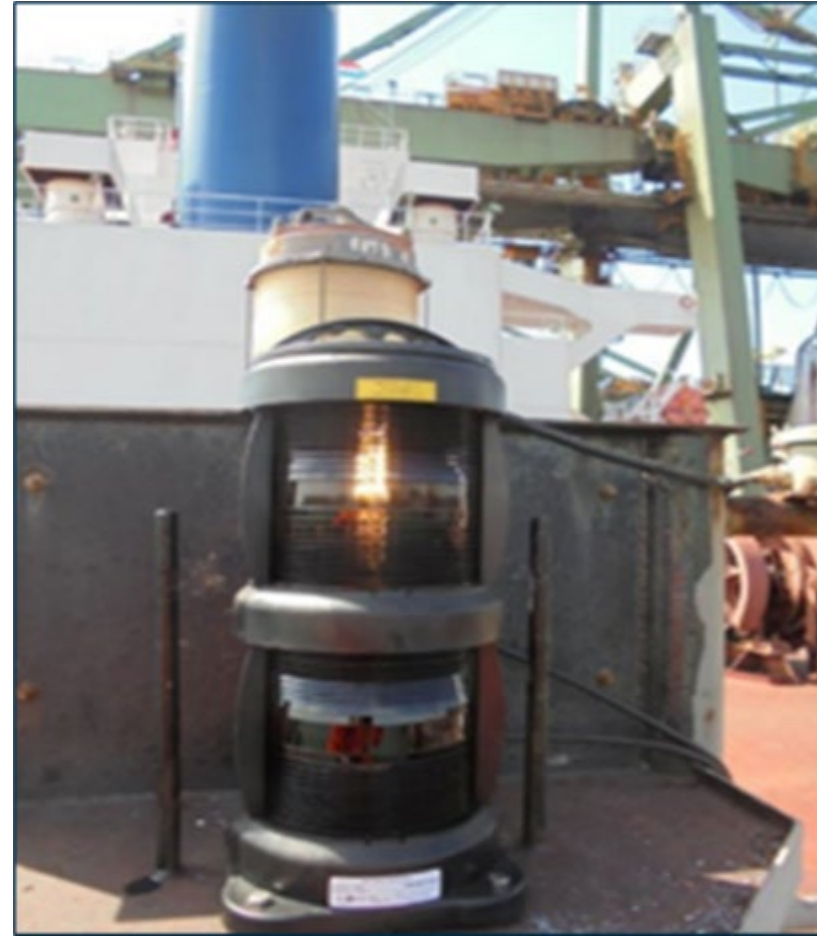
Stern light, after

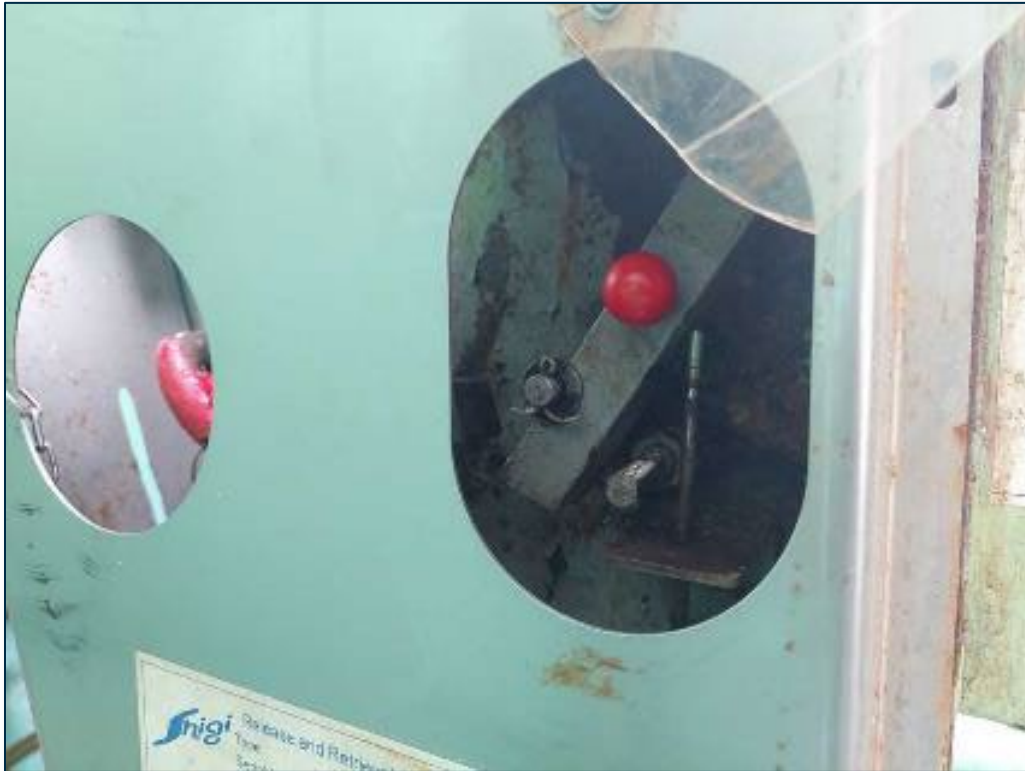
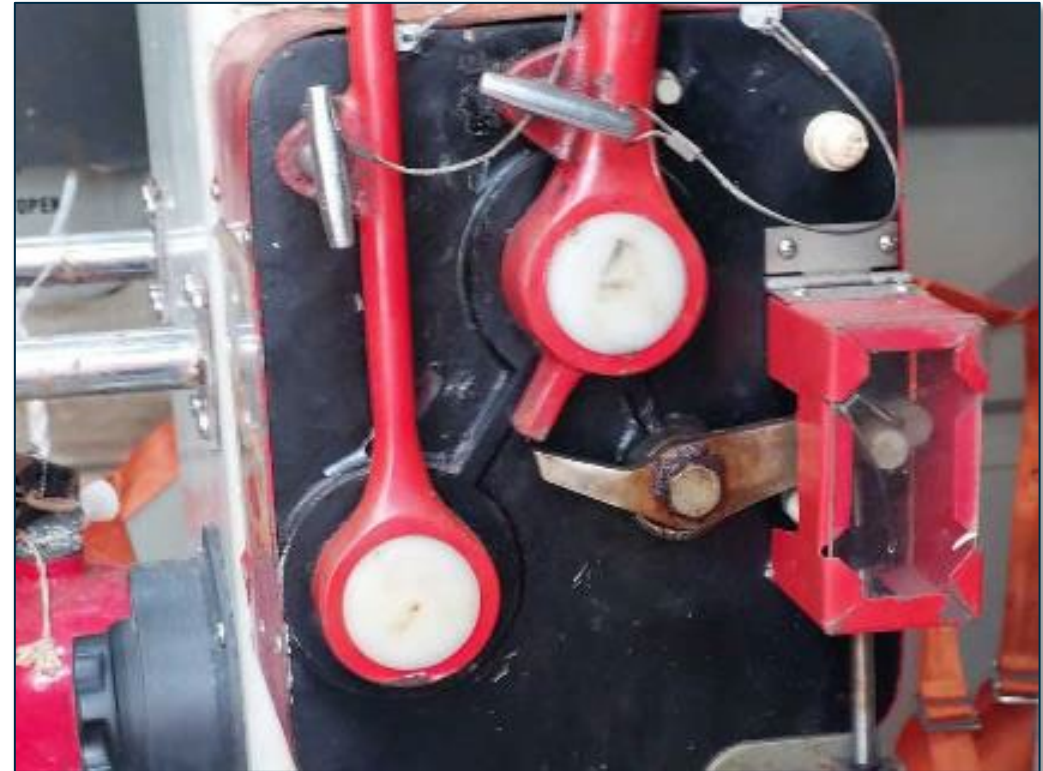
Release handles not properly reset and left in an open / unlocked position

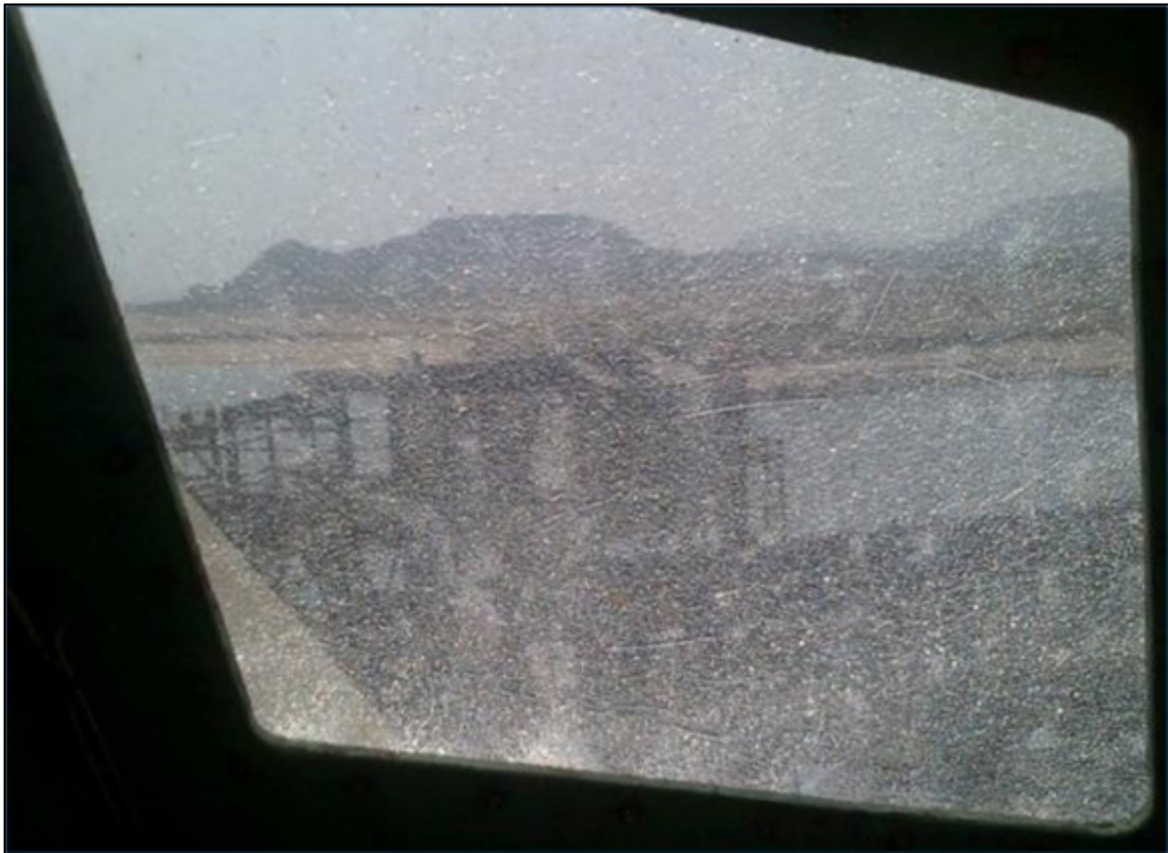
- Lifeboat glass / windows obscured or opaque.
- International Life-Saving Appliance (LSA) Code Chapter IV, Regulation 4.4.7.12.
- Every lifeboat shall be so arranged that an adequate view forward, aft, and to both sides is provided from the control and steering position for safe launching and maneuvering.

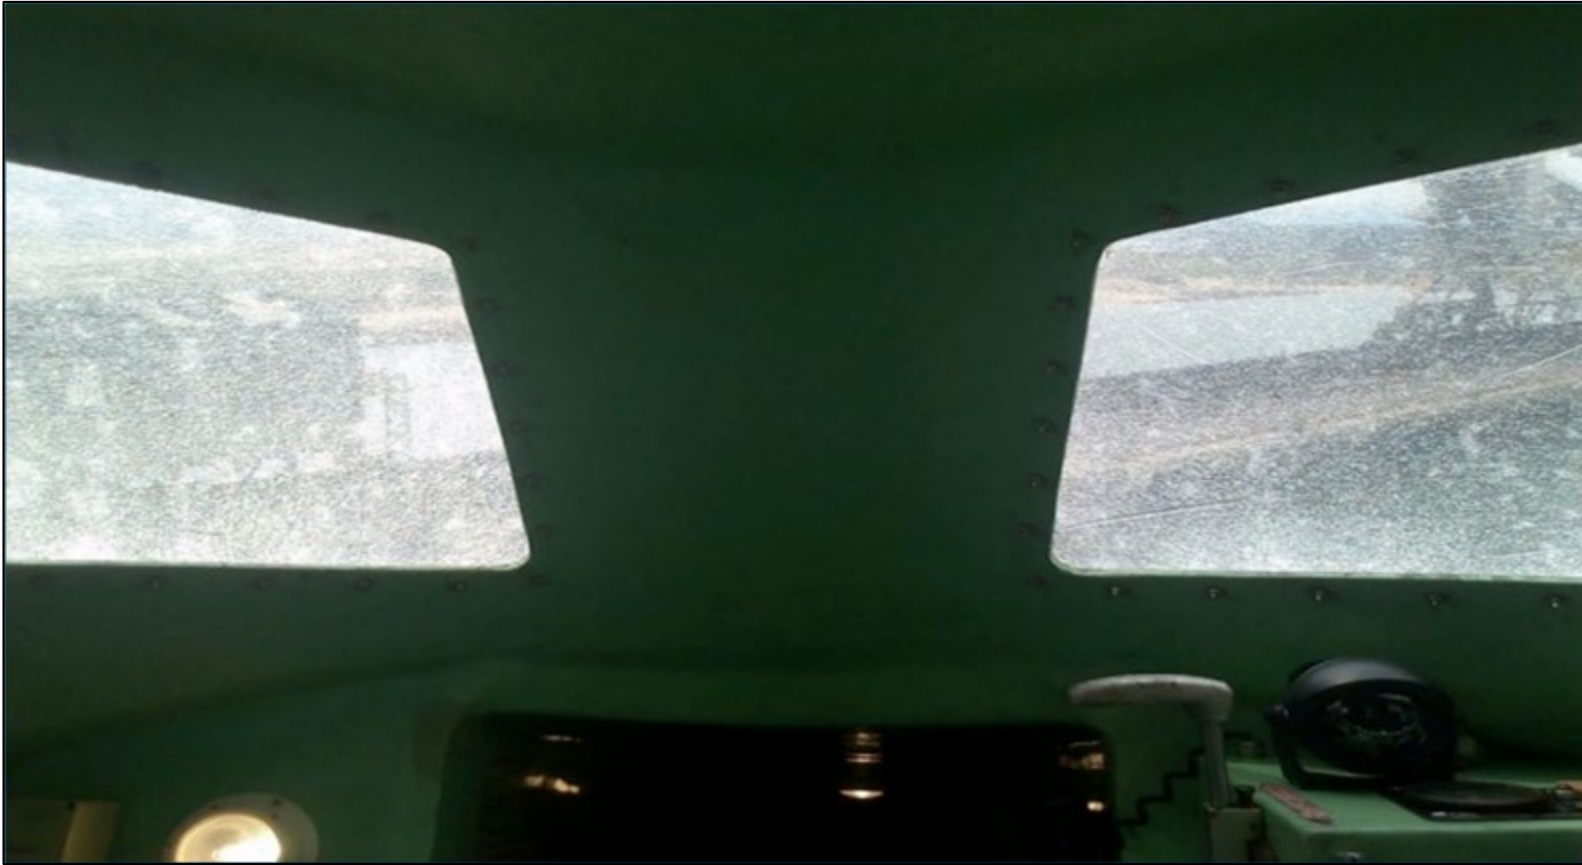
Free fall (FF) lifeboat front glass is obscured or opaque

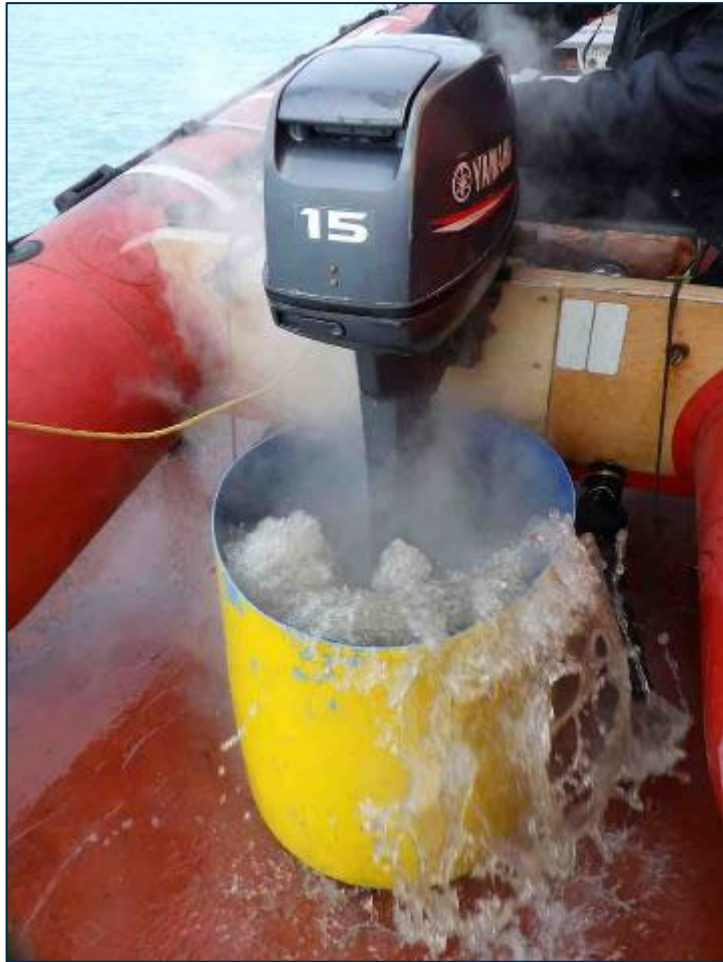
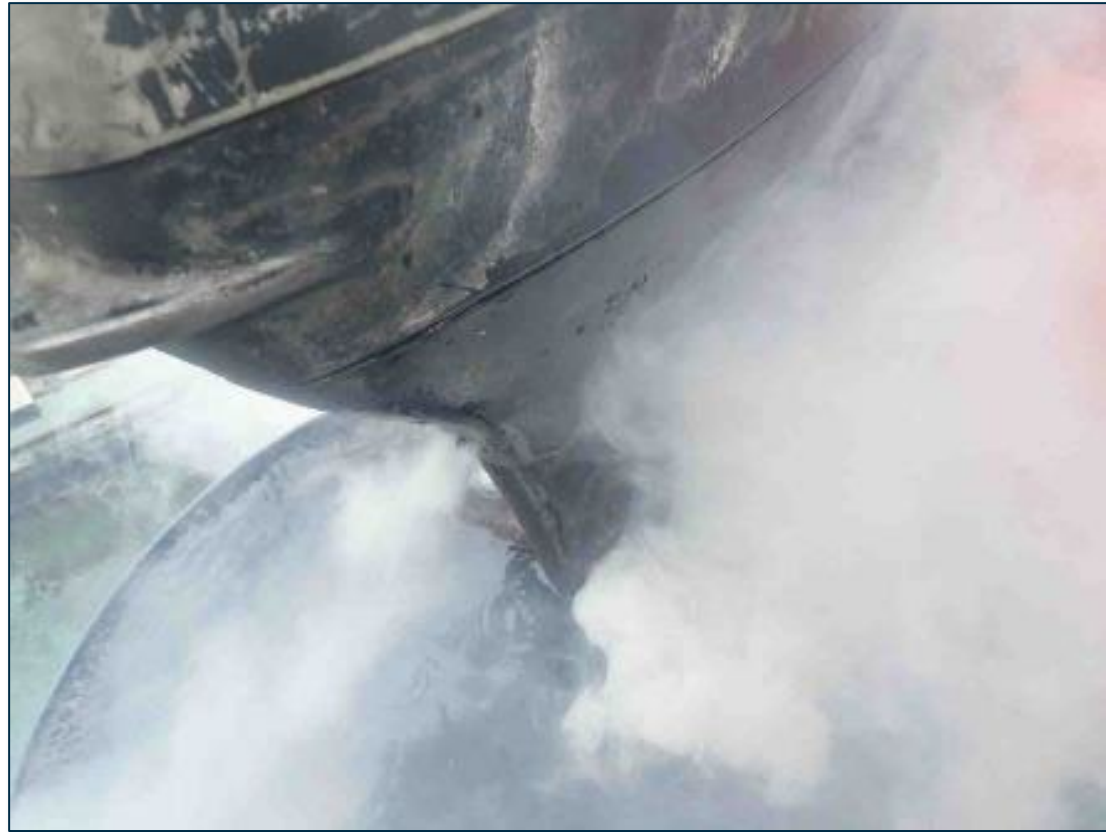
Outboard motor cooling system not functioning

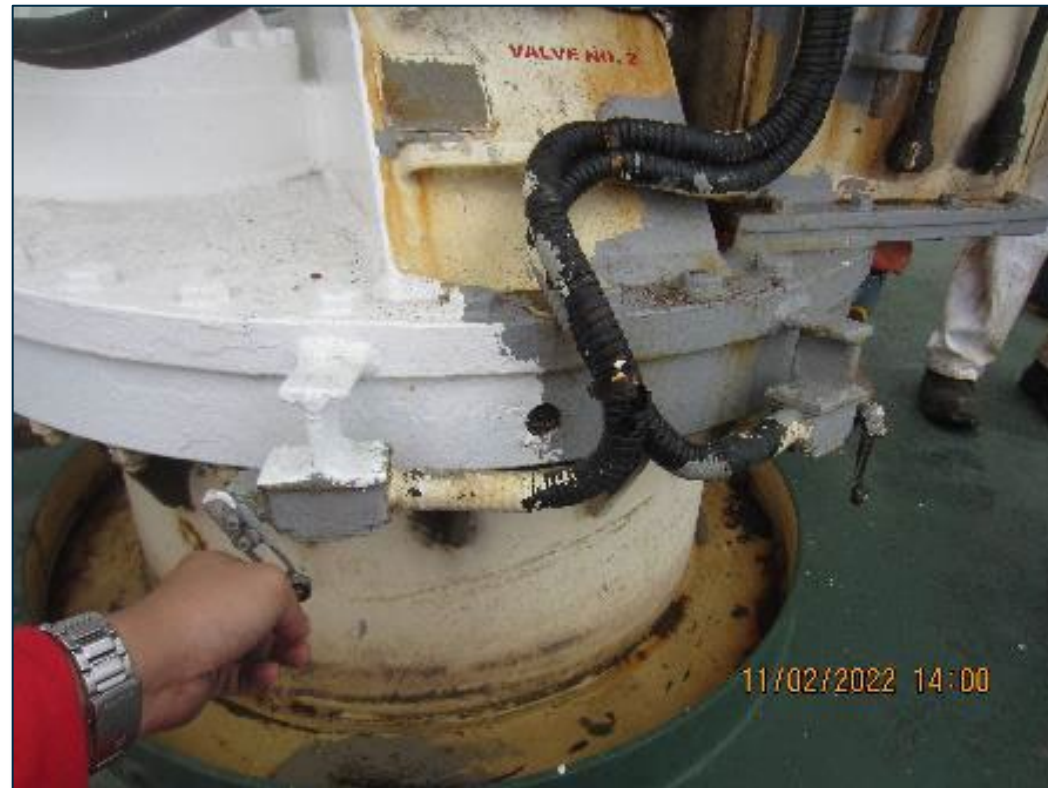
- Limit switches were found out of order during the swinging test of davit

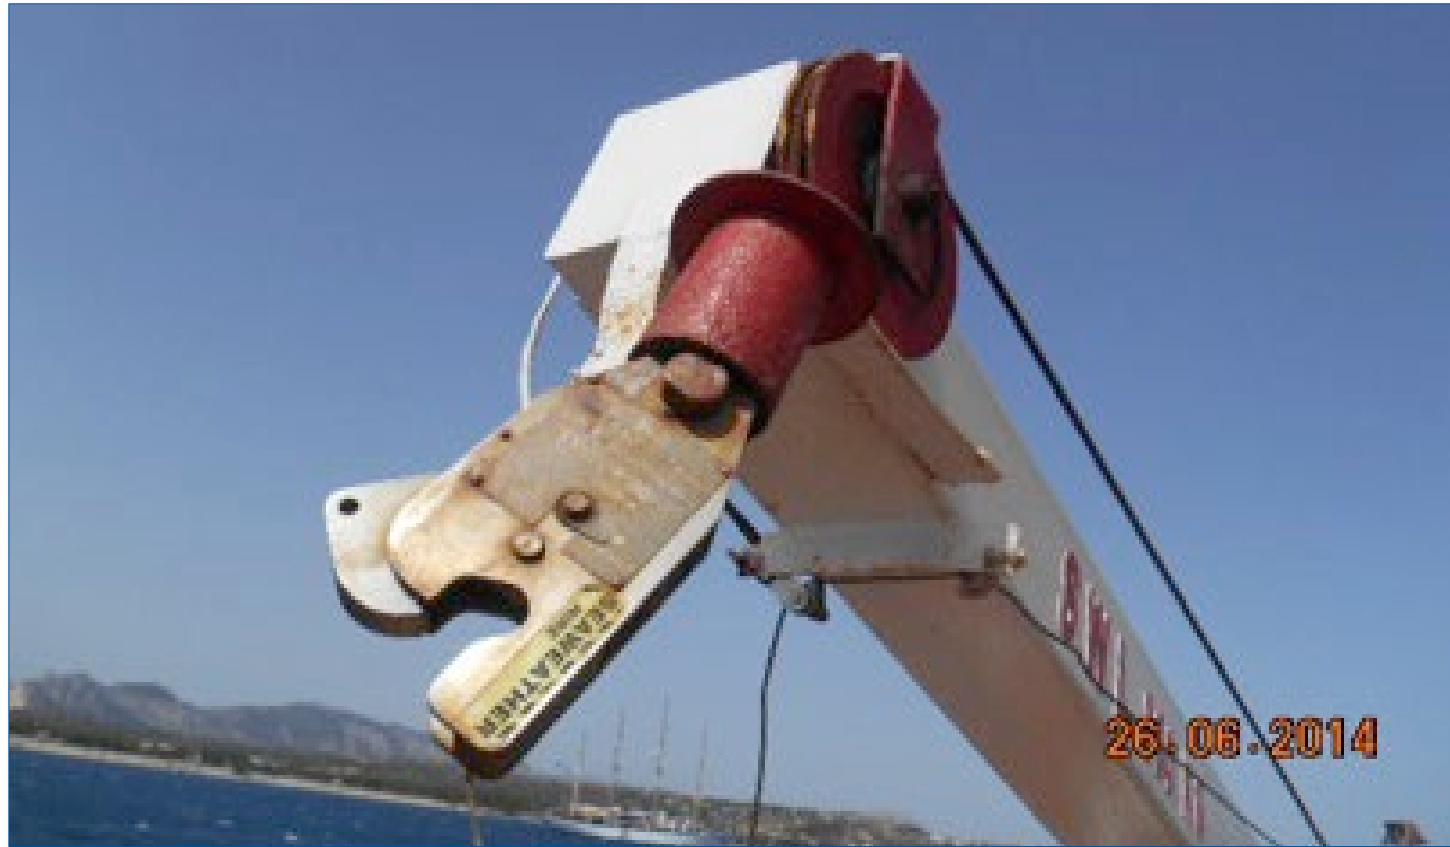
Rescue boat limit switch

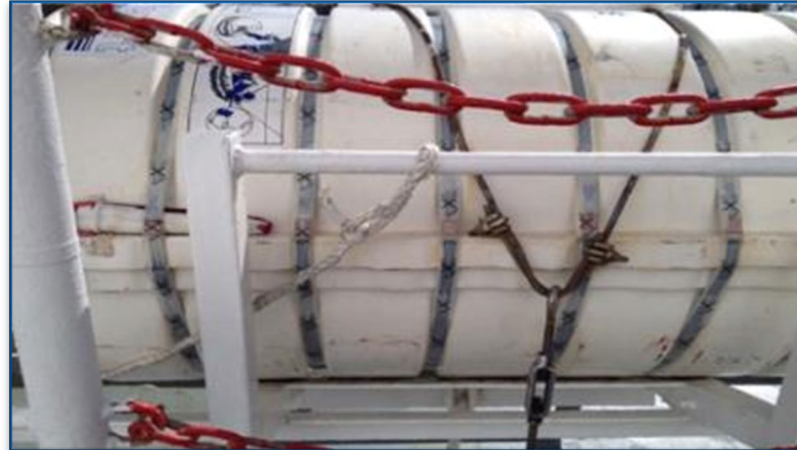
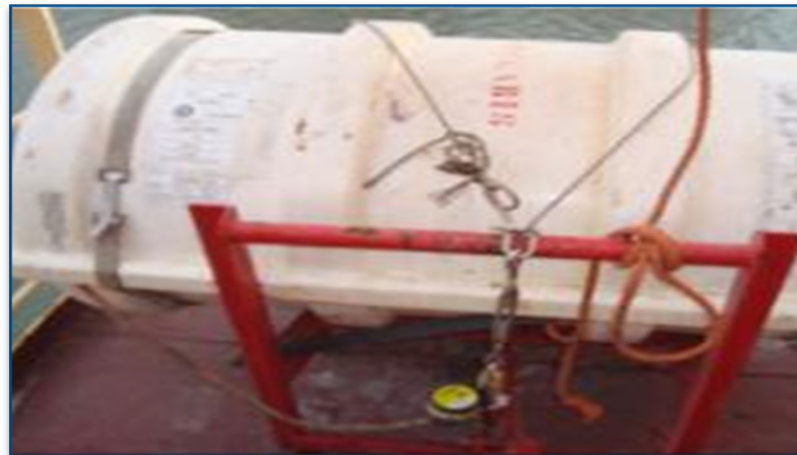
- Life raft's hydrostatic release units (HRUs) / painters' wrong connection and/or extra securing ropes

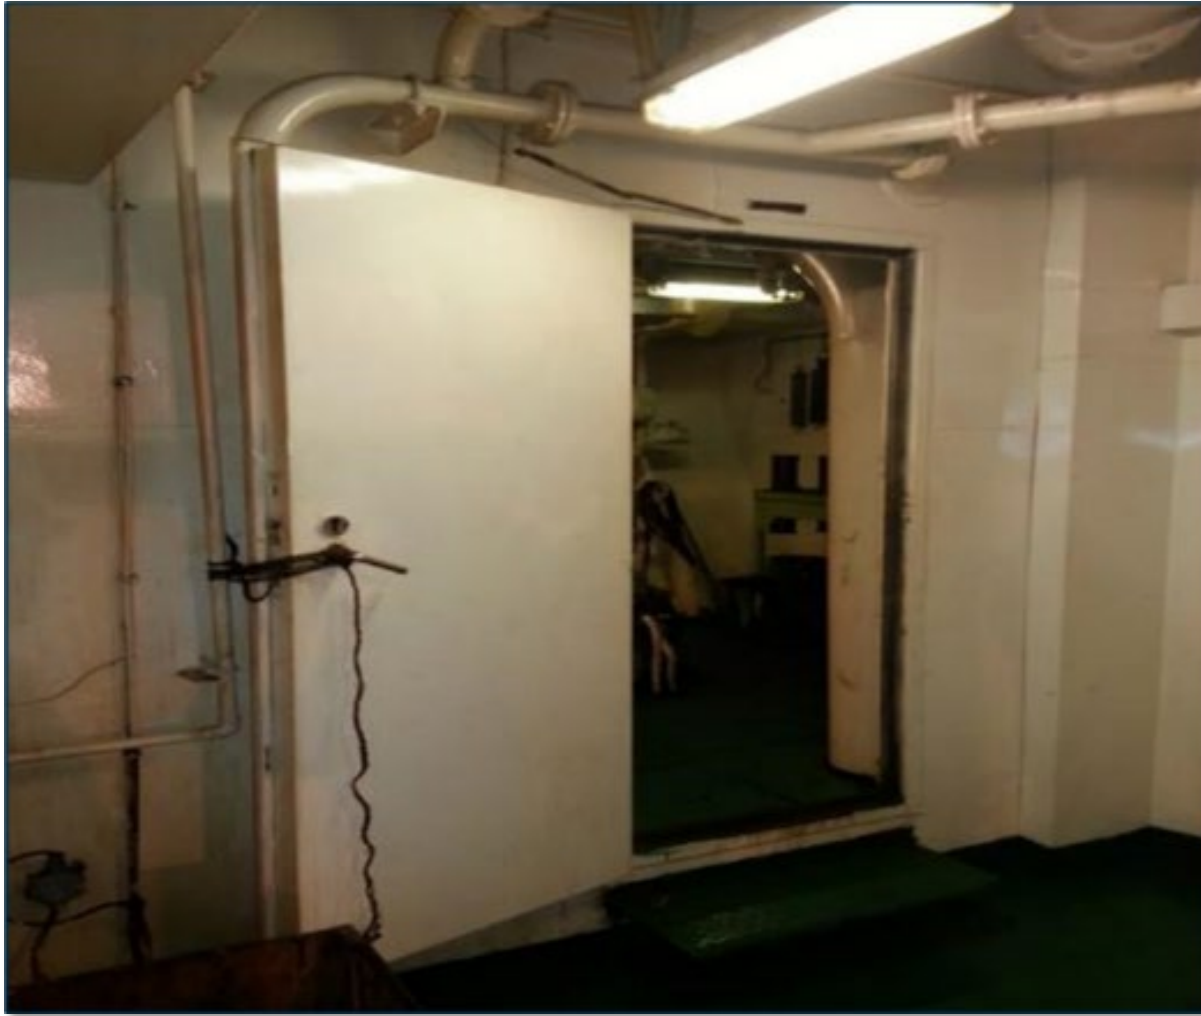
Class A door secured open

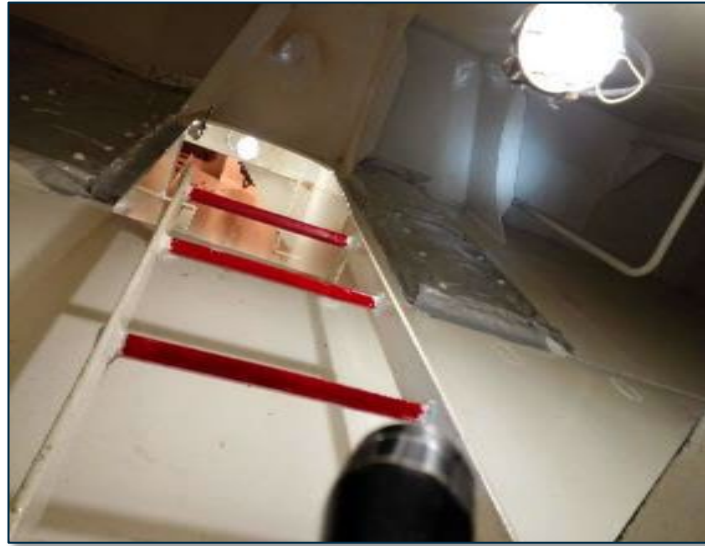
Escape trunk insulation missing

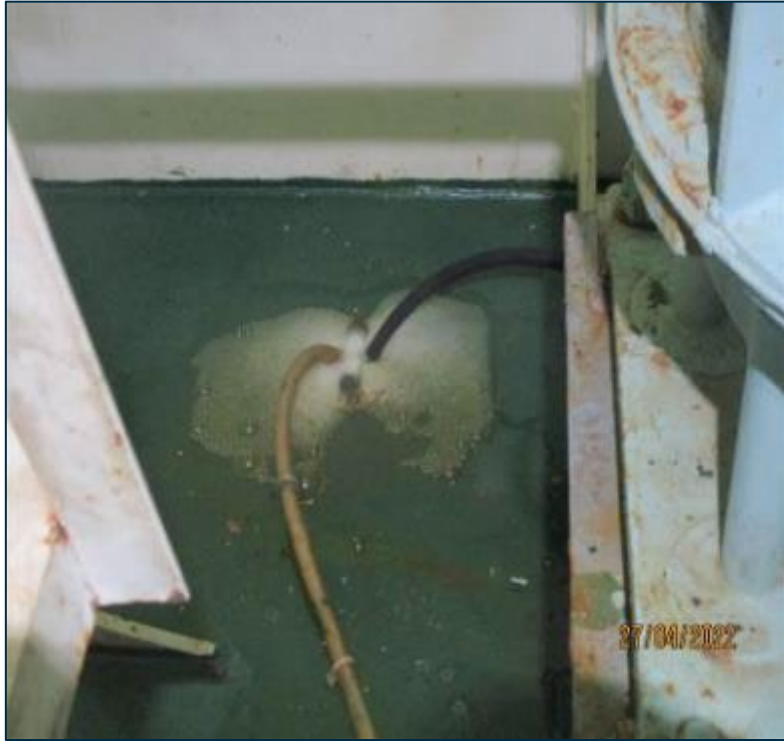
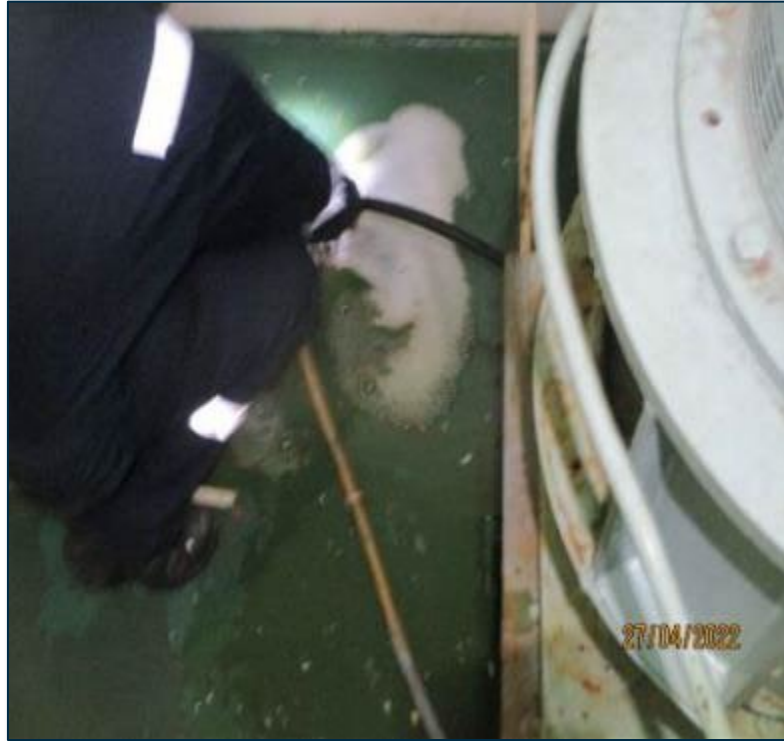
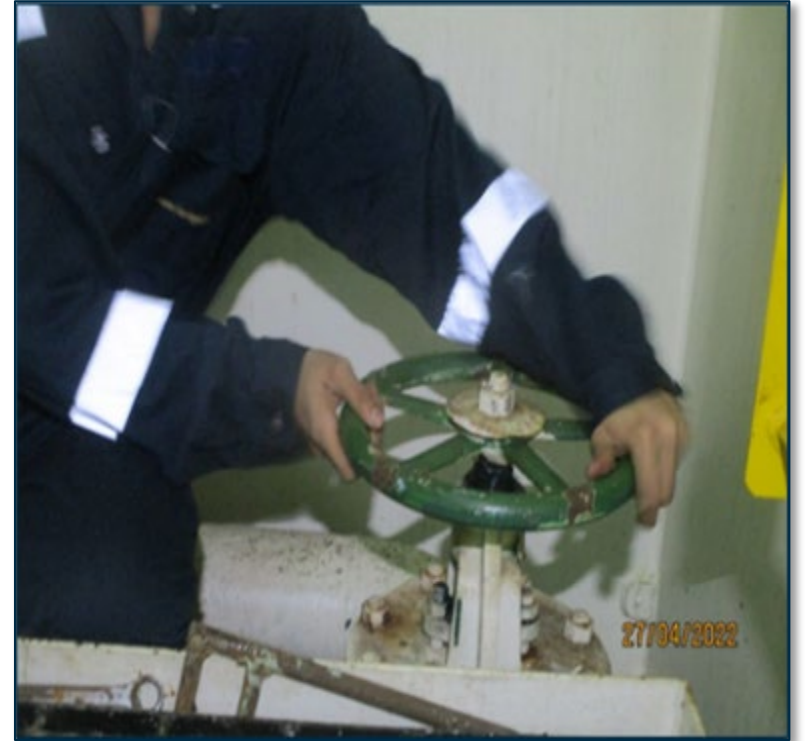
EFP not developing pressure and priming device non-operational

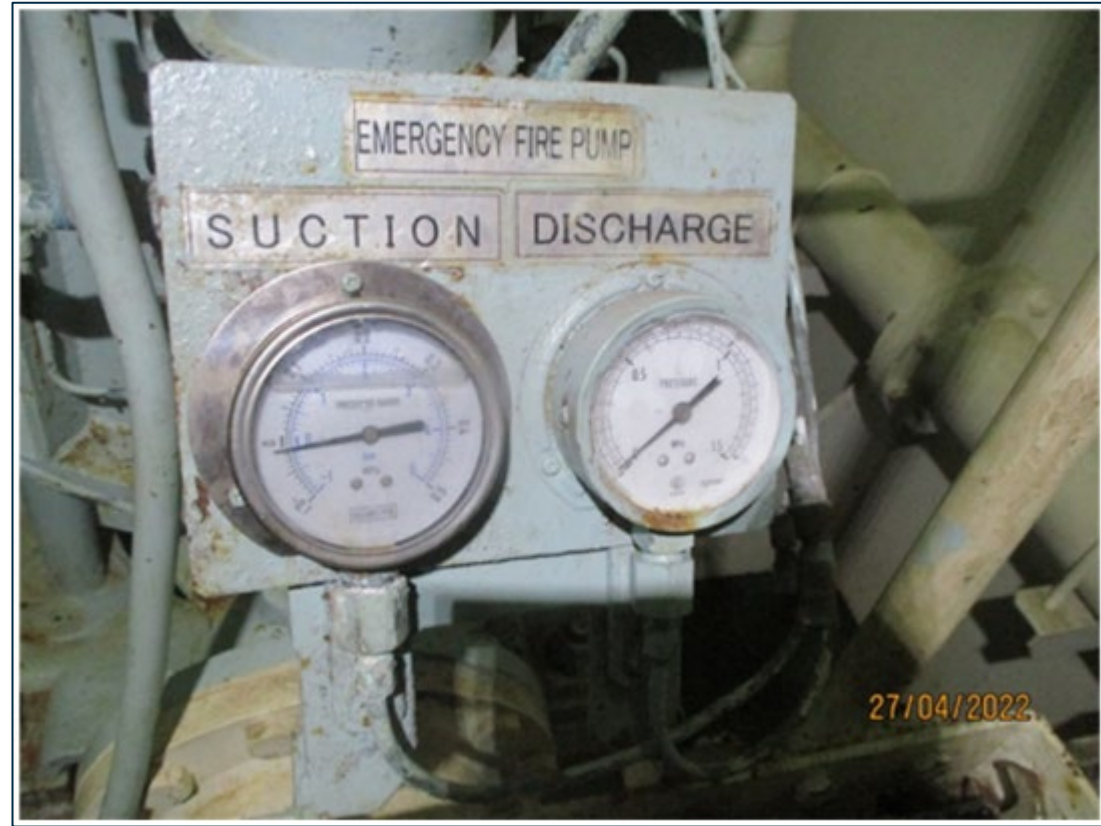
Compound gauge reading – vacuum, zero, or positive

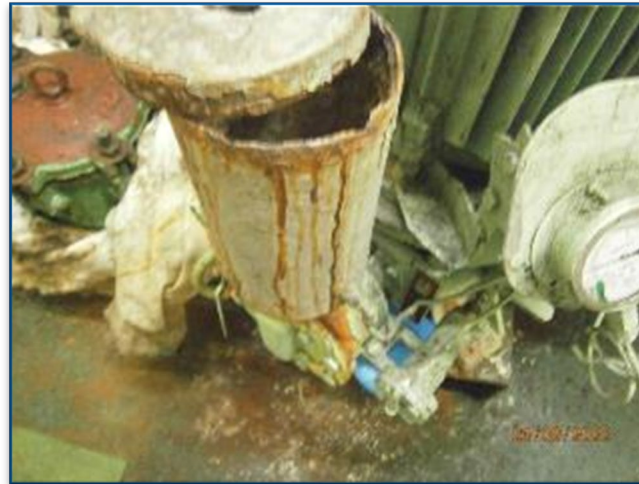
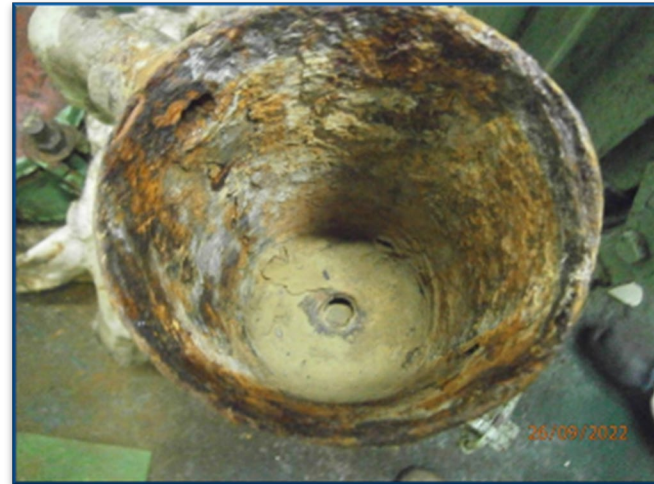
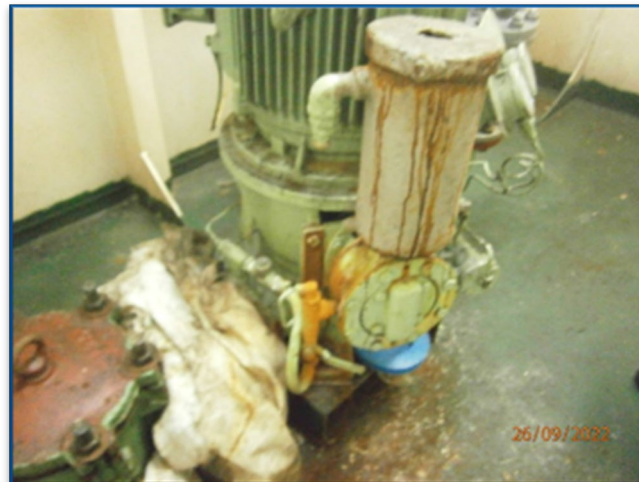
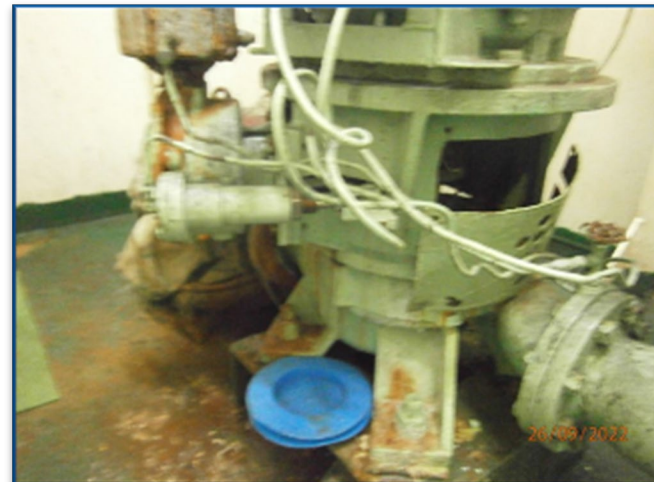
- Any leakages / water deposited in the emergency fire pump space?
- Priming device functioning correctly?
- Require manual priming by closing any valves?
- The above will provide a clear indication regarding the health of the priming system.
- More important especially when the ship is under light conditions.

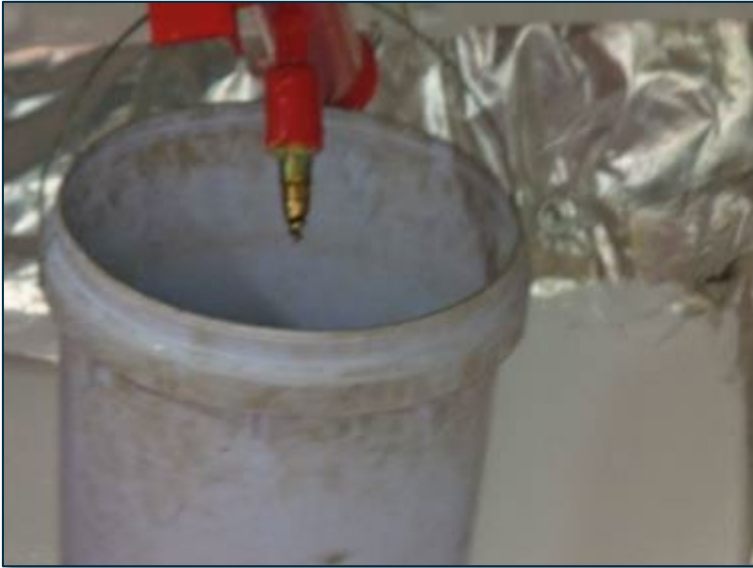
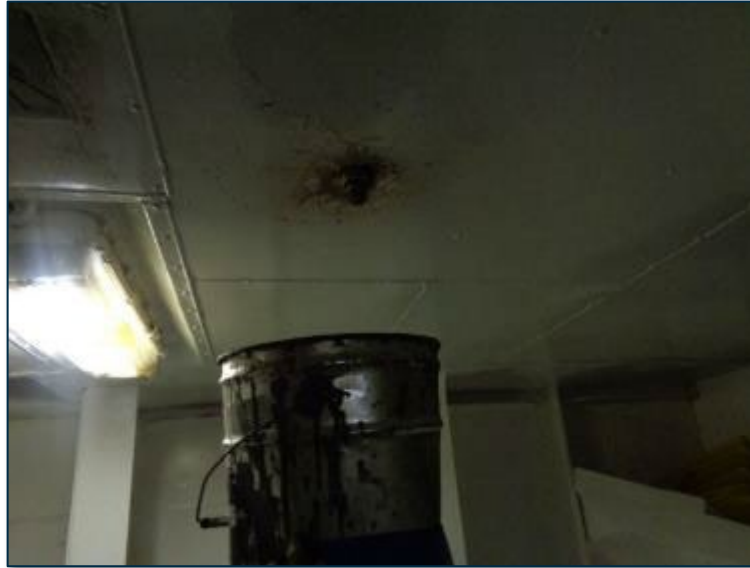
PAINT LOCKER SPRINKLERS

Sprinklers are choked

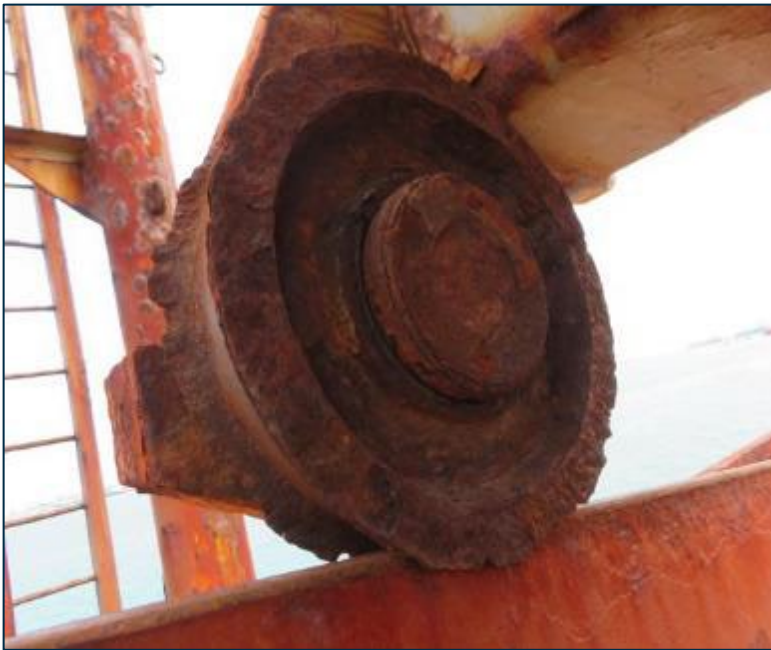
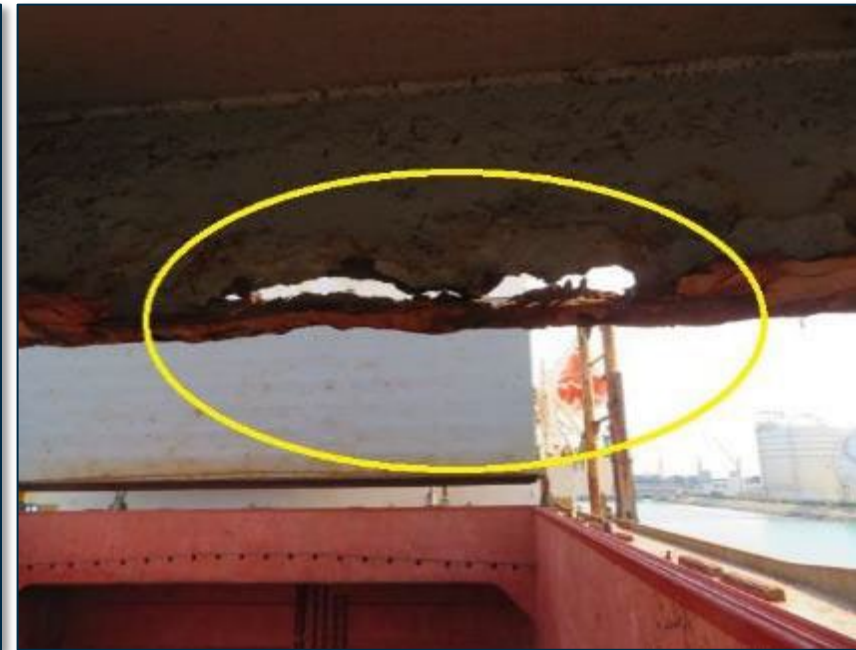
Wasted hatch cover wheel and panels

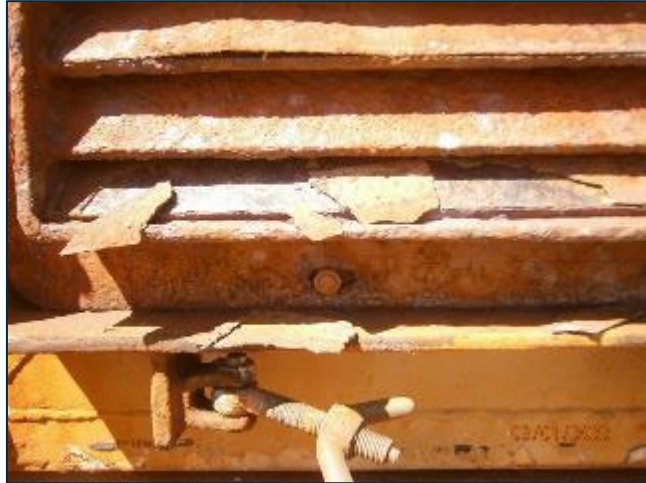
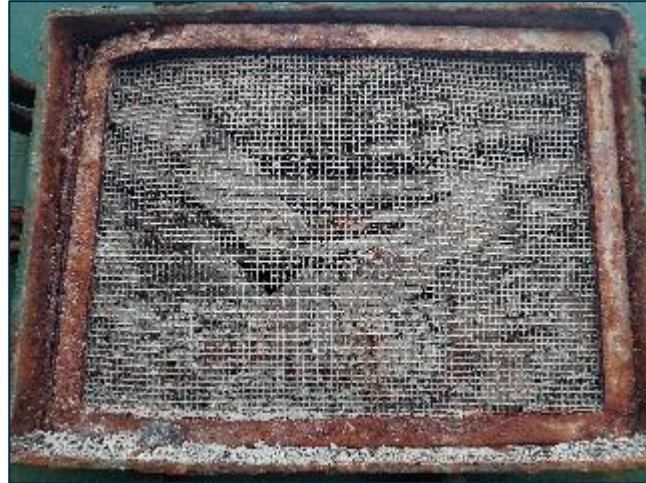
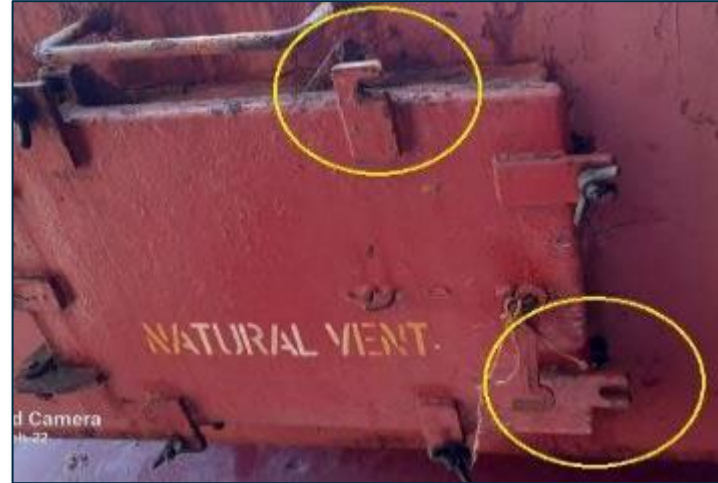
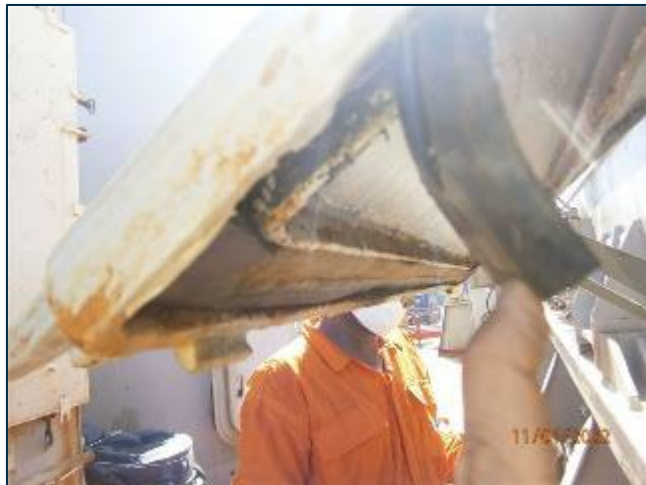
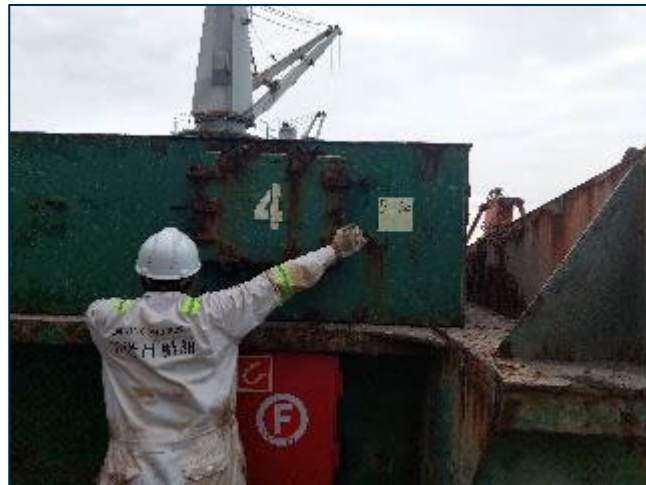
Hatch cover natural vents in poor condition
