FLAG STATE INSPECTIONS AND COMMON DEFICIENCIES

Captain Sascha Marcel Dyker

Fleet Operations Manager (Hong Kong)

March 2025

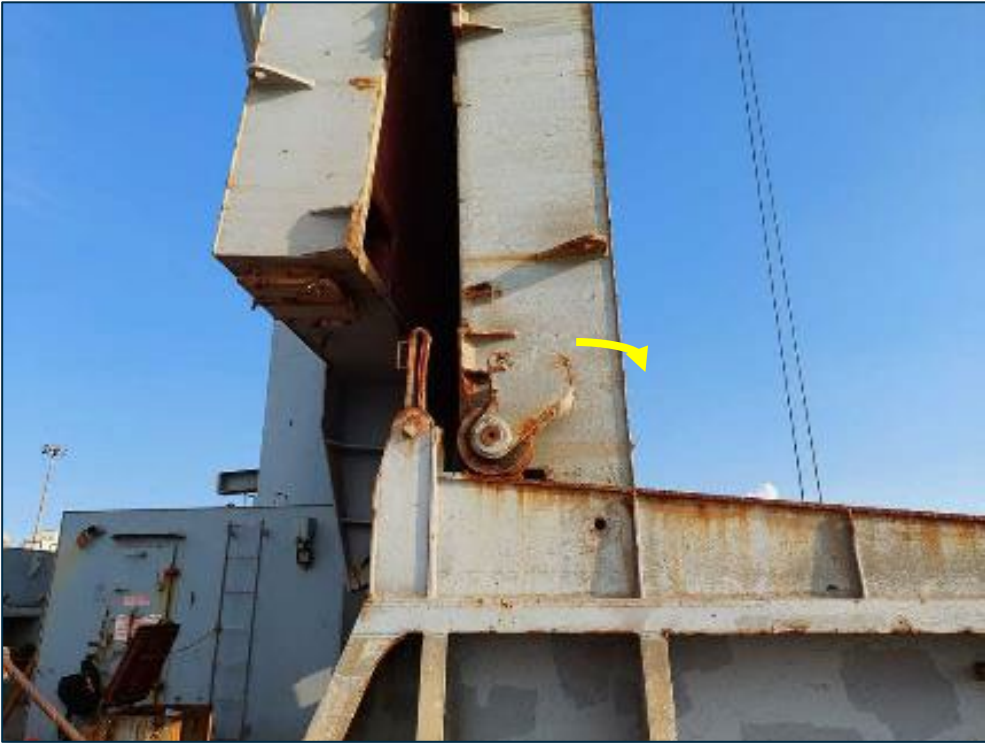
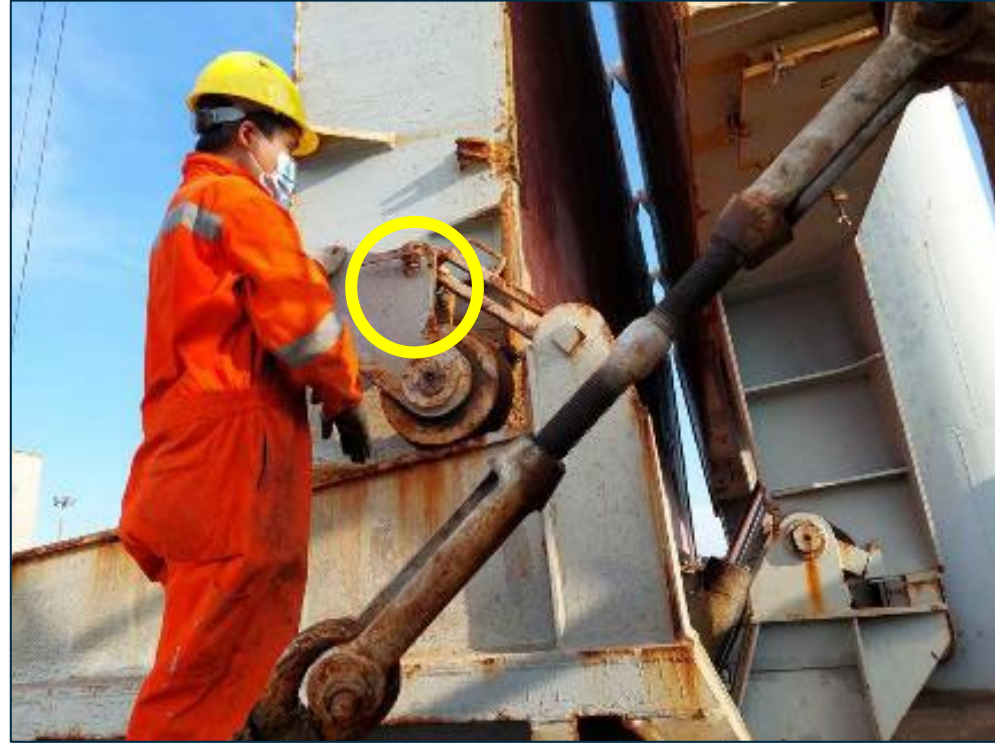
- Hatch covers are not secured while in the open position.
- Locking pins are stuck / seized.

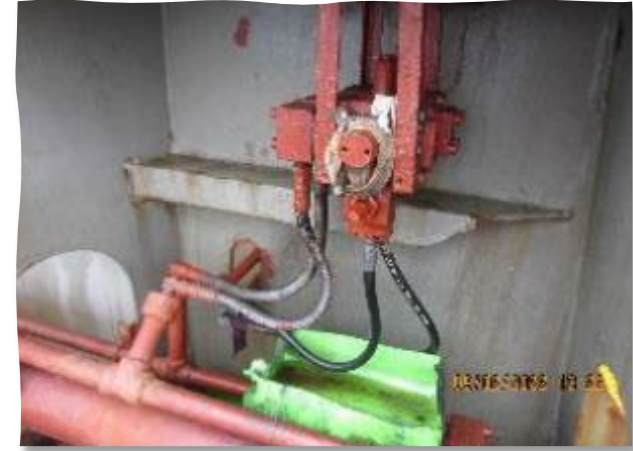
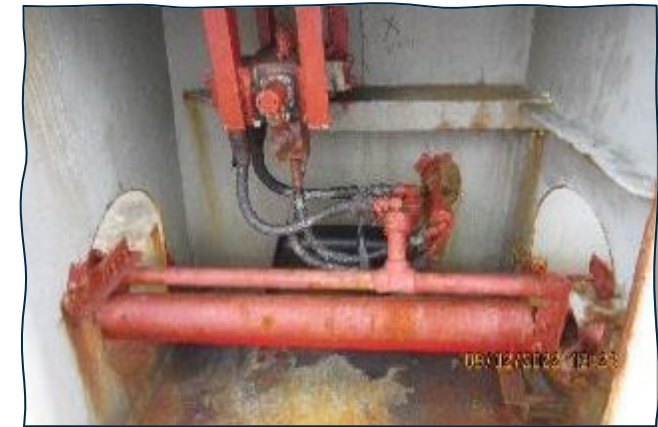
Hydraulic leaks

Second most common deficiency related to hatch covers from January to June 2022.

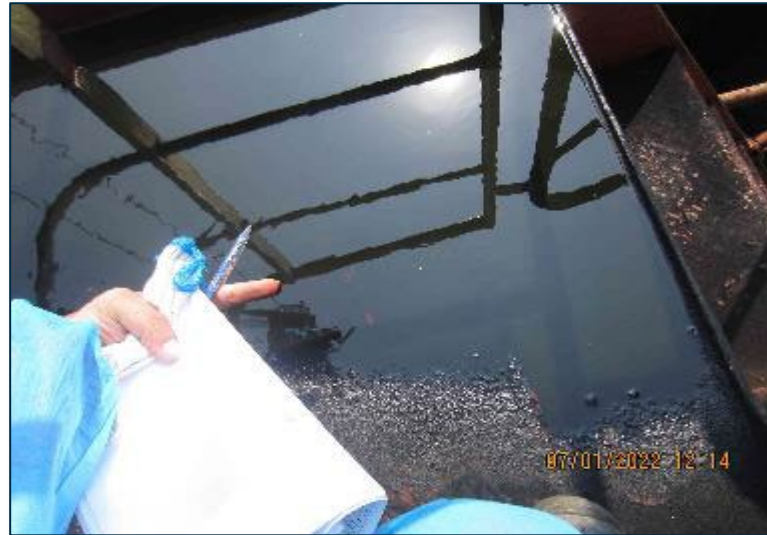
Hydraulic leaks from winches and windlasses

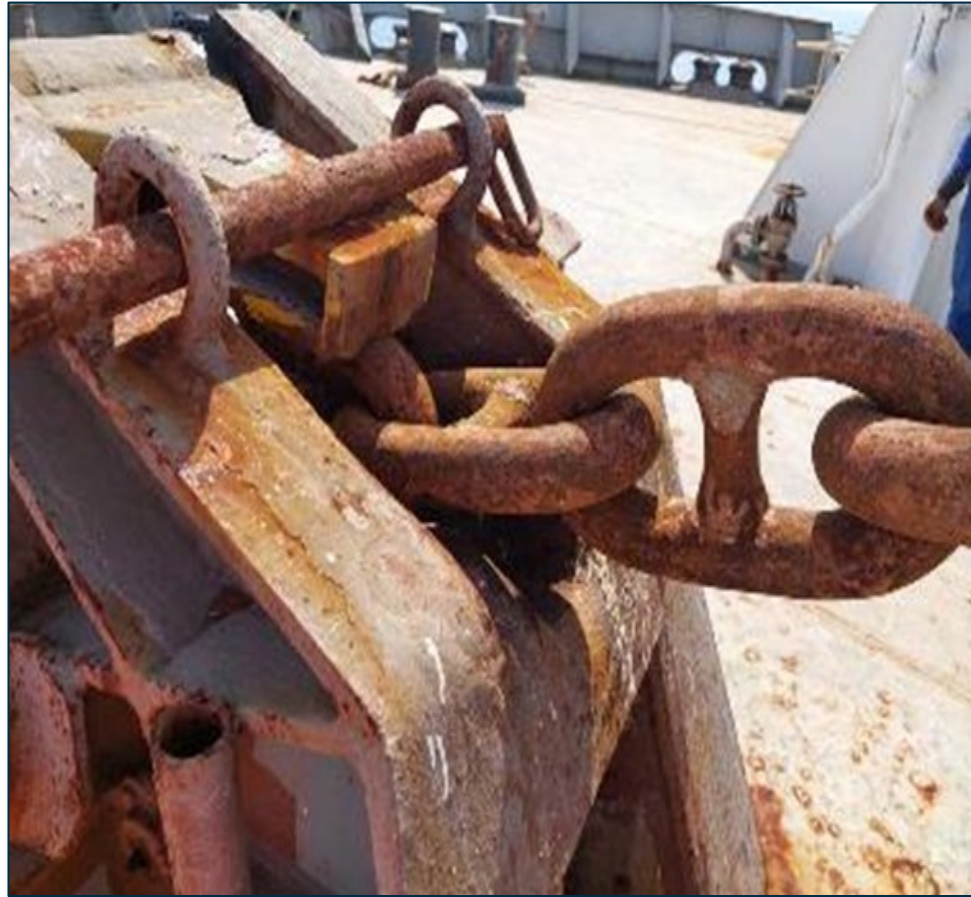
Chain not resting on stopper at anchor home position

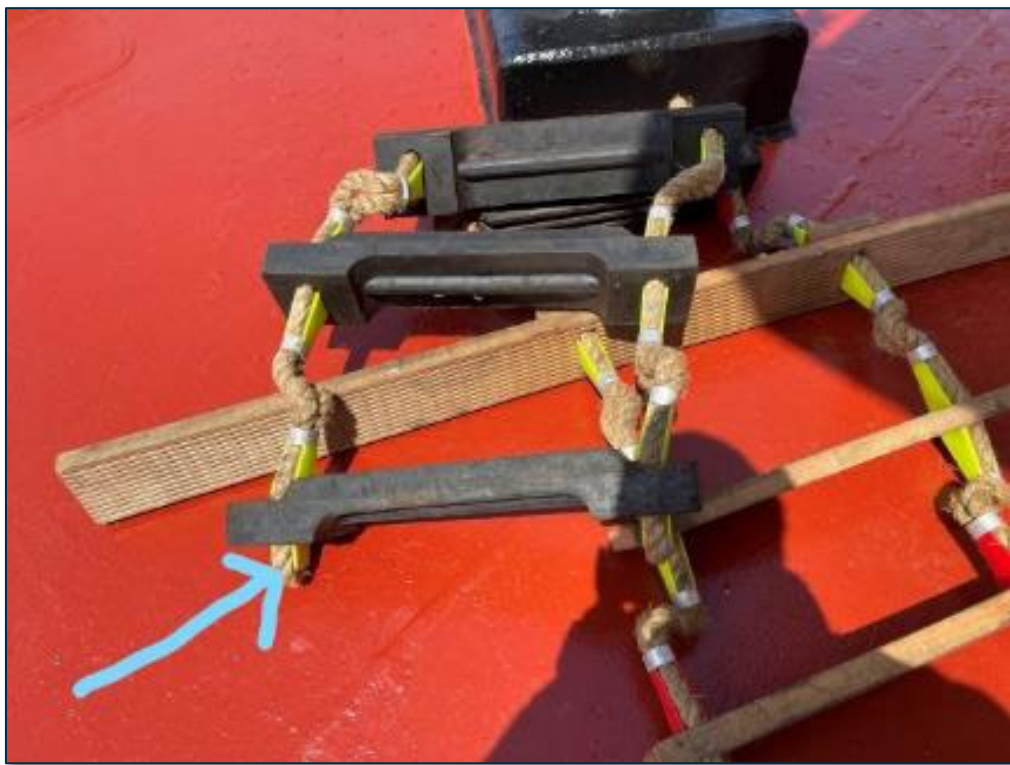
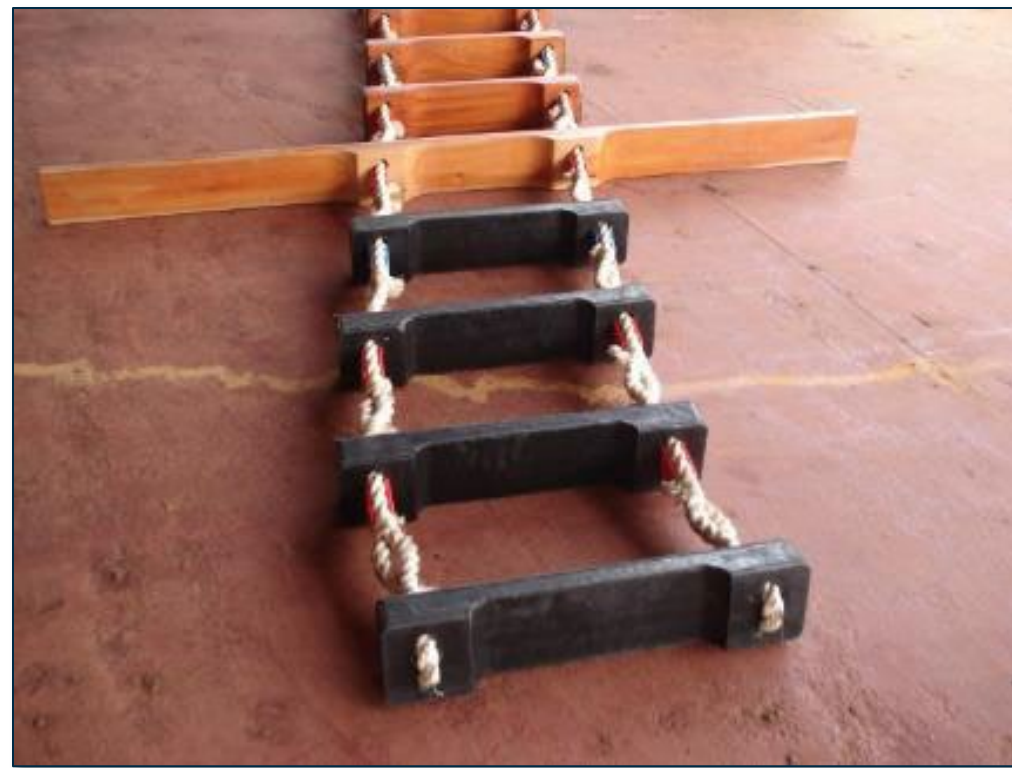
- Side rope's mid-point half length is not located on thimbles as specified in IMO Resolution A.1045(27) as recommended by the ISO 799:2004
- Updates stated in ISO 799:2019 say otherwise BUT currently it is not yet incorporated by IMO

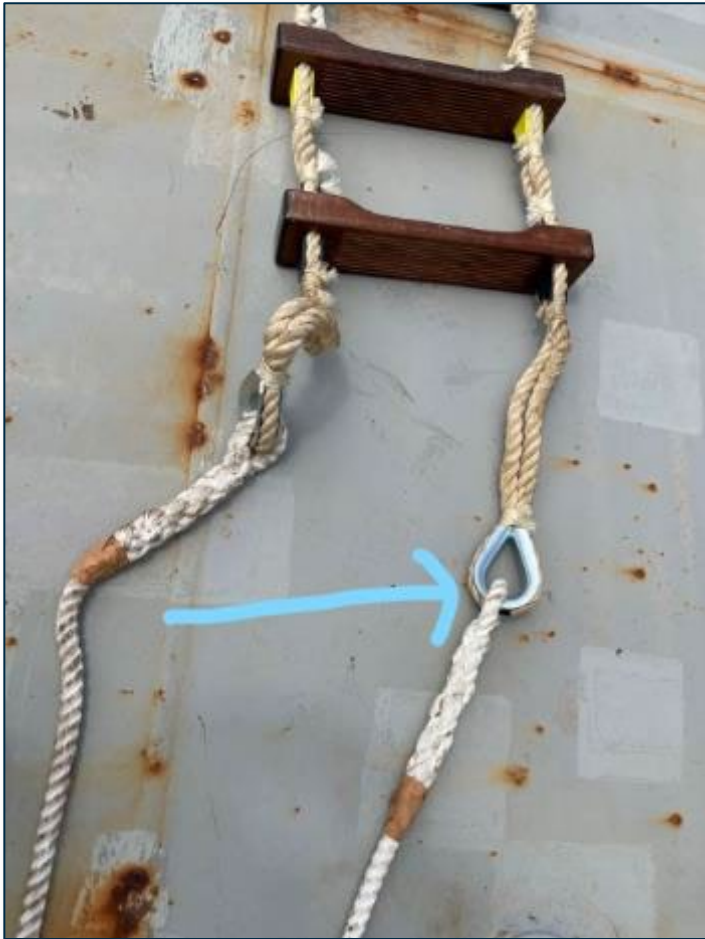
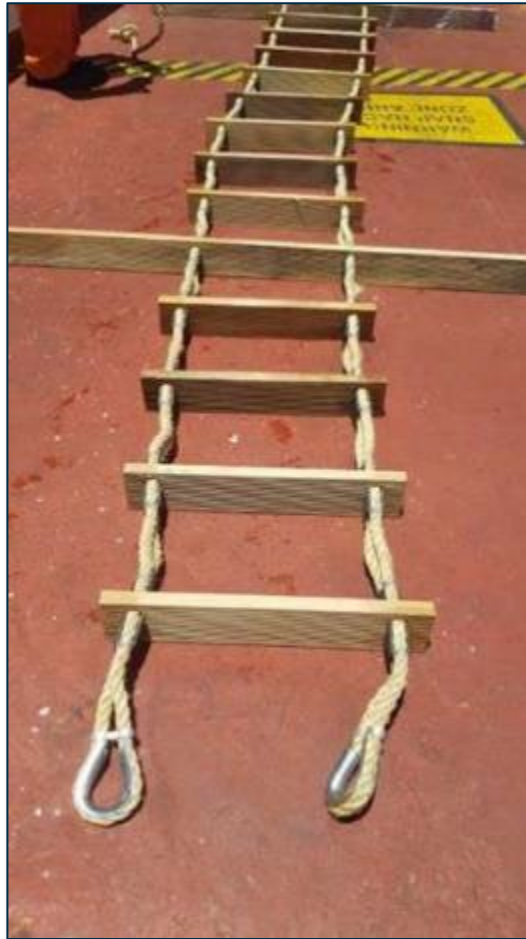
Sample of pilot ladders which have their side ropes' mid-point half length around thimbles

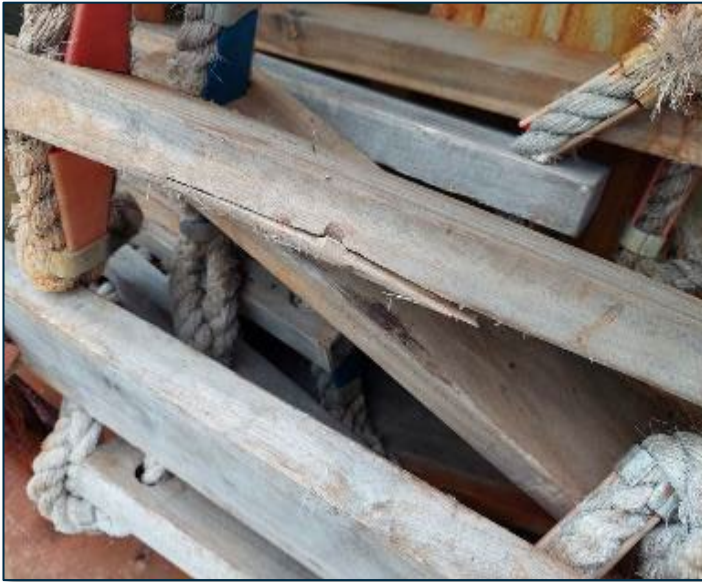
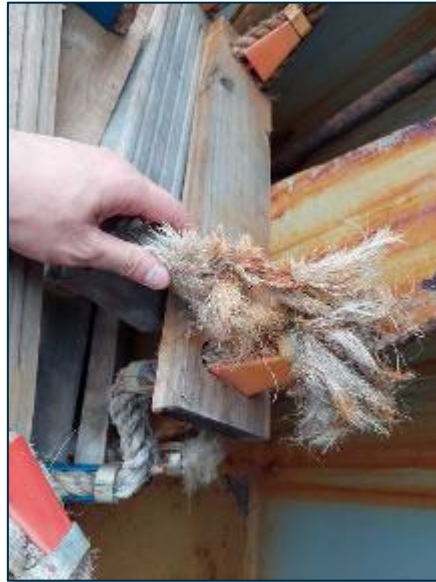
Pilot ladder wastages and cracks

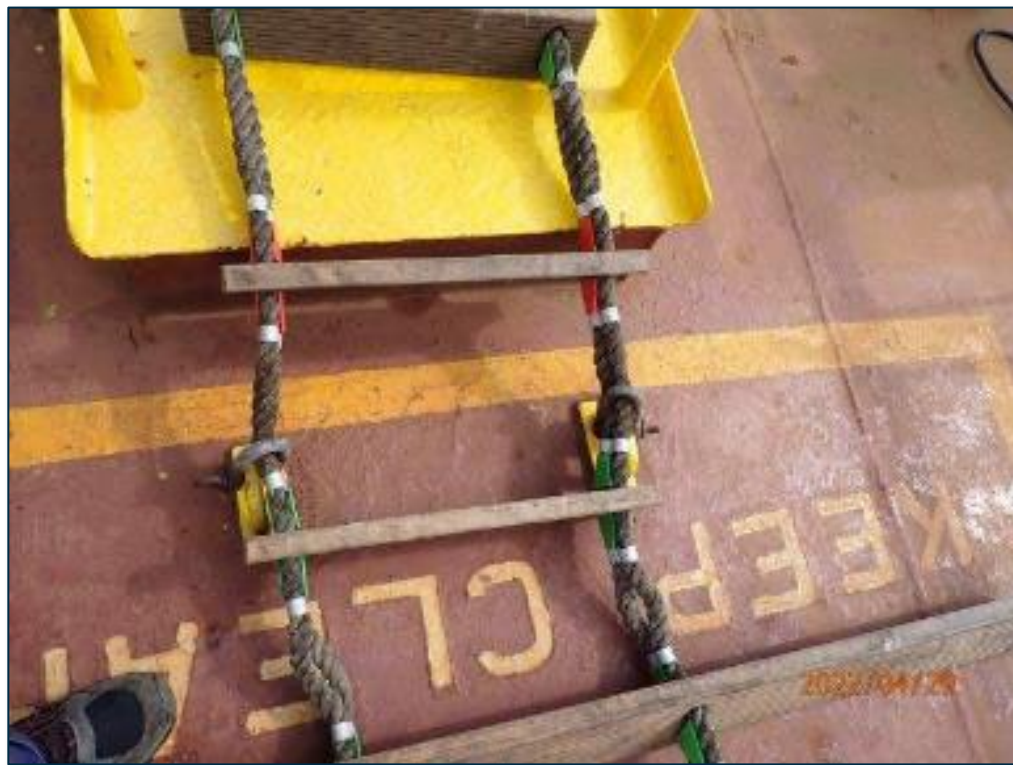
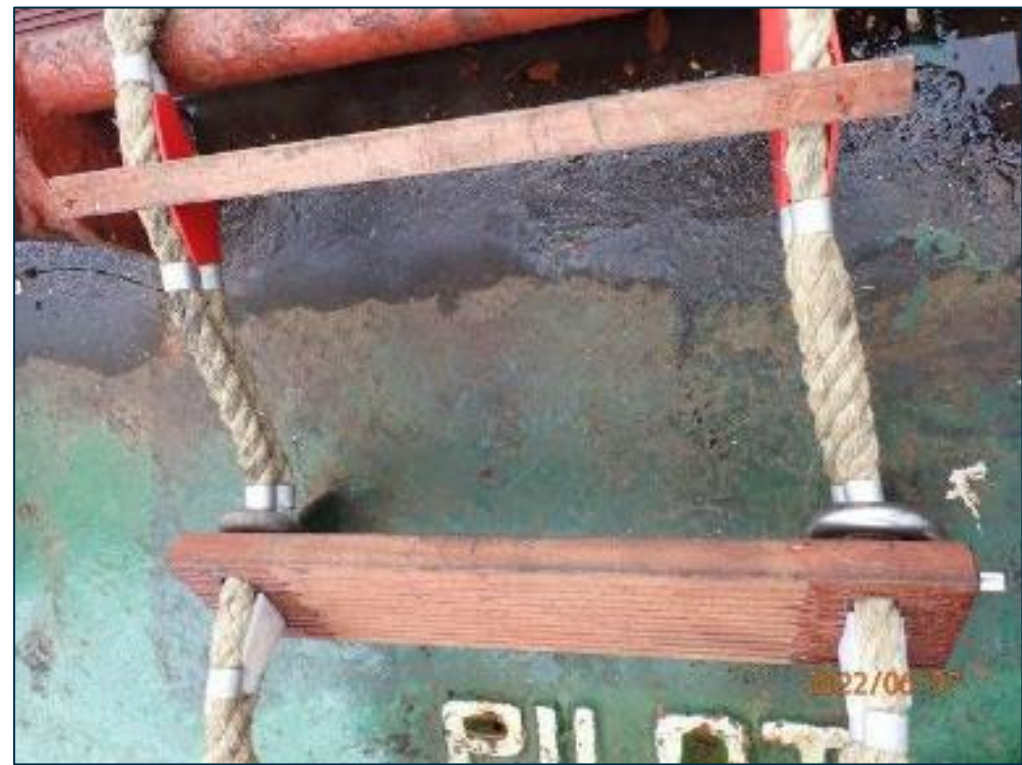
PILOT LADDERS (continued)

Pilot ladder rubber steps damaged

Pilot ladder chocks loosened / missing
(It does not ensure that the steps are prevented from moving)

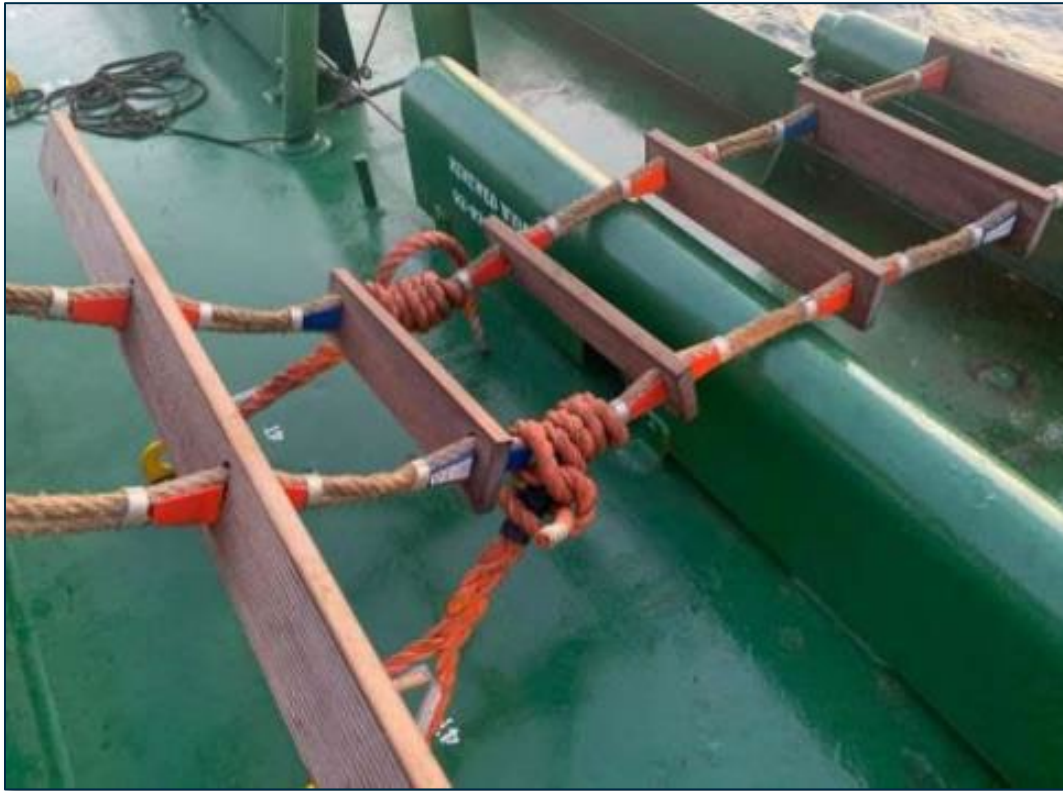
PILOT LADDERS (continued)

- The rolling hitch knot used on a well-rigged pilot ladder arrangement
- The pilot ladder should be secured to the ship's deck, on designated strong points, using the ladder's side ropes

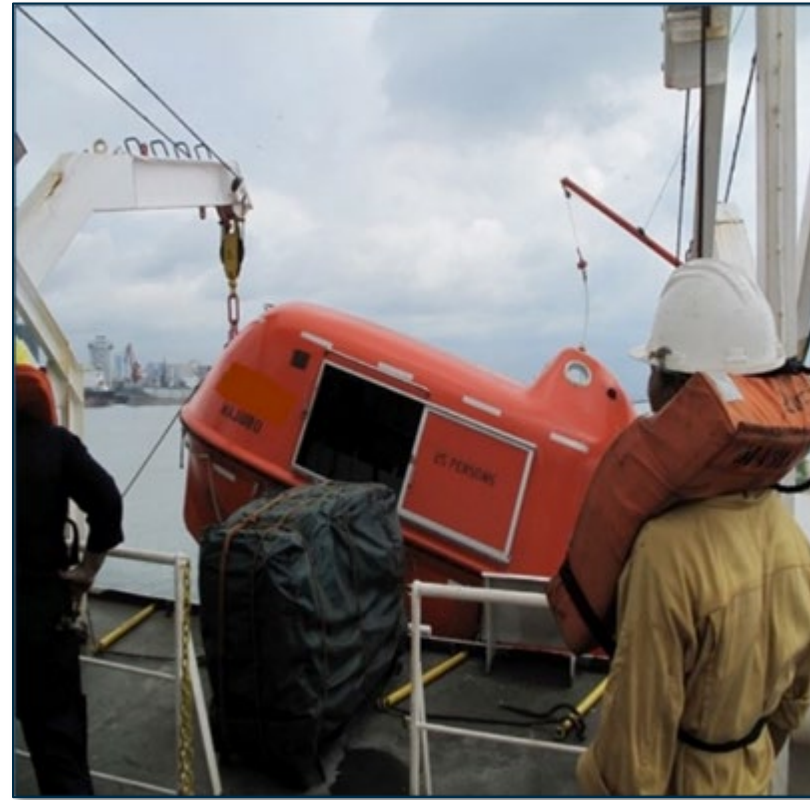
DRILLS (continued)

Lifeboat drill outcome

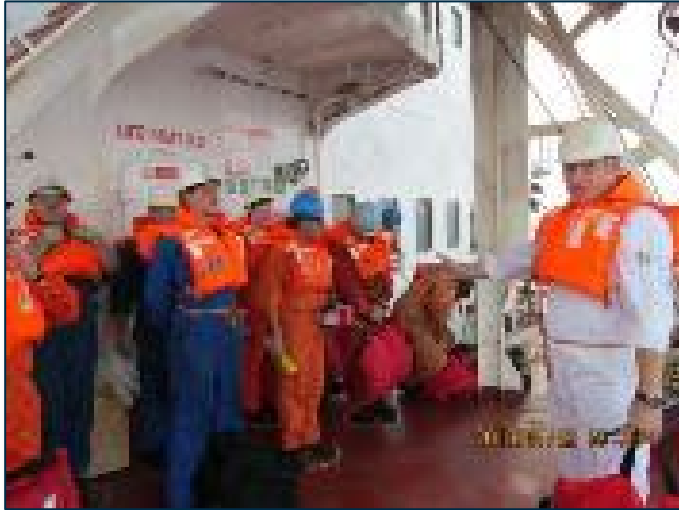
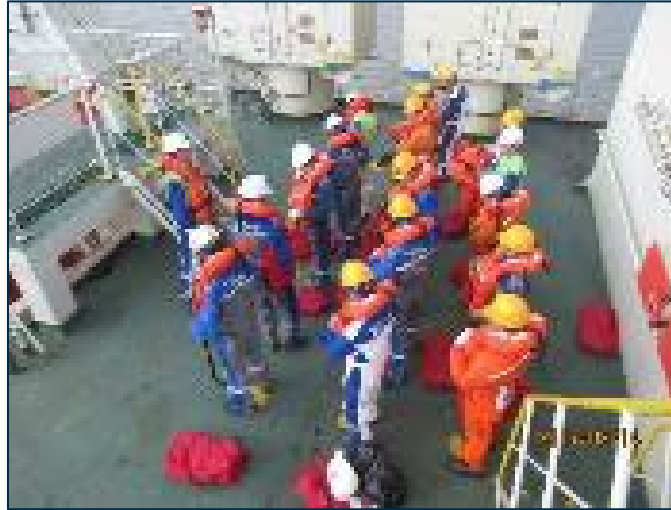
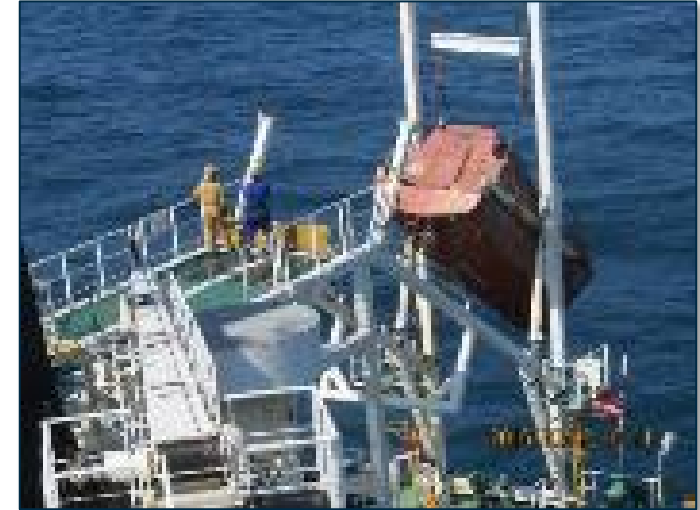
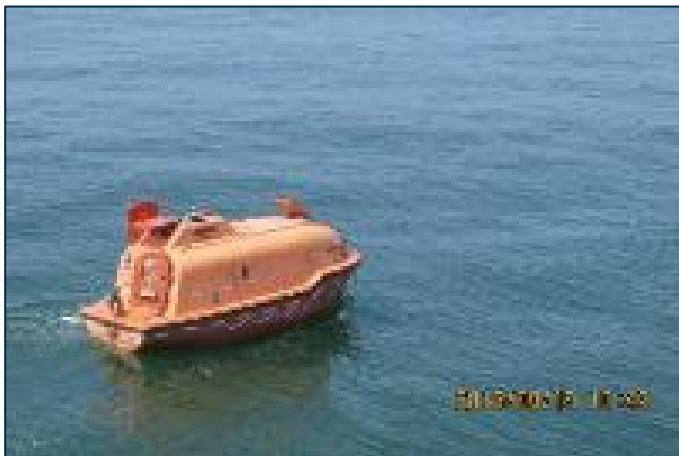
DRILLS (continued)

Simulated launching procedures for FF lifeboats
(see *Simulated Launching Procedures for Free-Fall Lifeboats* (MN 7-041-4))

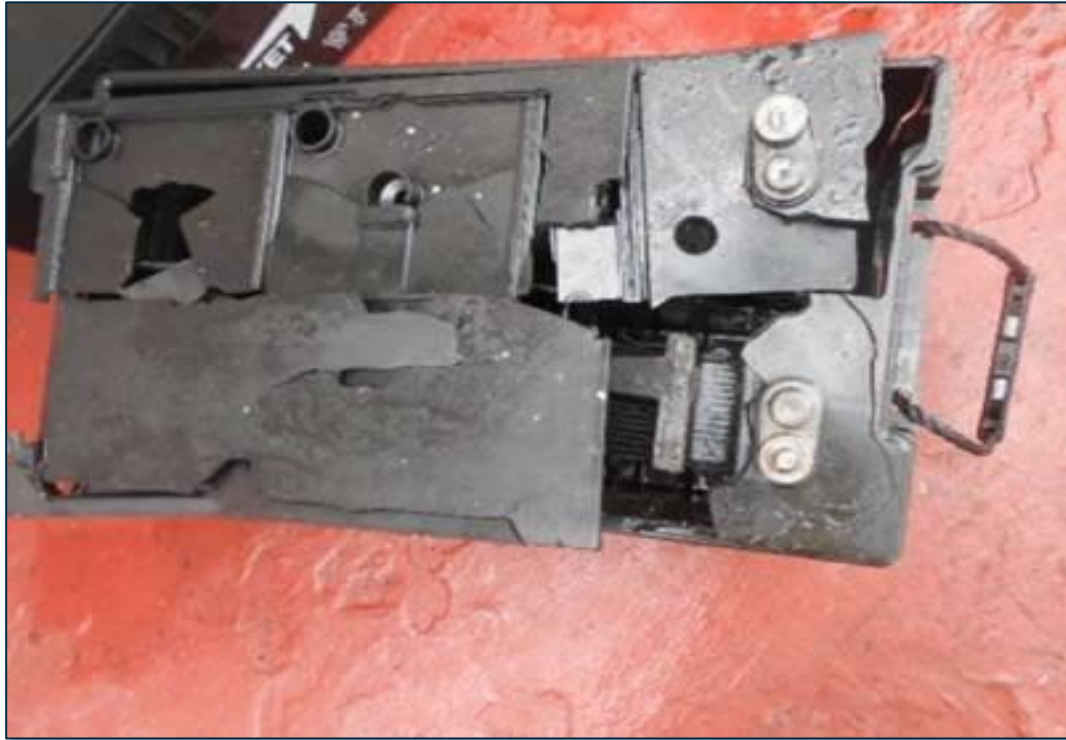
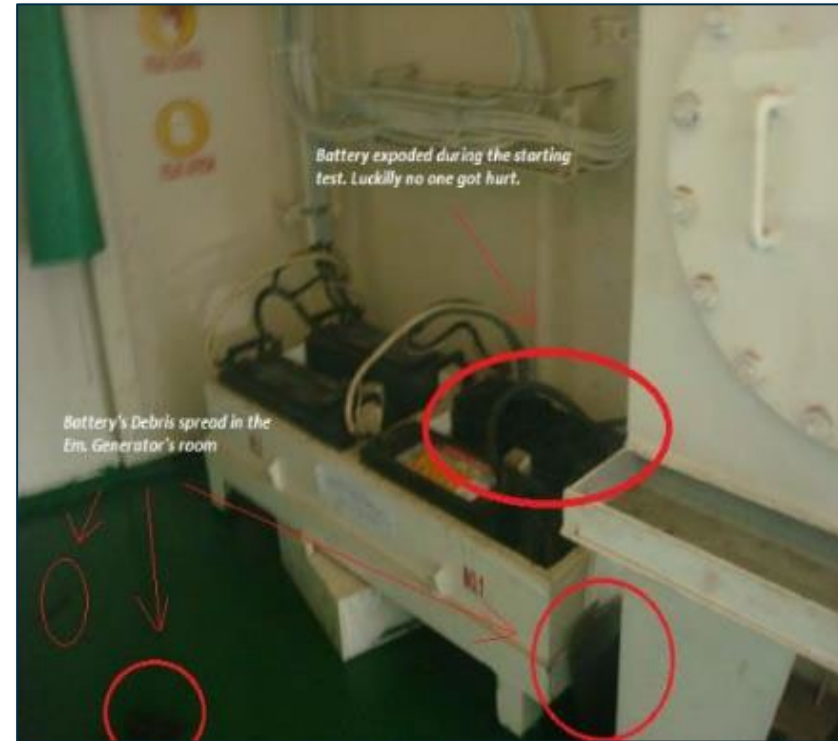
EMERGENCY GENERATOR (continued)

Emergency generator batteries explosion during testing

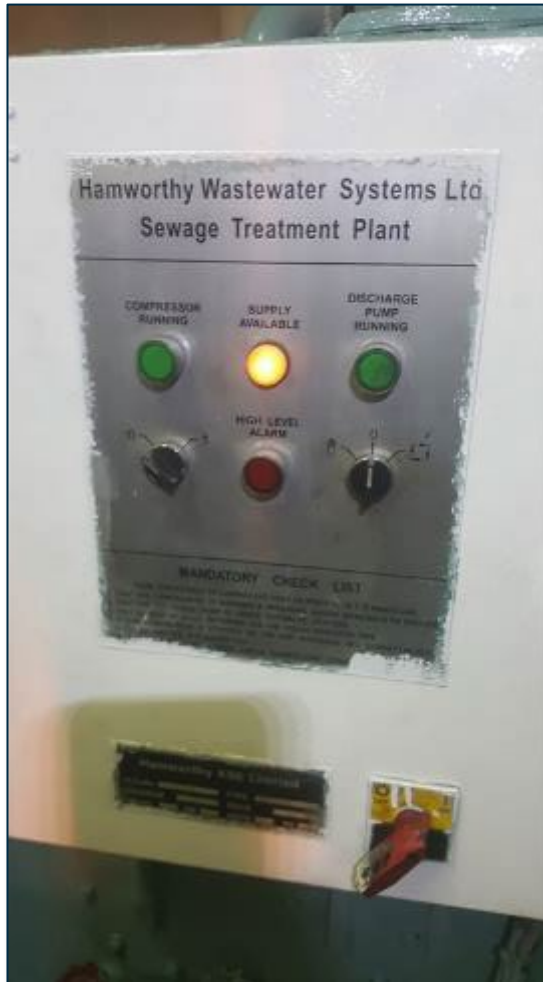
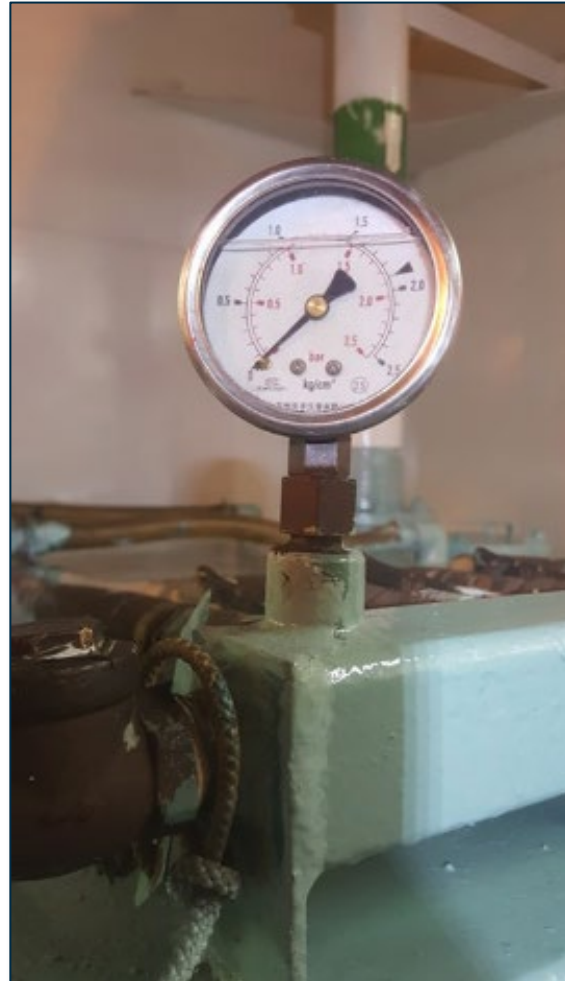
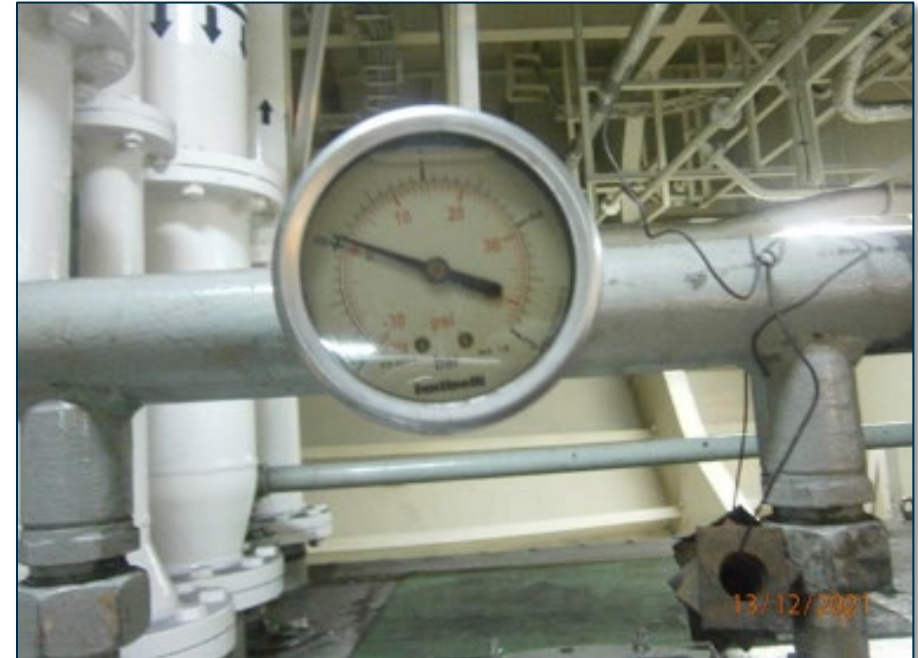
SEWAGE TREATMENT PLAN

Operational? First impression by looking at the lights / pressure gauges

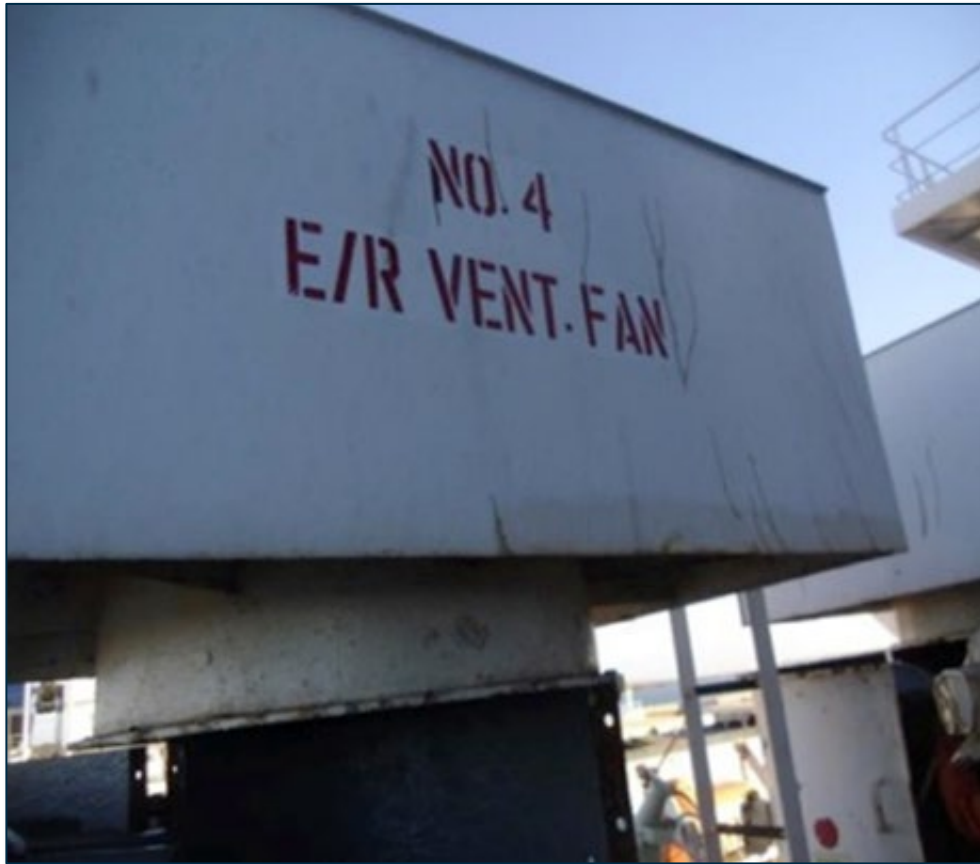
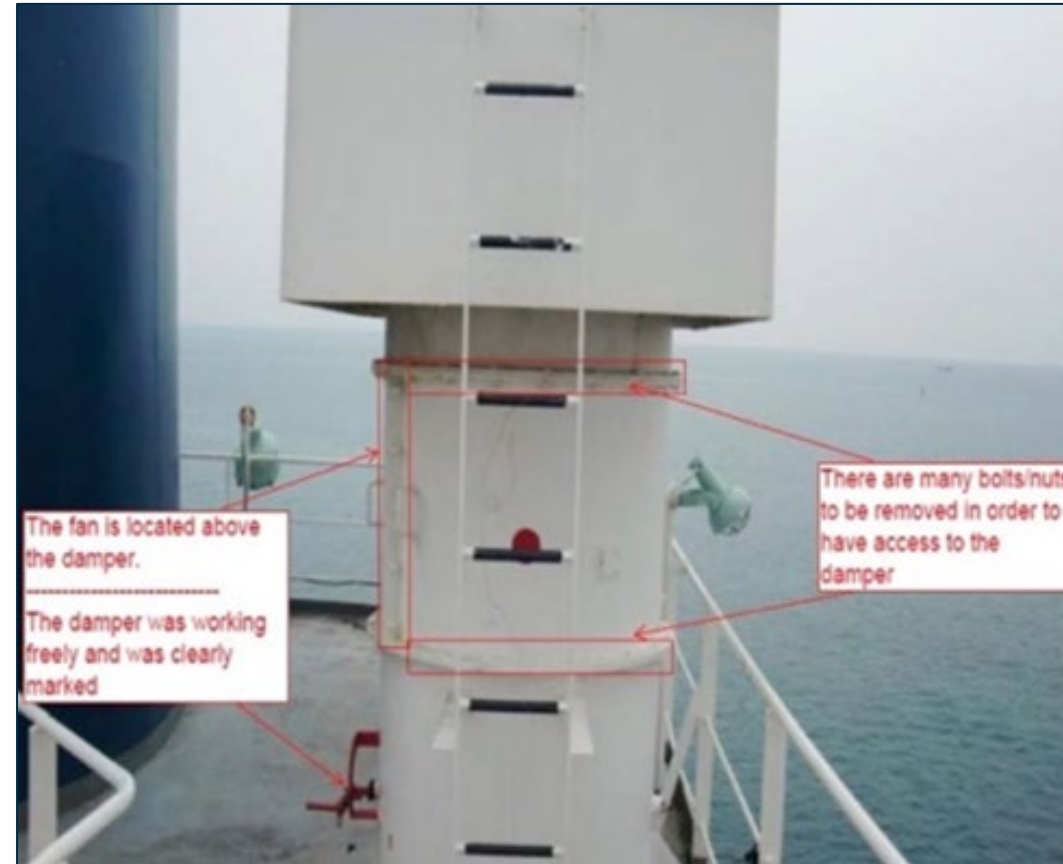
Visual inspection of the main engine fan

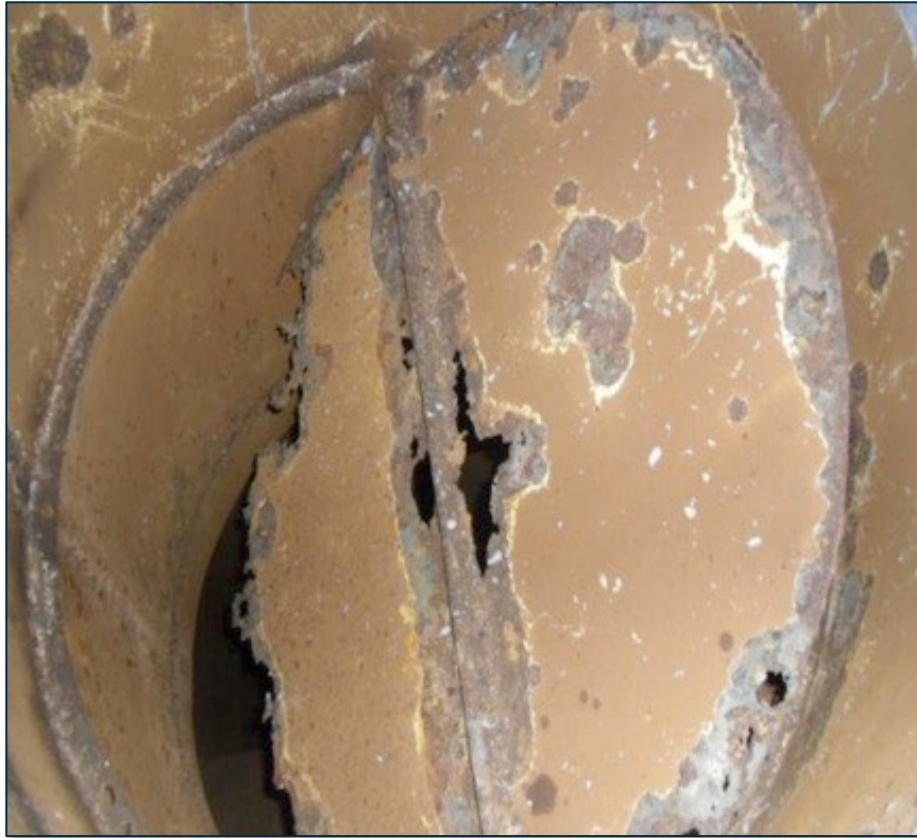
Damper (louver) before

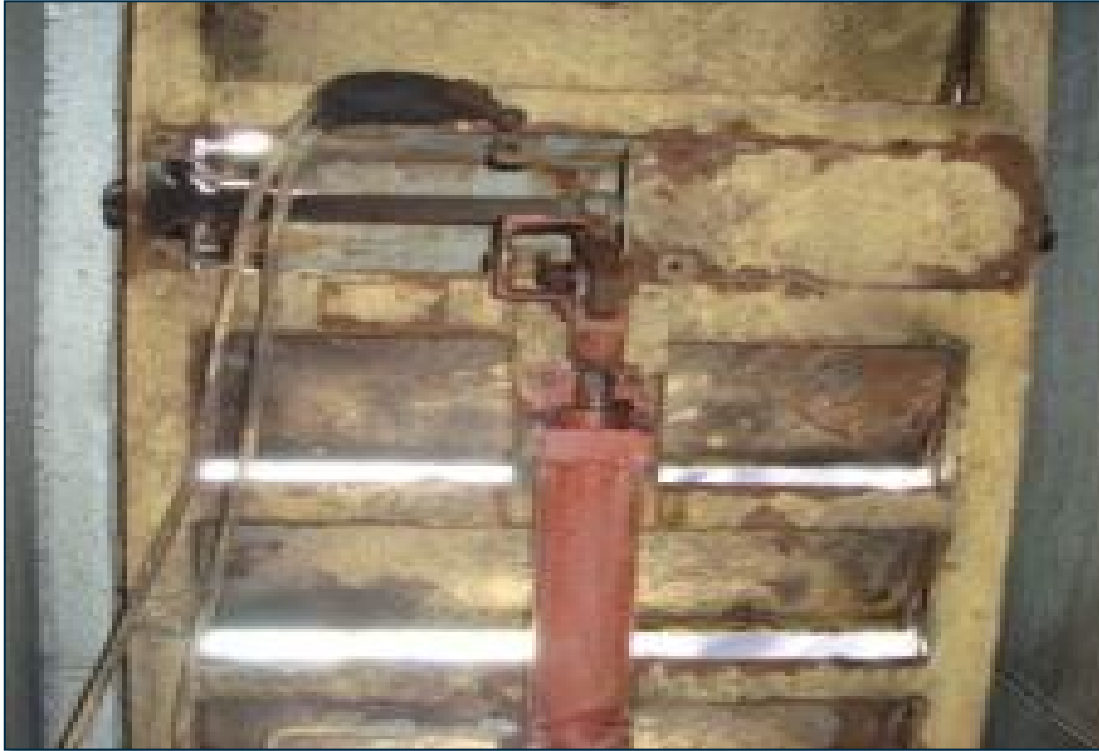
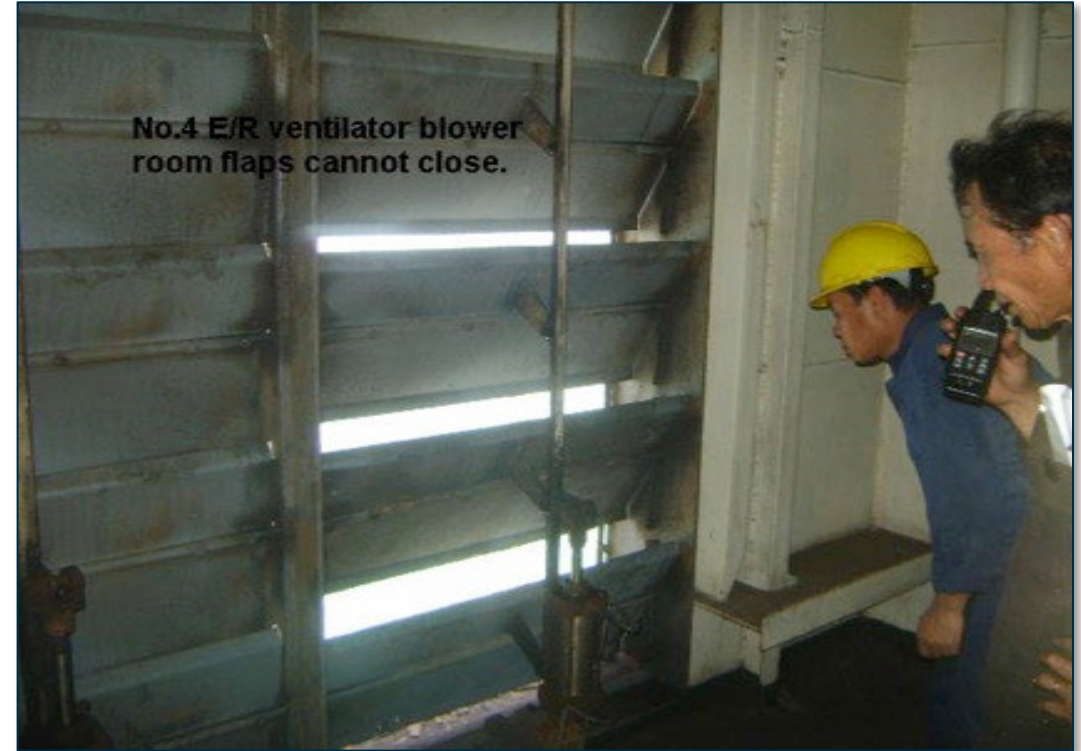
Flaps do not close fully

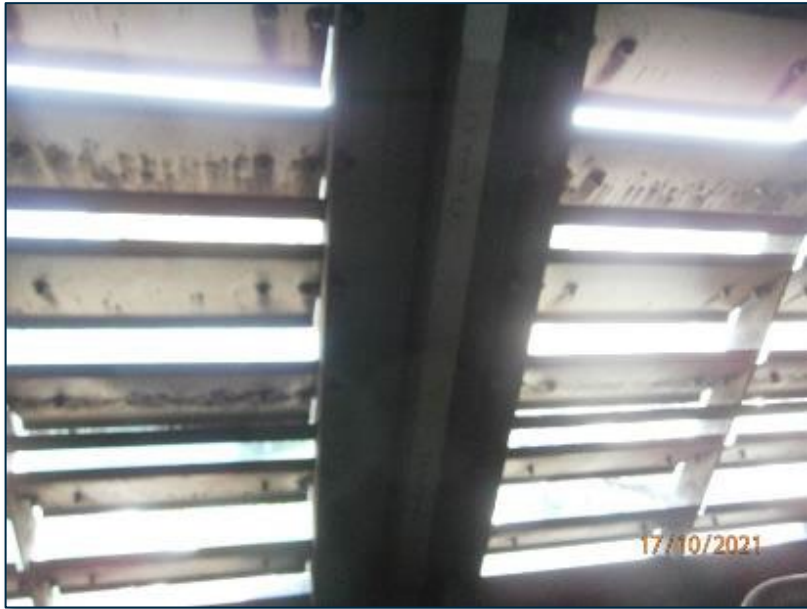
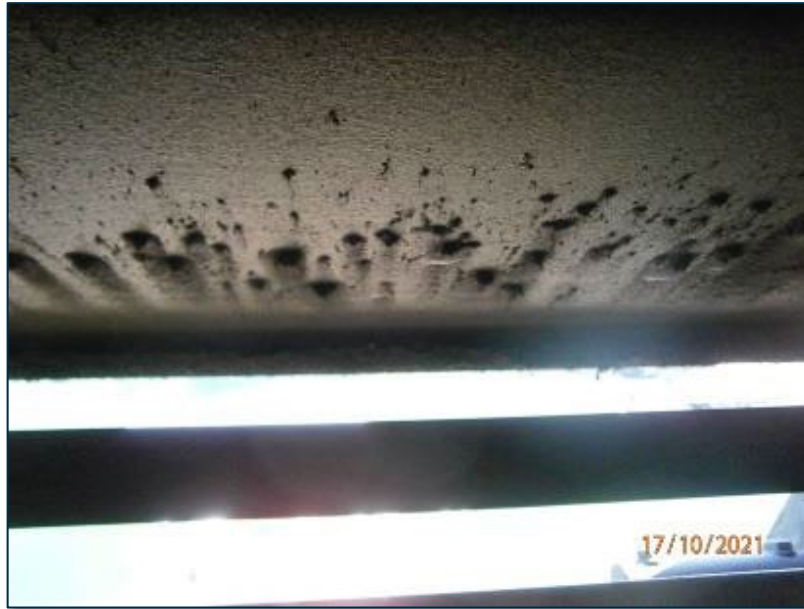
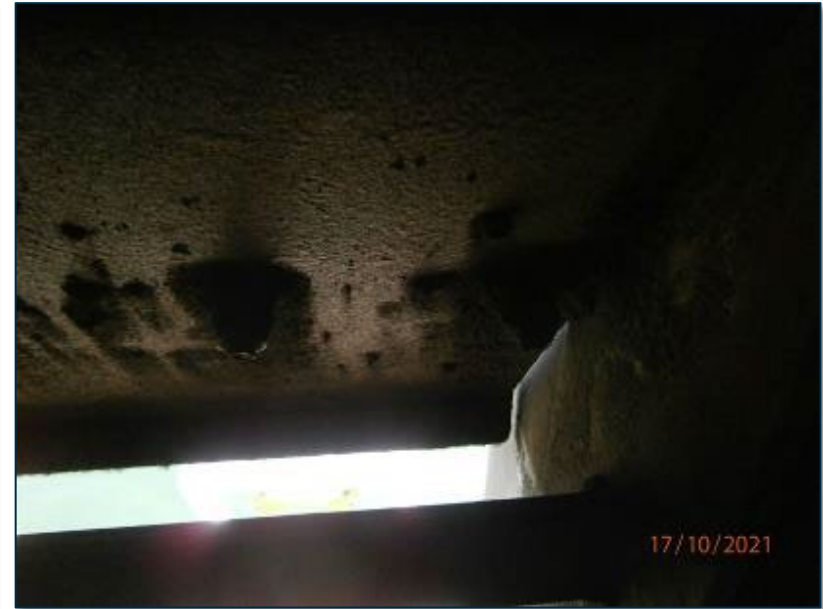
Large gap on sides or between the flaps as well?

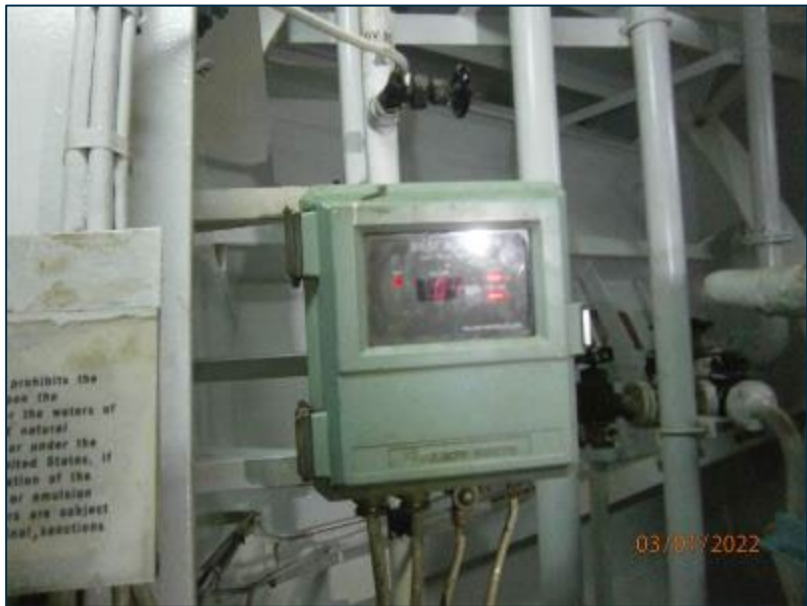
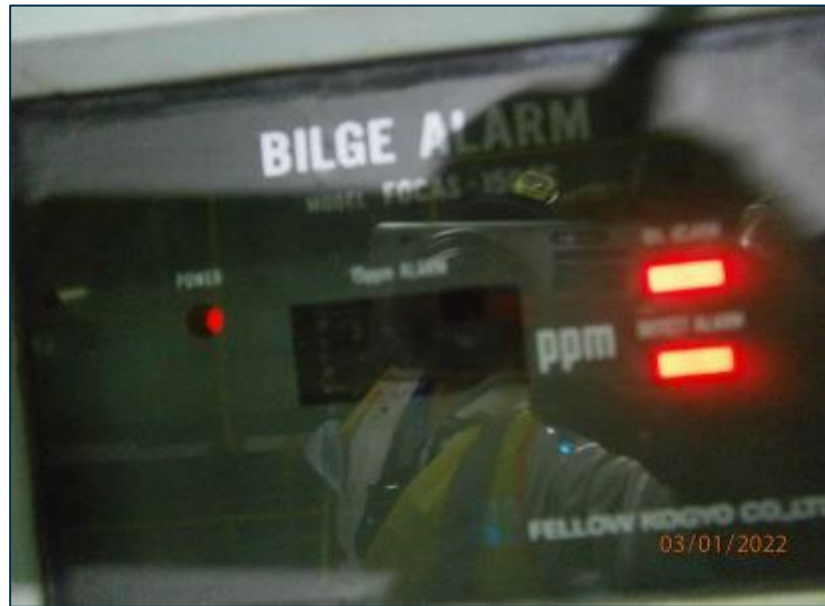
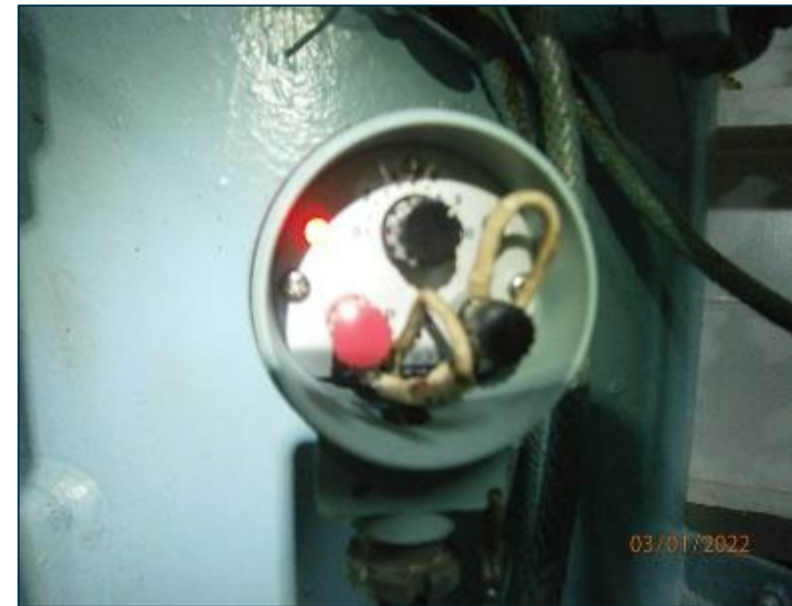
OWS (continued)

- Visually inspected for any leakages, soft patches, and suspicious piping?
- Running test carried out from bilge tank?
- Condition of OWS bilge pump or bilge pump.
- 15 pumps per minute (ppm) alarm monitor reading steady.
- Sampling line valve open?
- Water coming out from the 15 ppm monitor vent line?
- Is sampling done with fresh water or with sample water during the test?
- Oil content light ON?
- Three-way valve / change-over valves operational or pump stopping?
- Any indicator fitted to the three-way valve?
- Is the three-way valve sealing?
- Any hopper or sight glass fitted to verify water stopping?
