FLAG STATE INSPECTIONS AND COMMON DEFICIENCIES

Captain Sascha Marcel Dyker

Fleet Operations Manager (Hong Kong)

March 2025

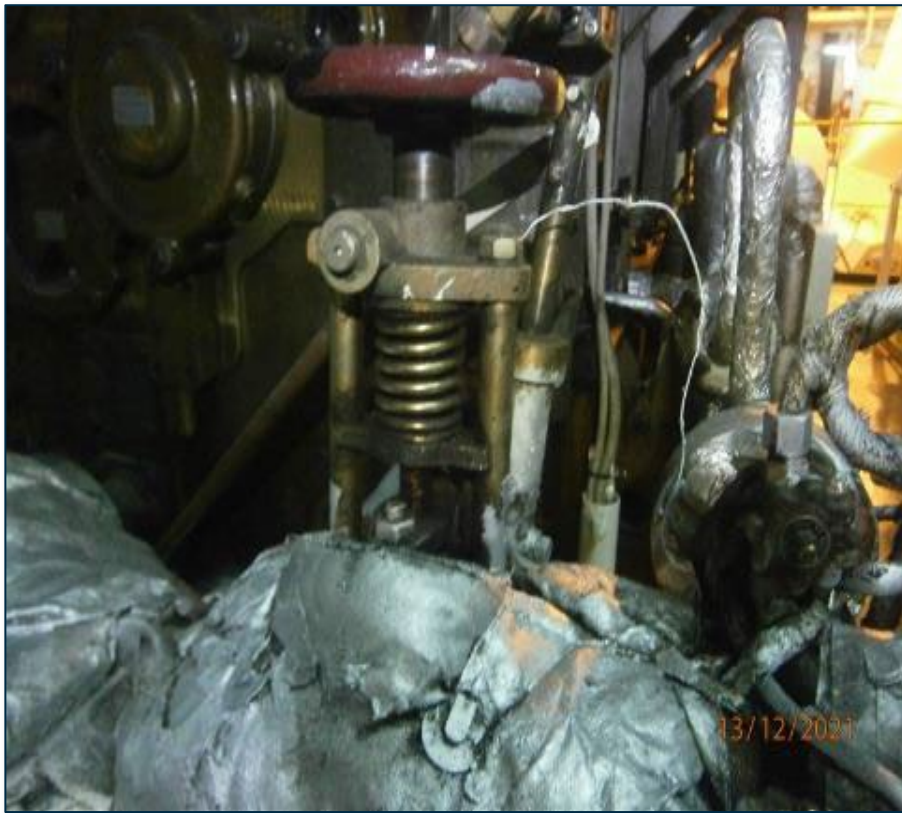
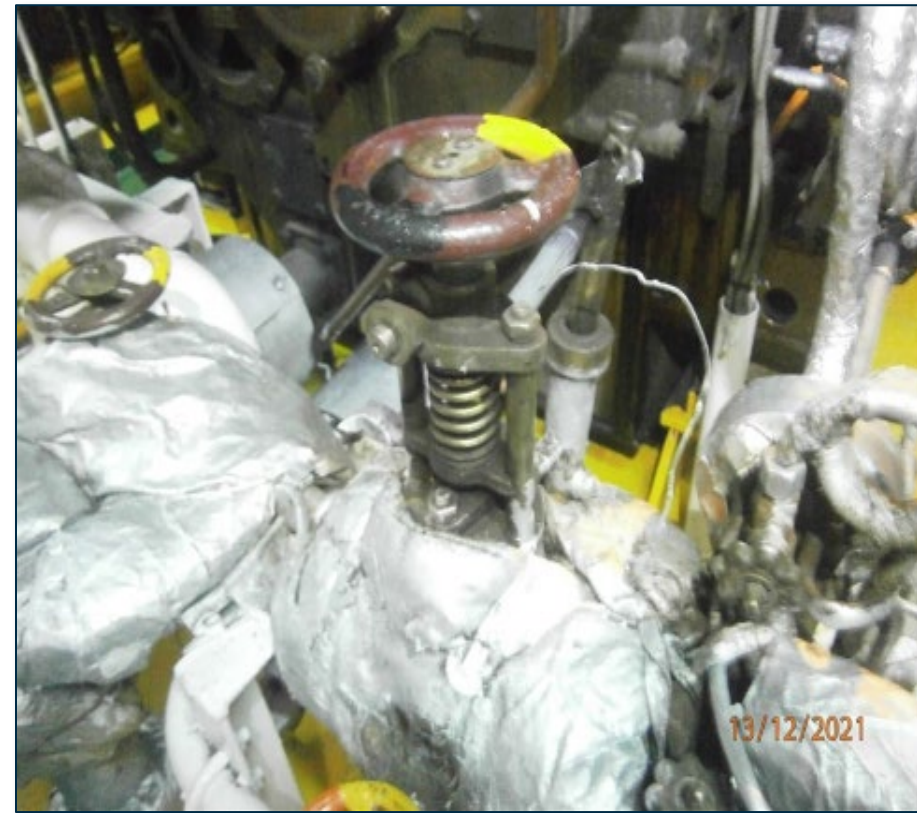
QCVs (continued)

- Visual inspection – looks maintained or neglected?
- Any leakages from the seal or valve body?
- Any blockages, wedges, or gagging noted?
- Any physical damage to the operating mechanism especially on the auxiliary engine platform?
- On testing is the piston moving? Is the valve closing or stuck?

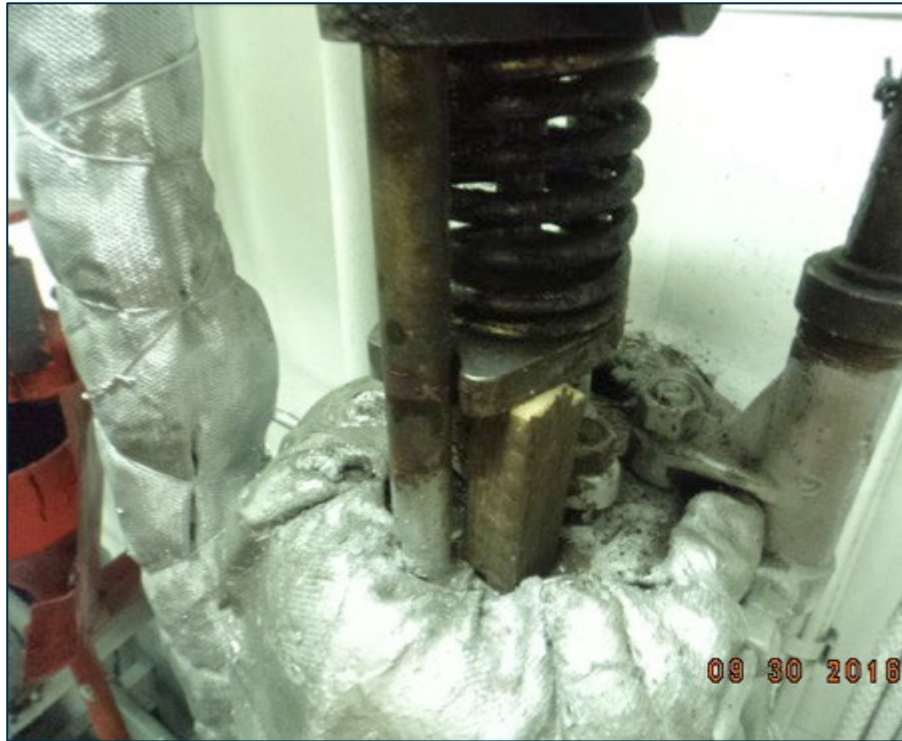
QCV blocked open

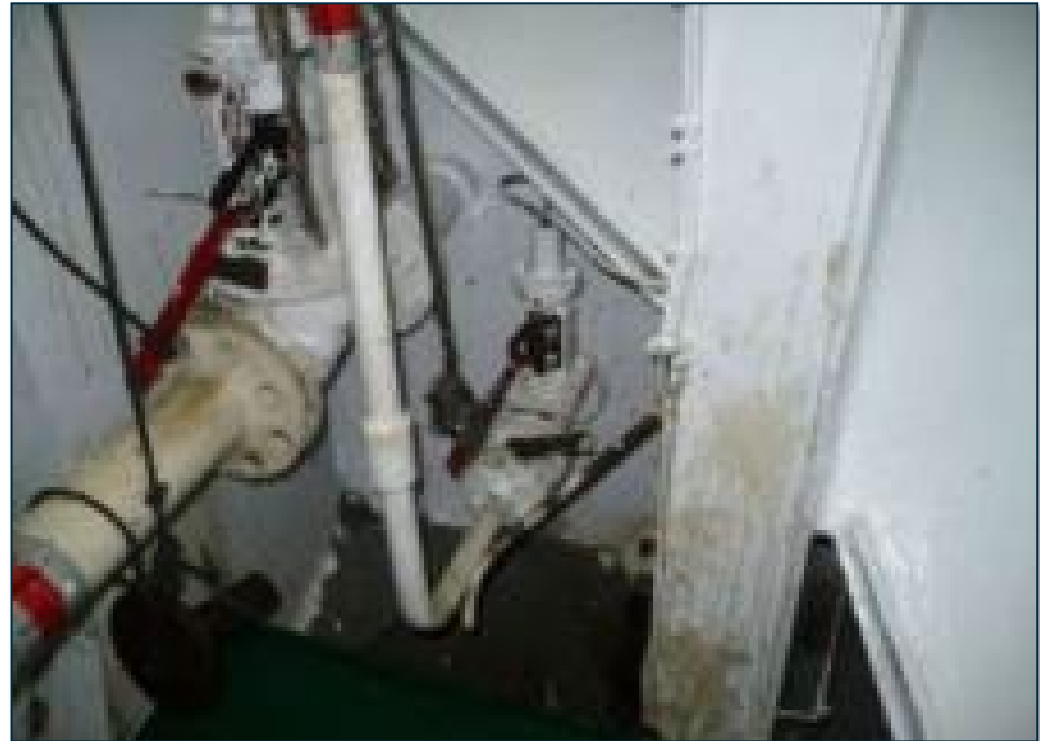
QCV tied open

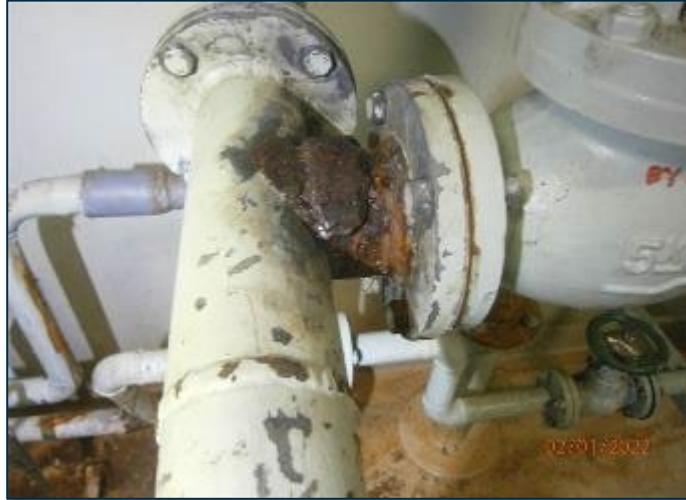
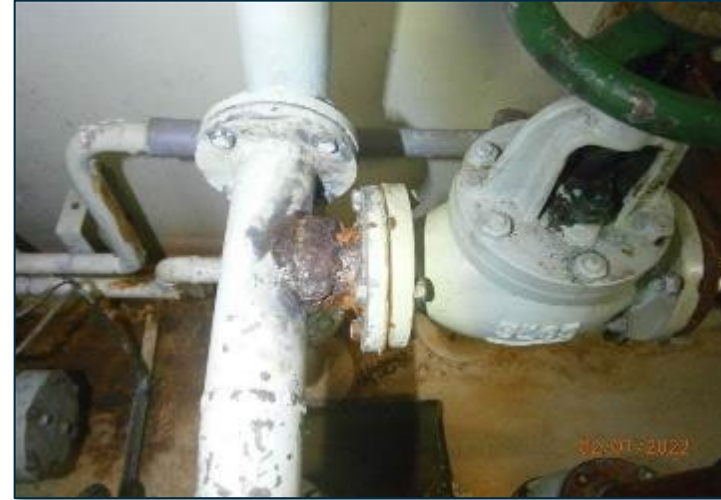
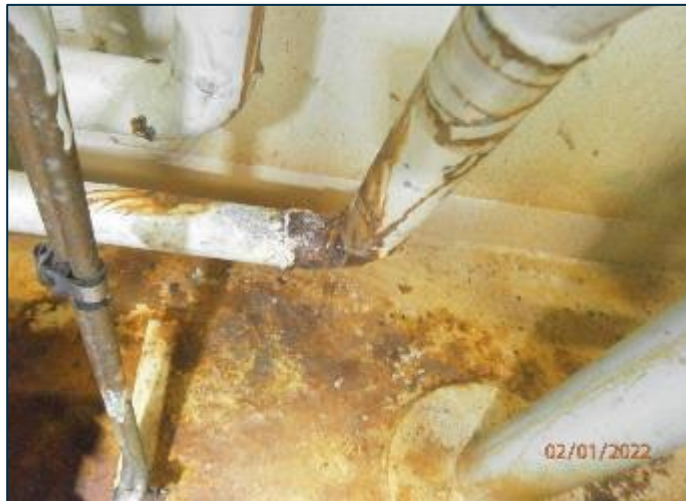
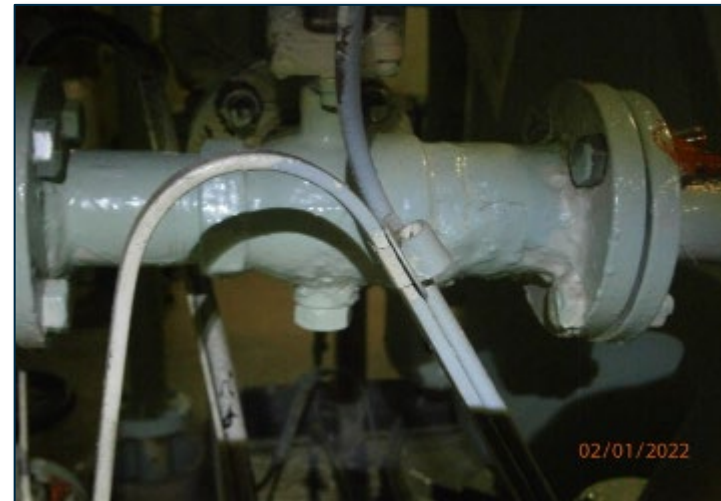
SW PIPING AND COOLERS (continued)

- Visual inspection.
- Any funnels / hoses or catchment trays fitted?
- Any fresh paint noted on certain sections?
- How are the pipe entry / exit areas at the SW coolers?
- Any SW stains on the drip tray or from the overhead pipelines?

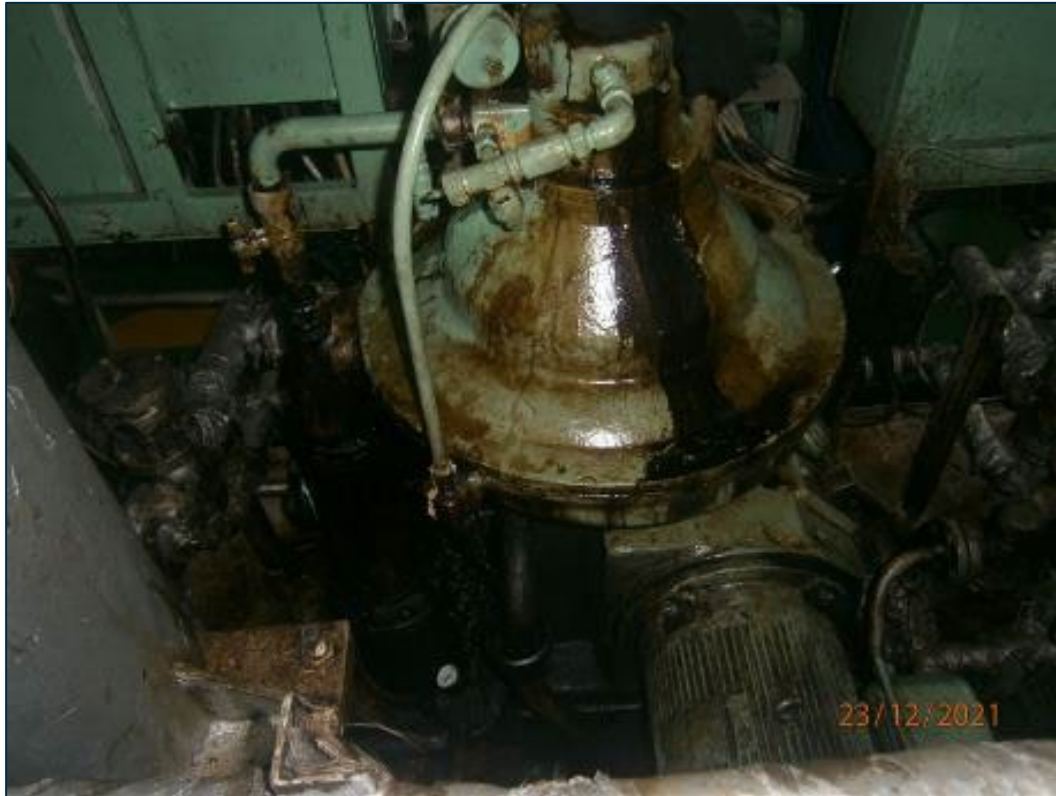
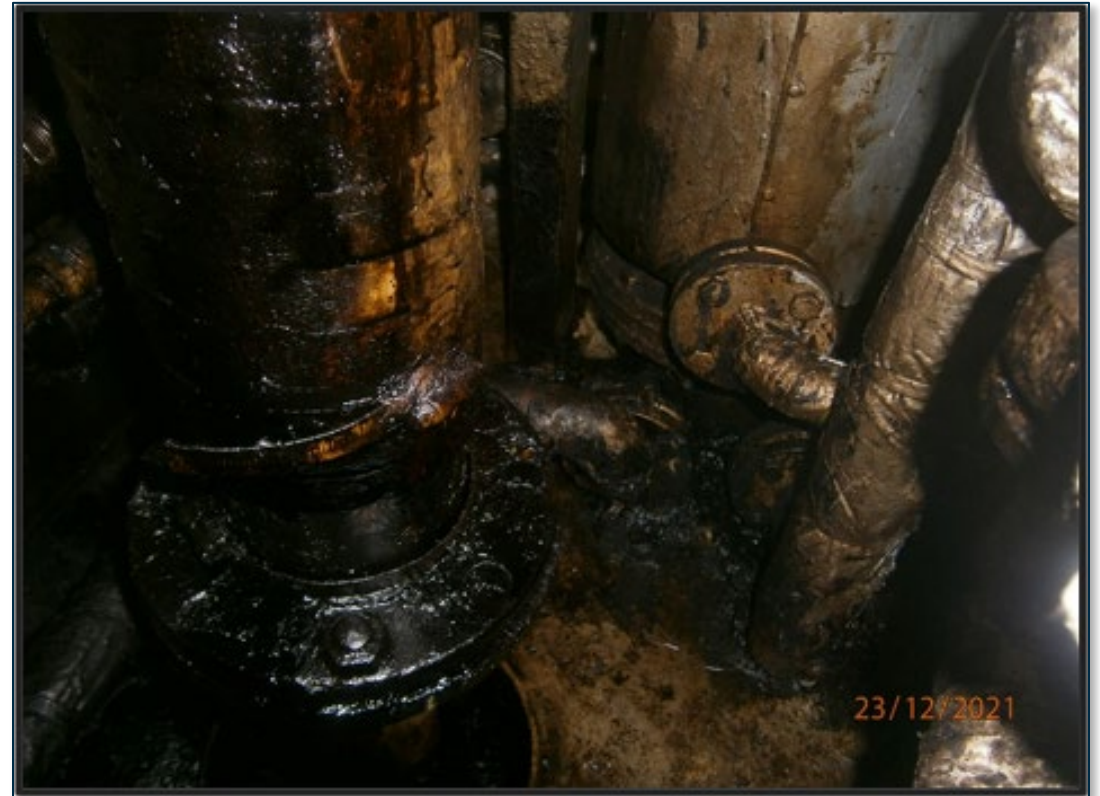
PIPE LAGGINGS AND PURIFIER ROOM (continued)

- Visual inspection.
- Oily / clean / painted?
- Any signs of leakage / catchment containers / leaking seals / leaking filters?
- Condition of bilge?

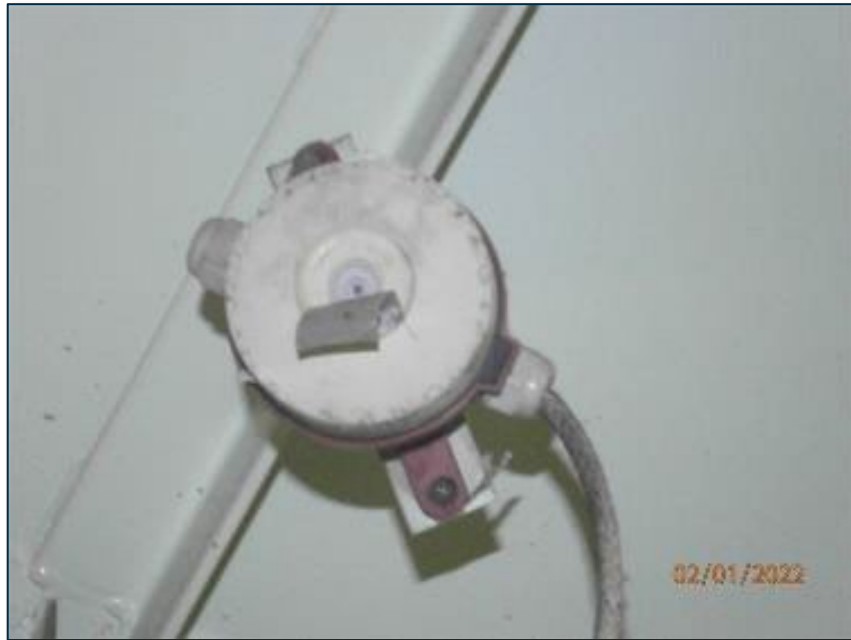
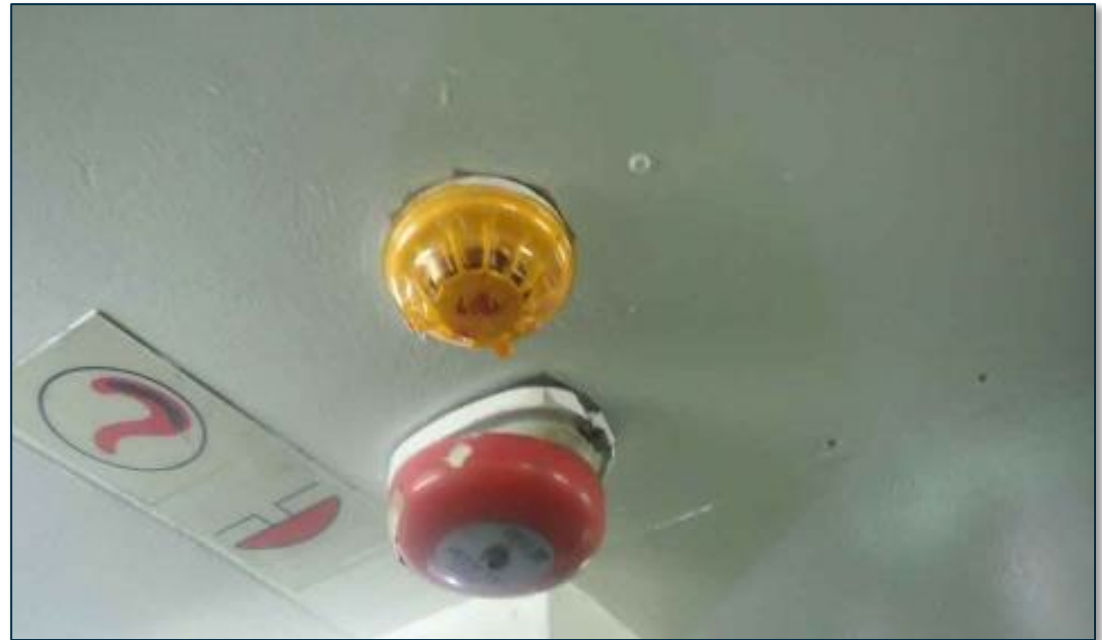
Sensors covered with tapes

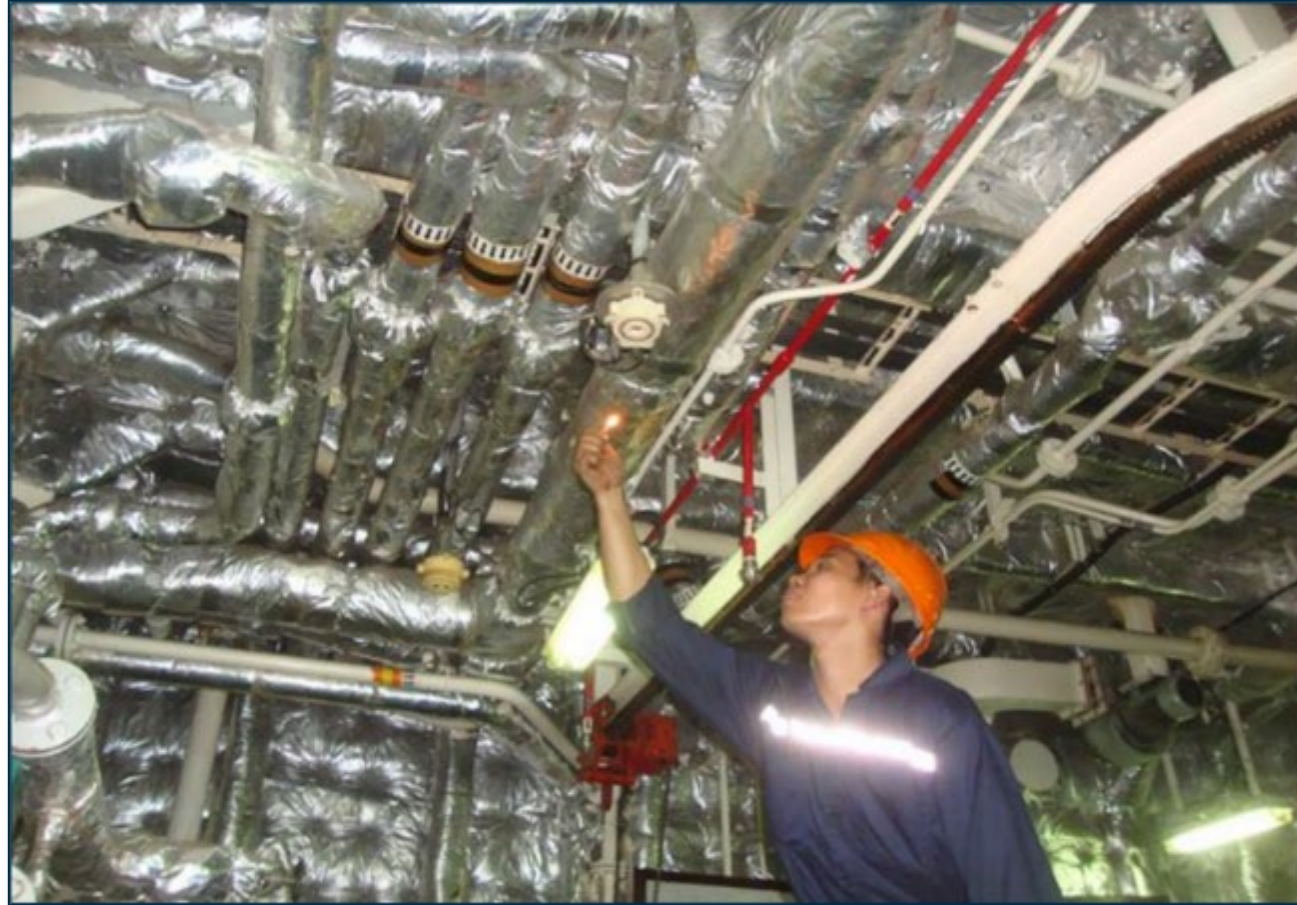
FIRE DETECTORS –TESTING EQUIPMENT

Heat detector inappropriate testing material

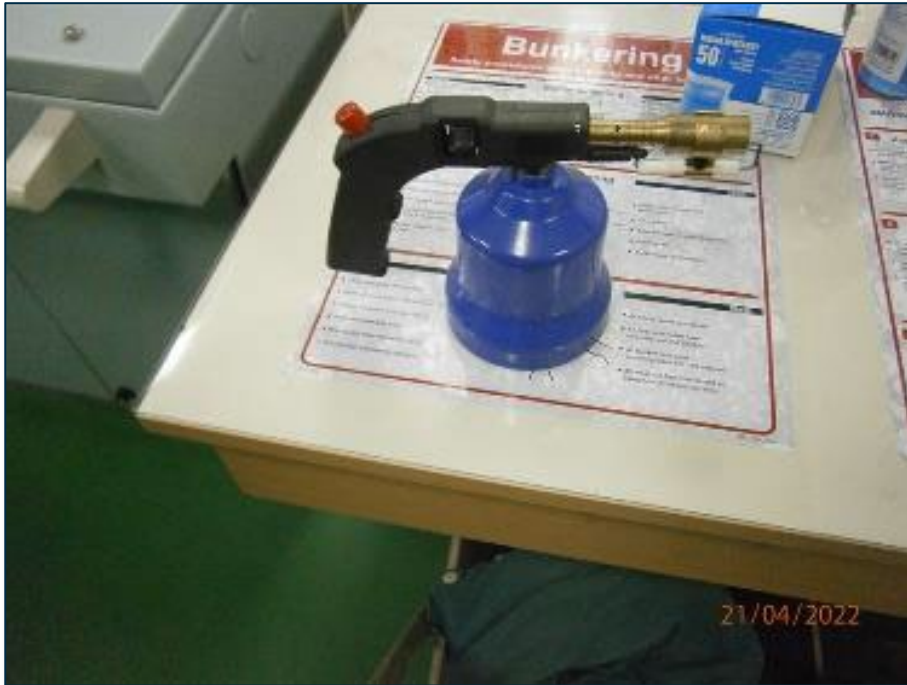
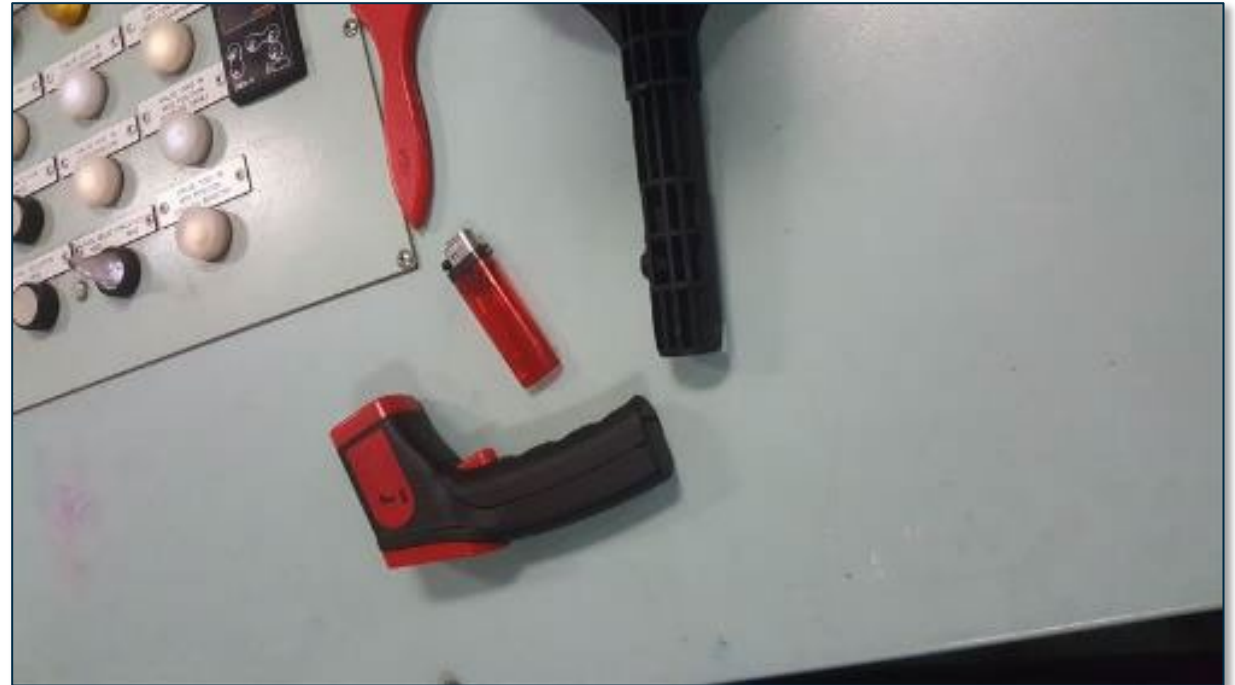
FIRE DETECTORS – TESTING EQUIPMENT (continued)

Lighters used as tester for sensors

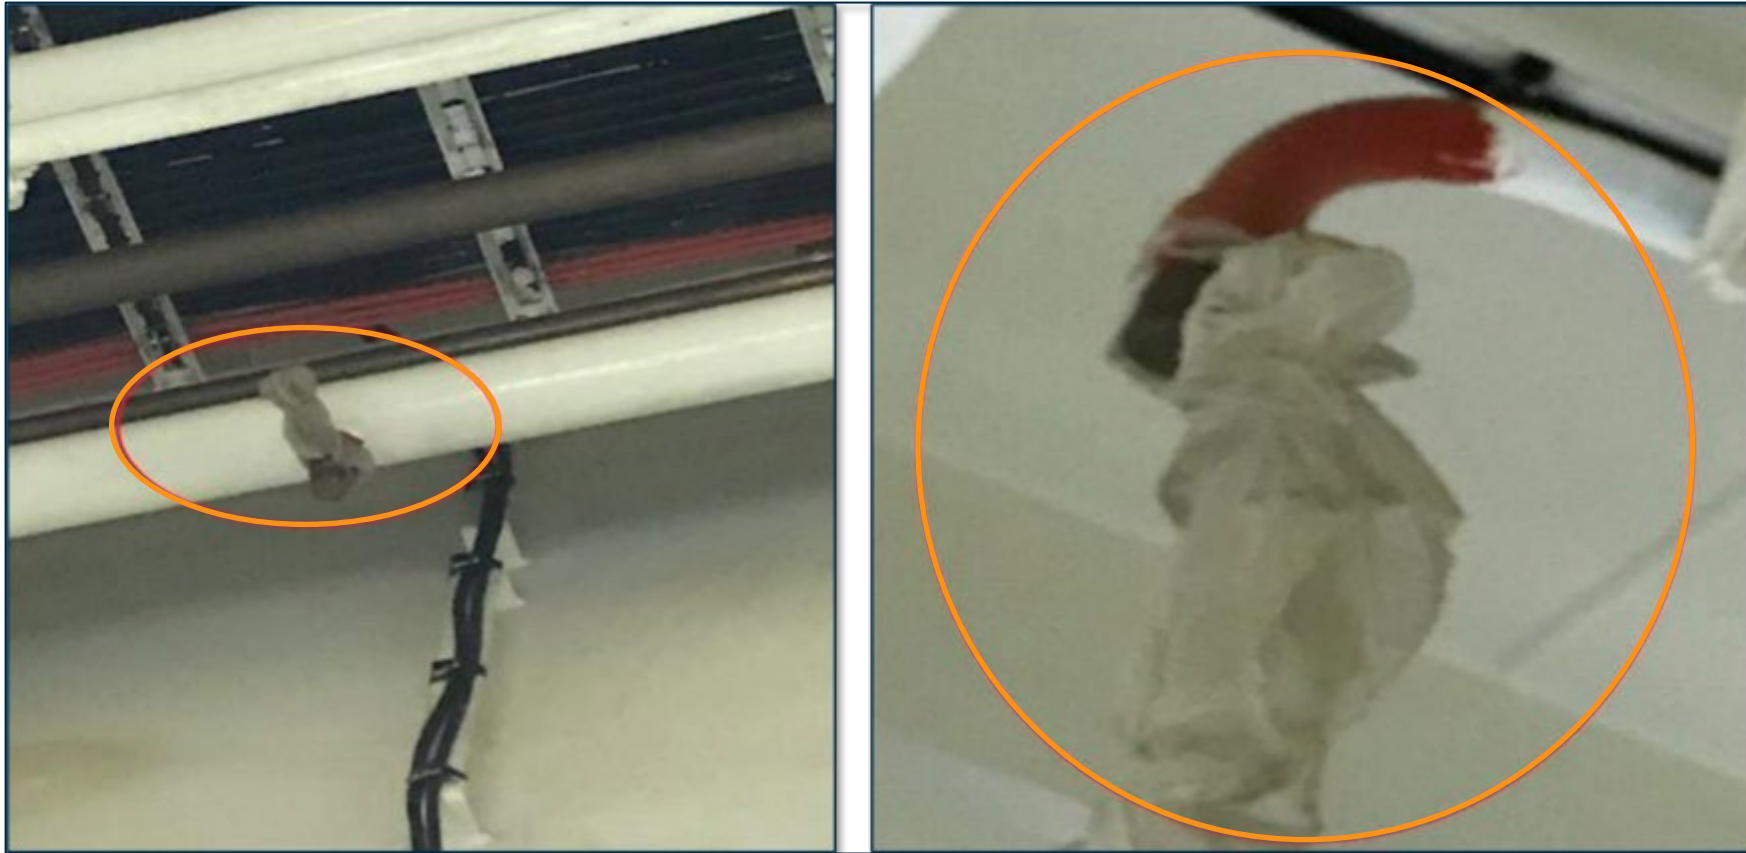
LOCAL FIRE FIGHTING SYSTEM IN MANUAL MODE (continued)

Hypermist nozzles wrapped in plastic

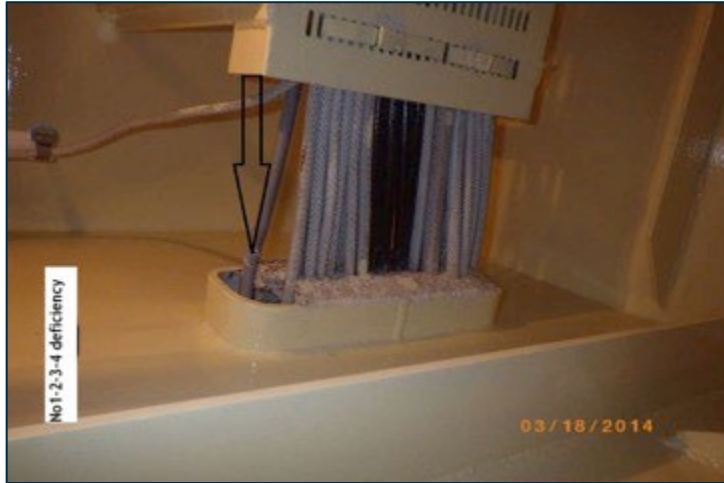
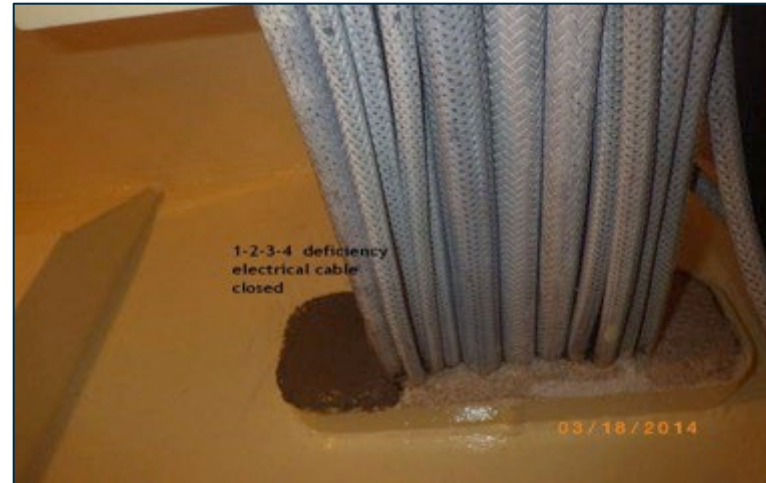
CABLE PENETRATIONS (continued)

Fire integrity of bulkheads
being destroyed

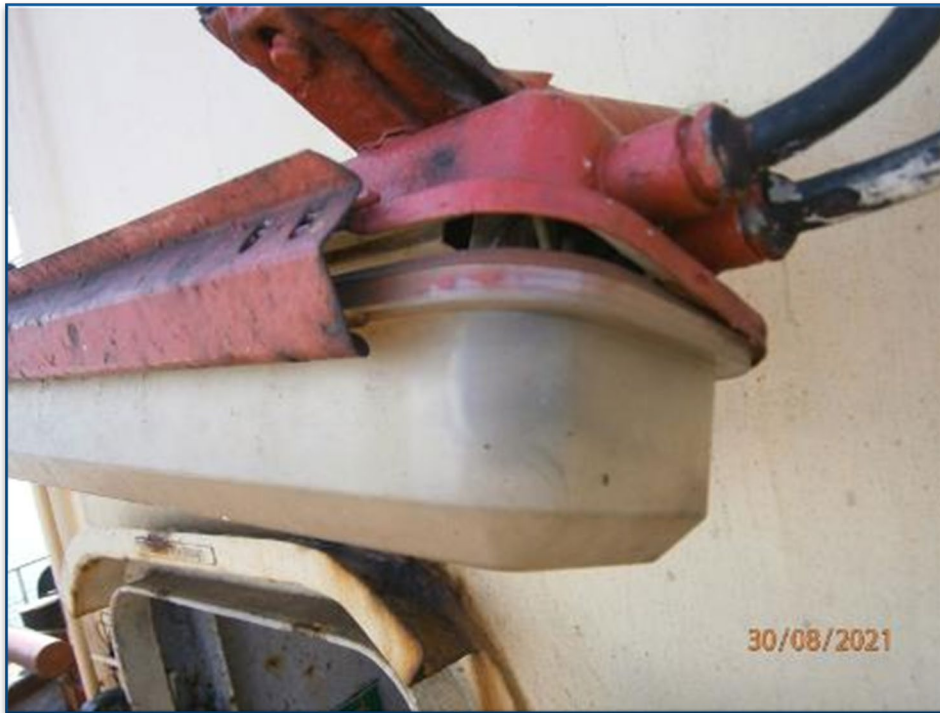
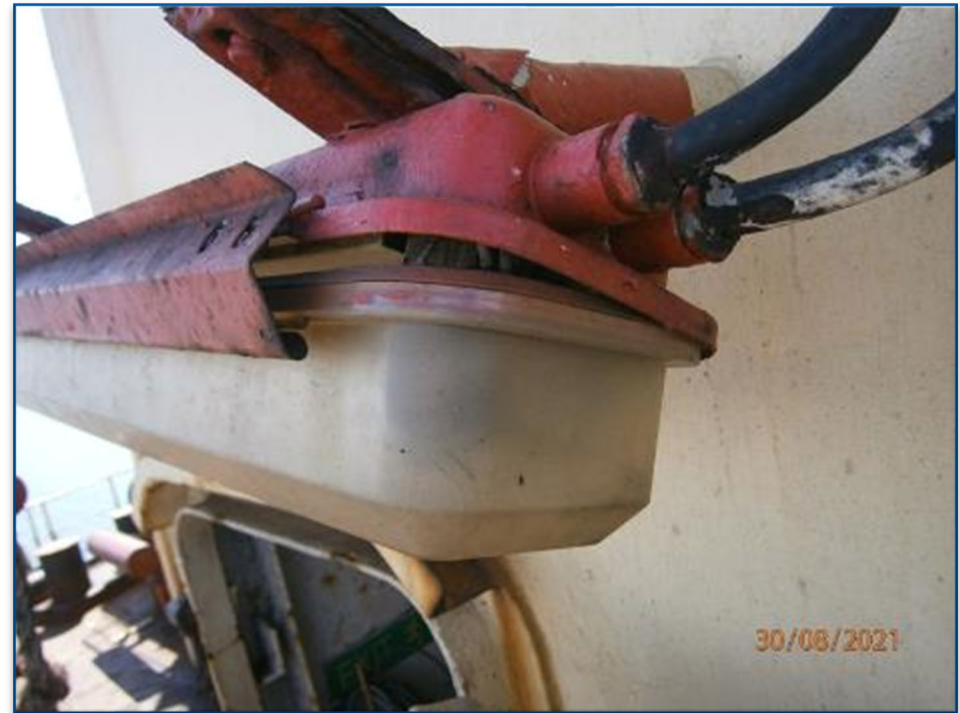
DECK LIGHTS (continued)

- Functional?
- Damage to the light fittings?
- Ageing / translucent?

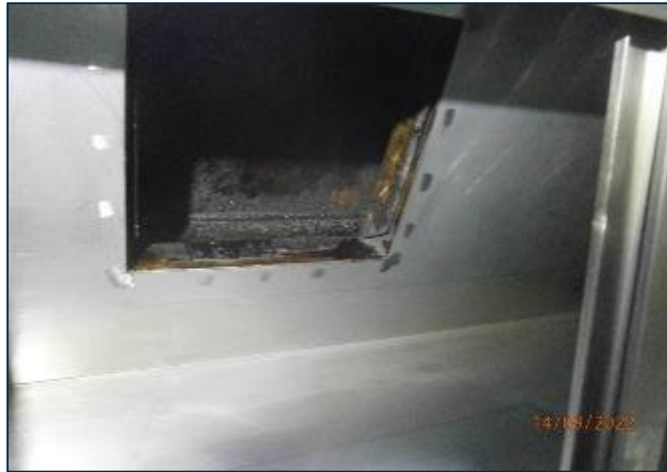
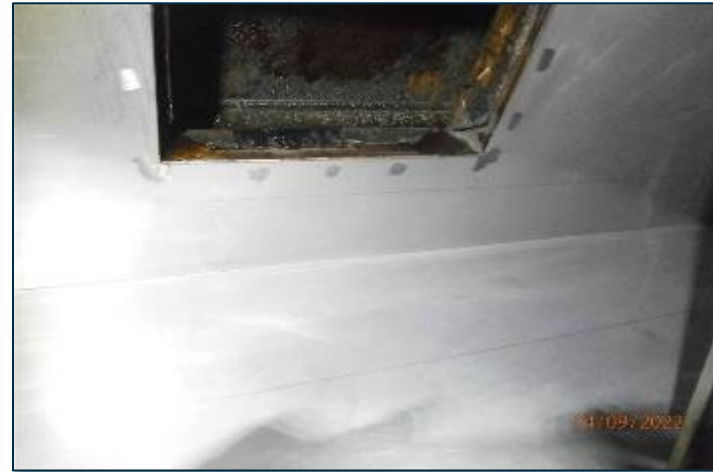
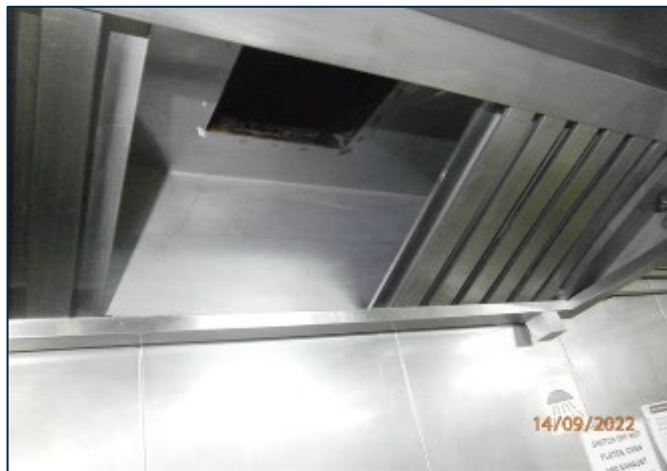
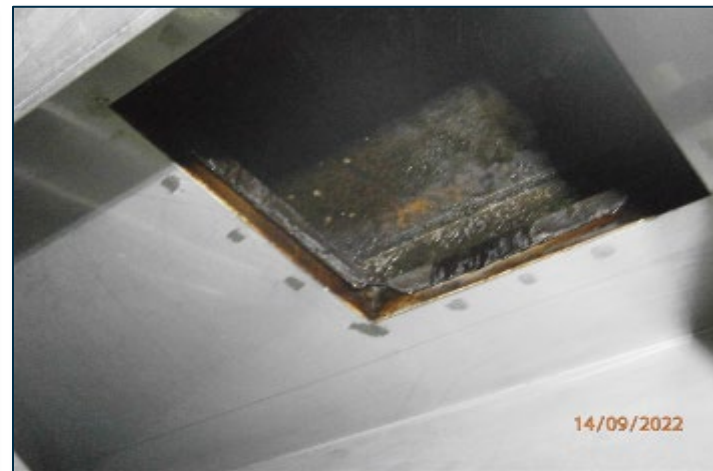
GALLEY (continued)

- Condition, visual appearance.
- Flame hood / wire mesh condition satisfactory?
- Tiles condition?

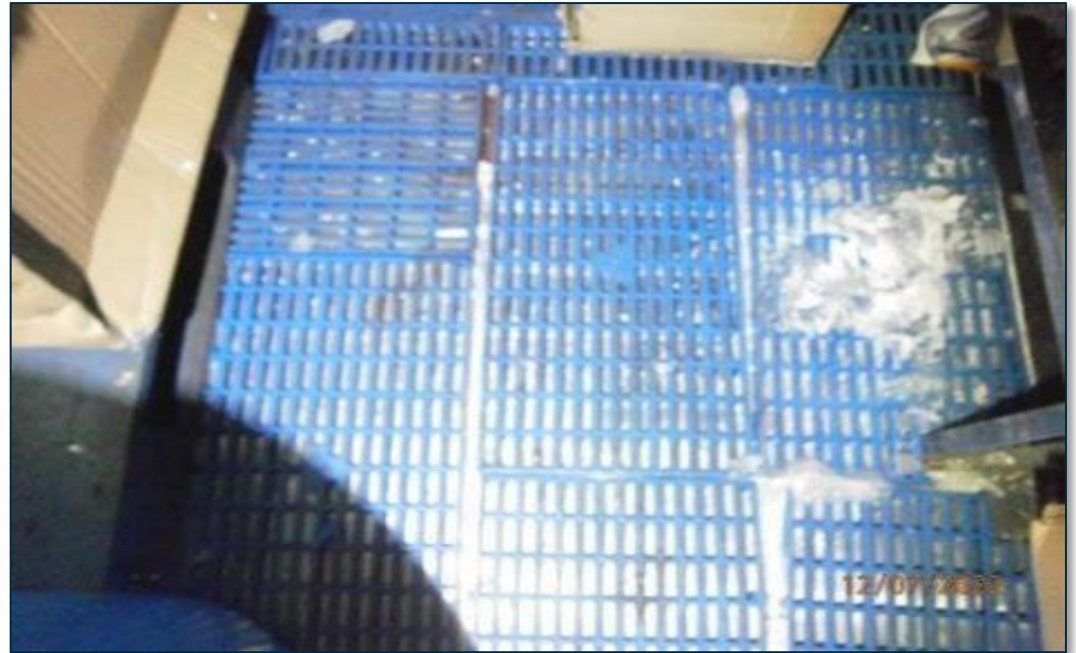
PROVISION SPACE

- Visual inspection of the condition.
- Alarm and light working?

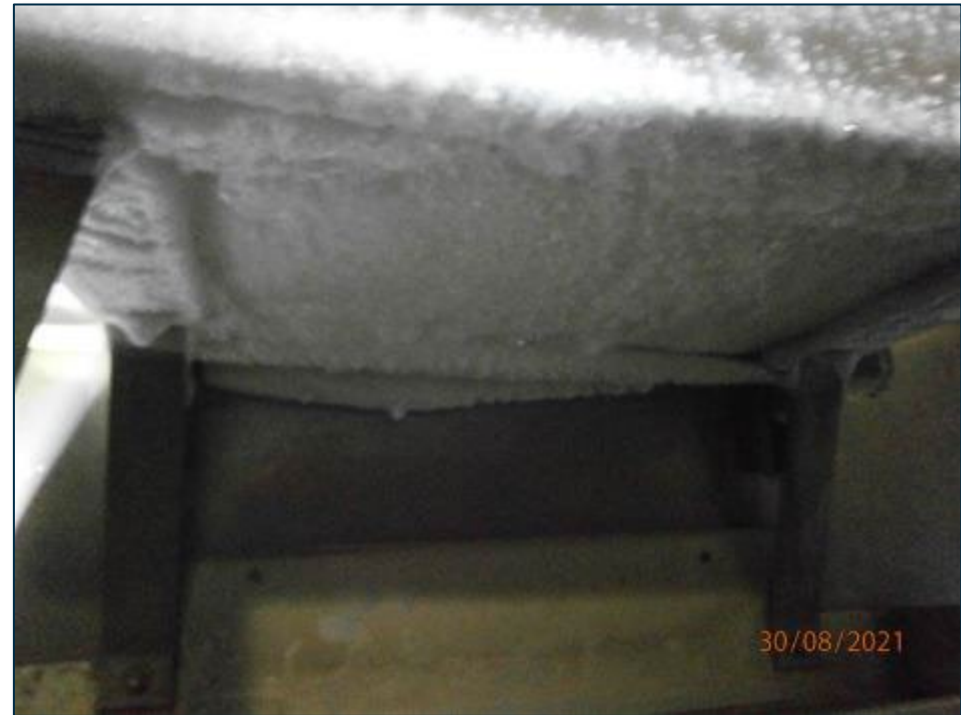
PROVISION SPACE (continued)

Any icing on the panel / door frame

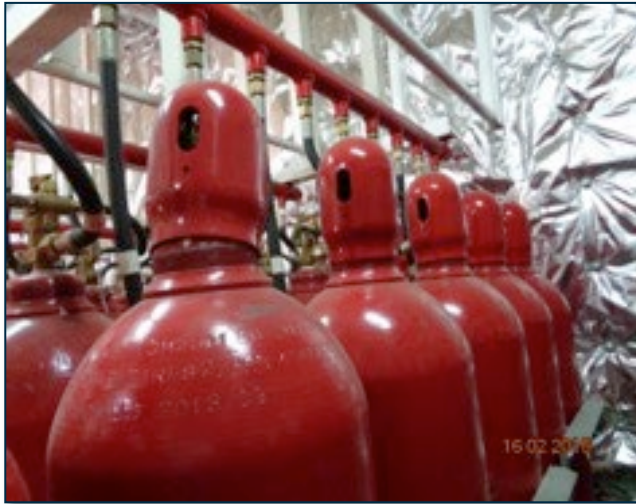
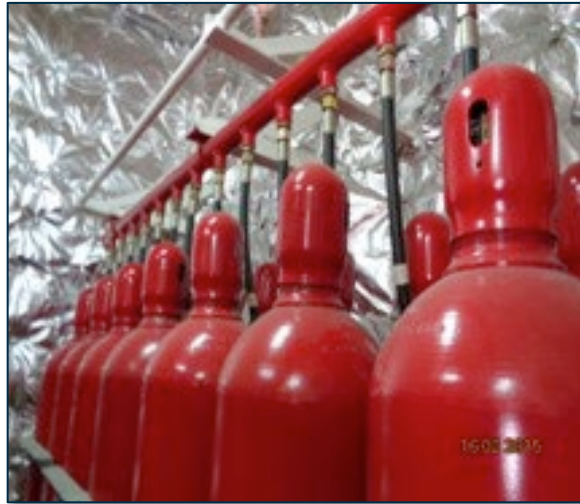
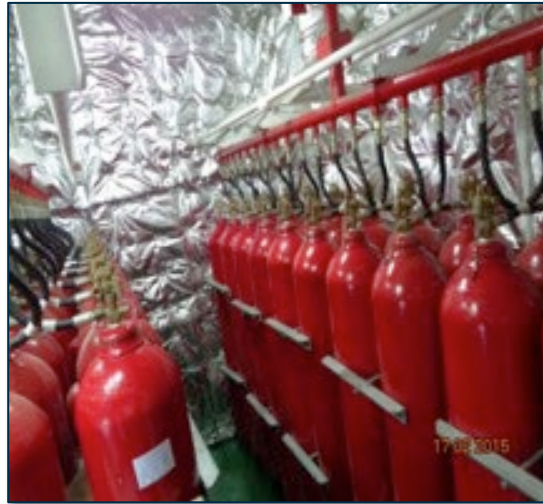
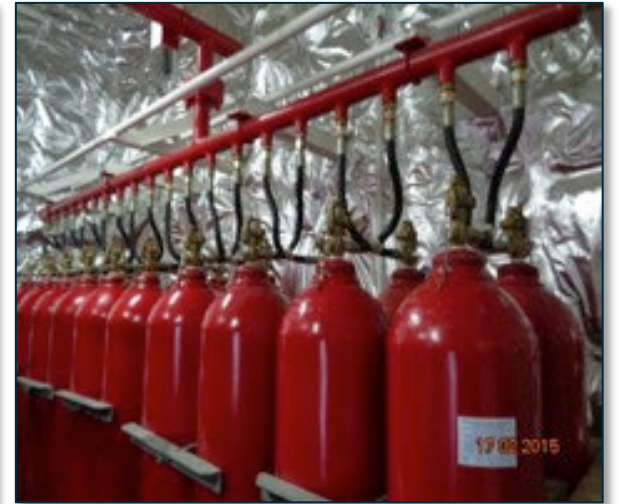
CO₂ ROOM (continued)

- New build bulk carrier detained on maiden voyage by Australian Maritime Safety Authority (AMSA) for fixed CO₂ system not readily available for operation.
- Three manifold rows had flexible hoses fitted but not connected to CO₂ cylinders (caps were on).
- The ship's staff were misinformed at the yard that they were spare cylinders.
- These 28 cylinders covered the cargo holds.
- All cylinders aligned and three loose hoses connected.
- There was a Total Organic Carbon Analysis at delivery.

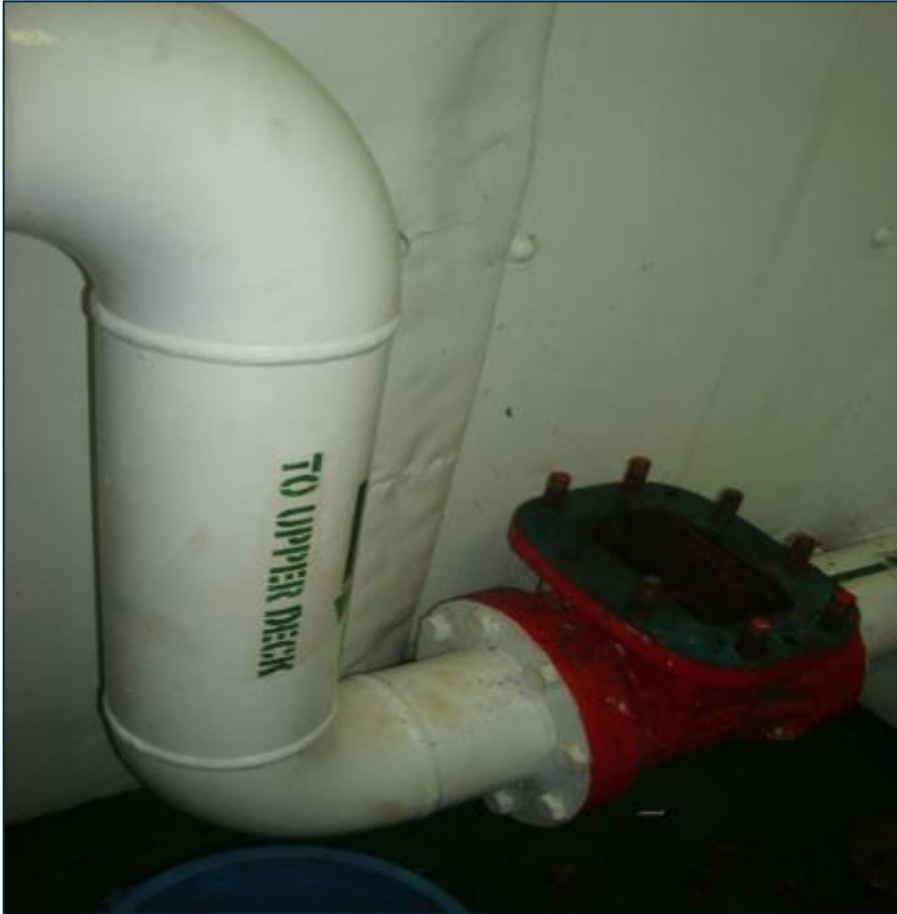
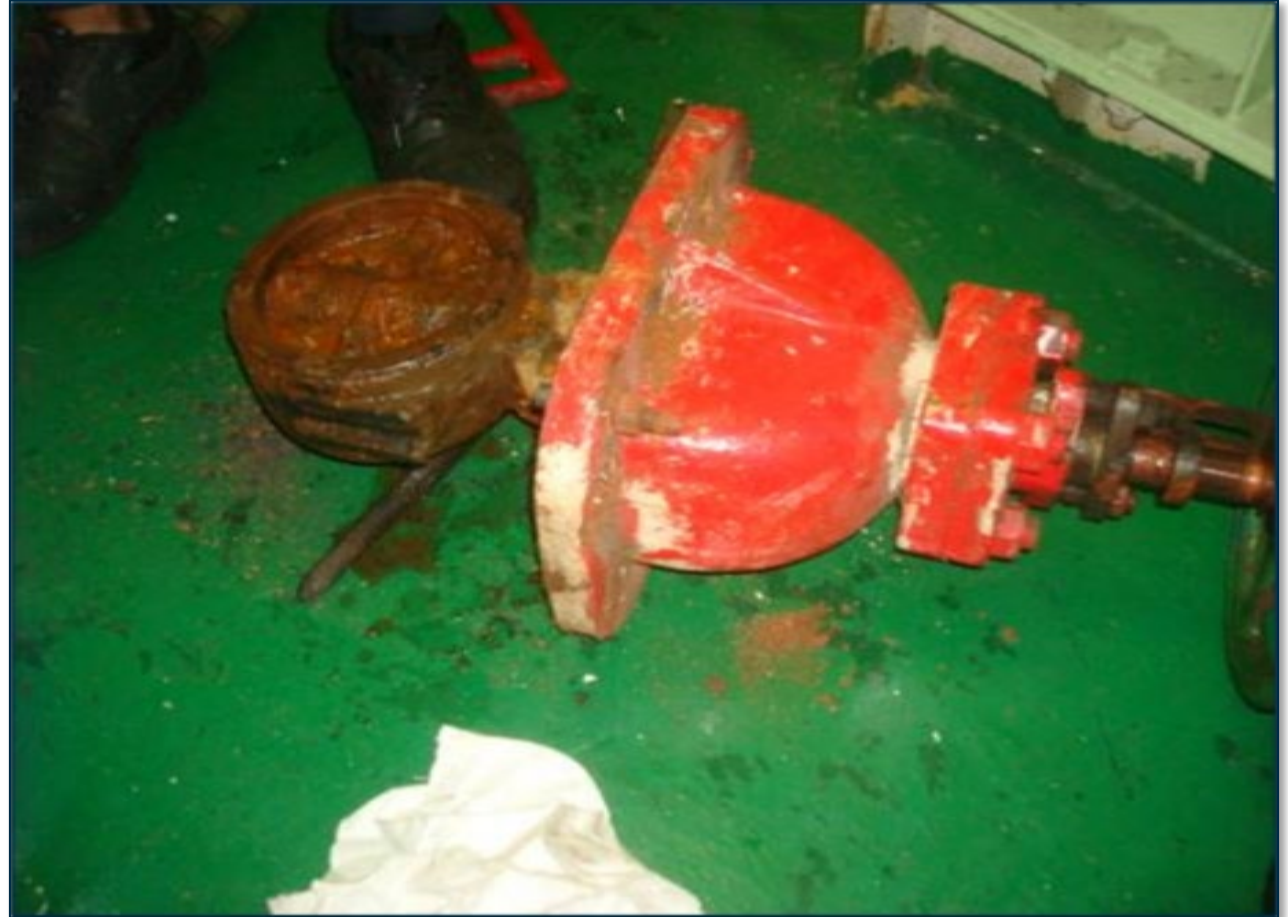
FIRE LINE ISOLATION VALVES (continued)

- Fire line main isolating valve frozen (foam room).
- Fire line main leak on deck.
- Lifeboat sprinkler line holed.

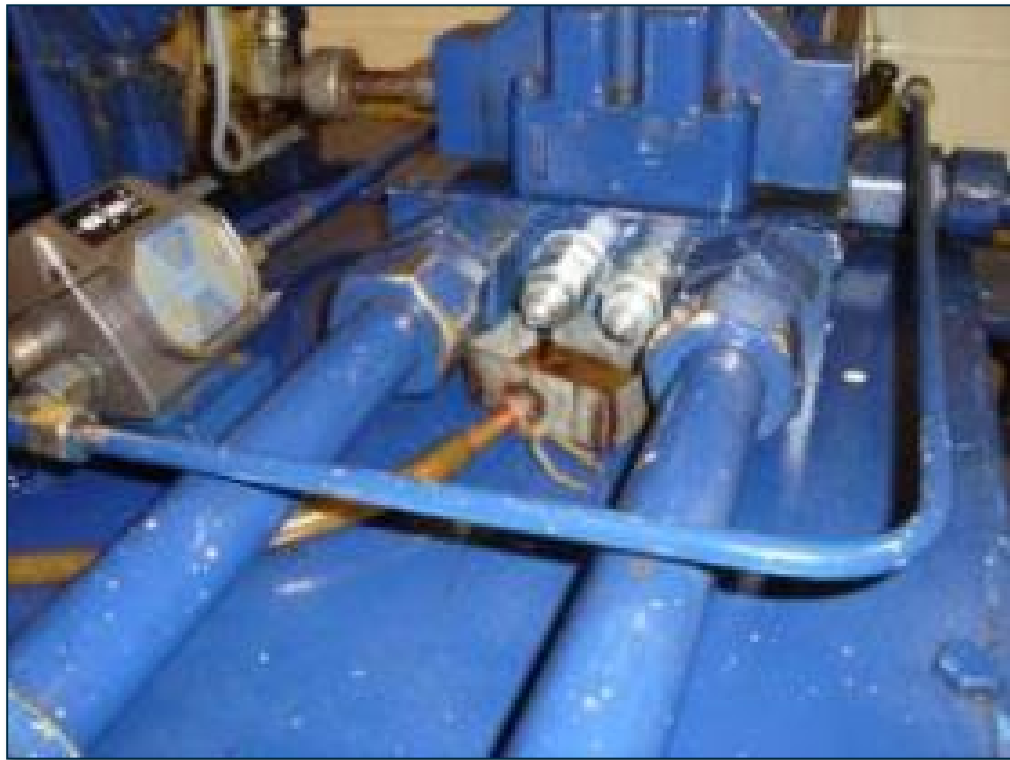
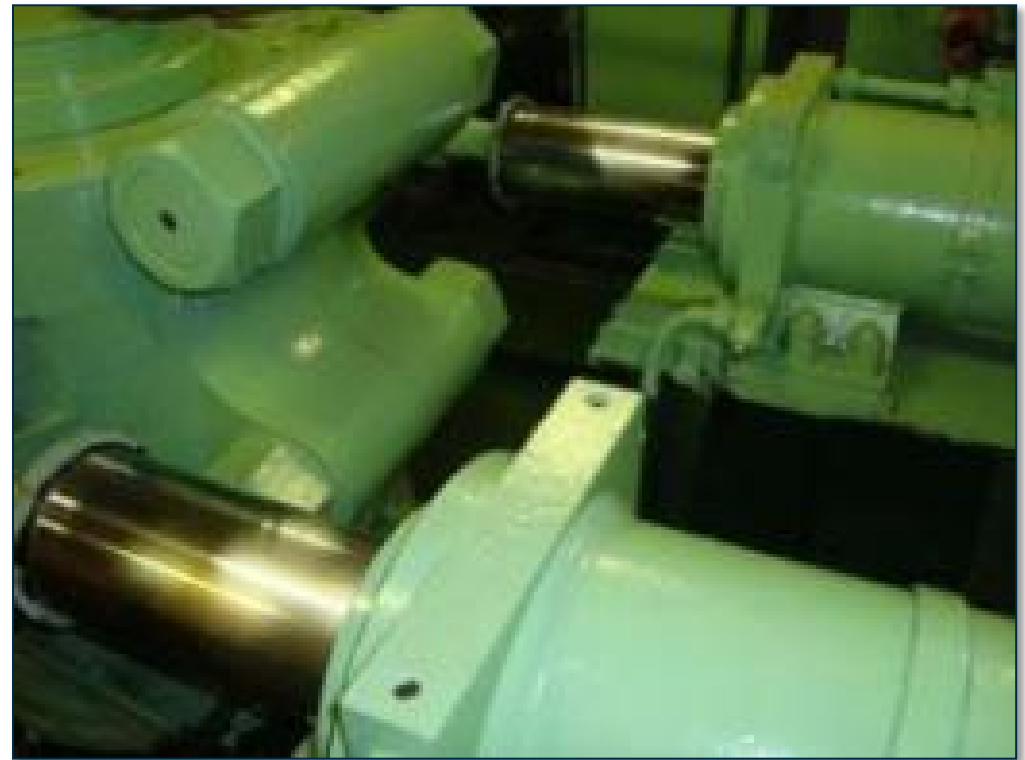
STEERING GEAR (continued)

- Rudder packing worn and leaking?
- Hydraulic leak with makeshift container and drain line.
- Well maintained and in good condition?

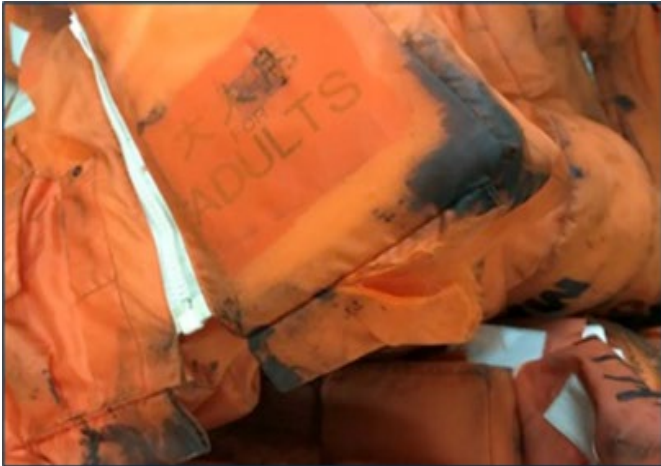
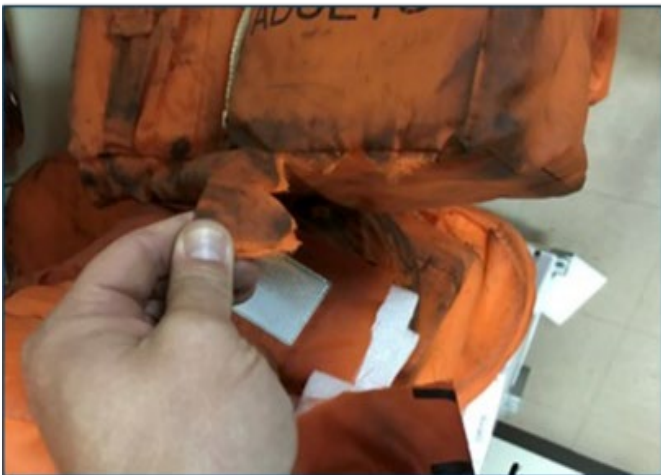
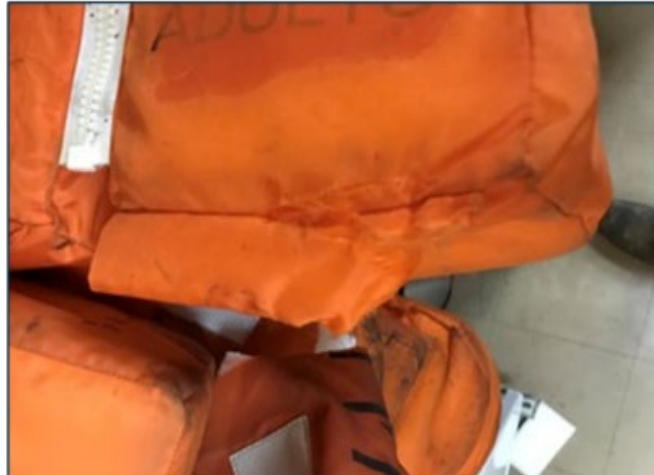
LIFE JACKETS

Life jackets poor condition

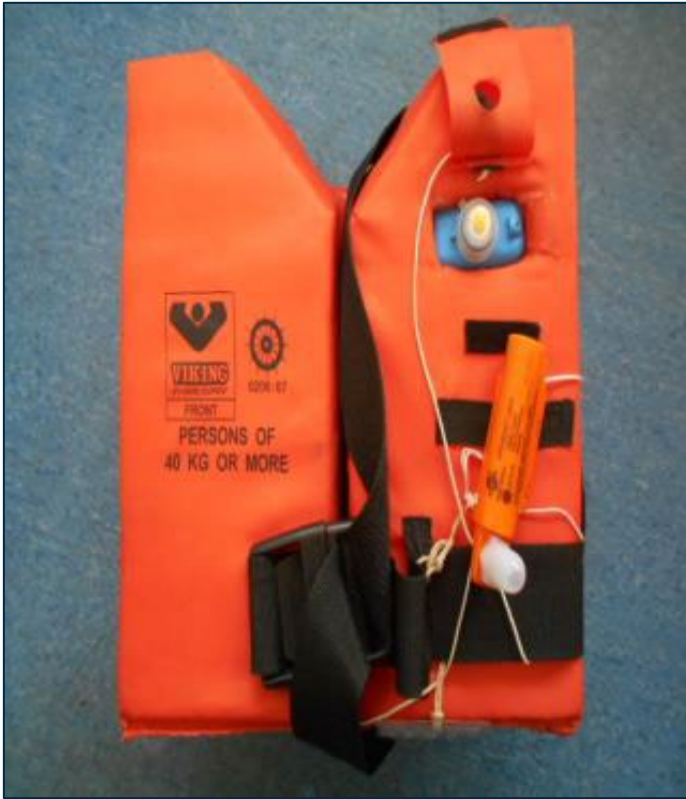
Life jacket – original design
