FLAG STATE INSPECTIONS AND COMMON DEFICIENCIES

Captain Sascha Marcel Dyker

Fleet Operations Manager (Hong Kong)

March 2025

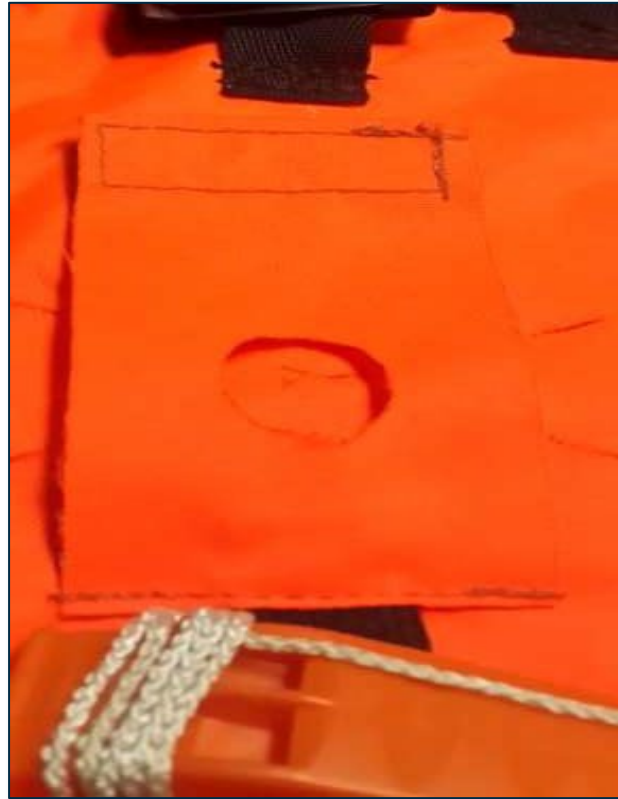
Life jacket flap without light

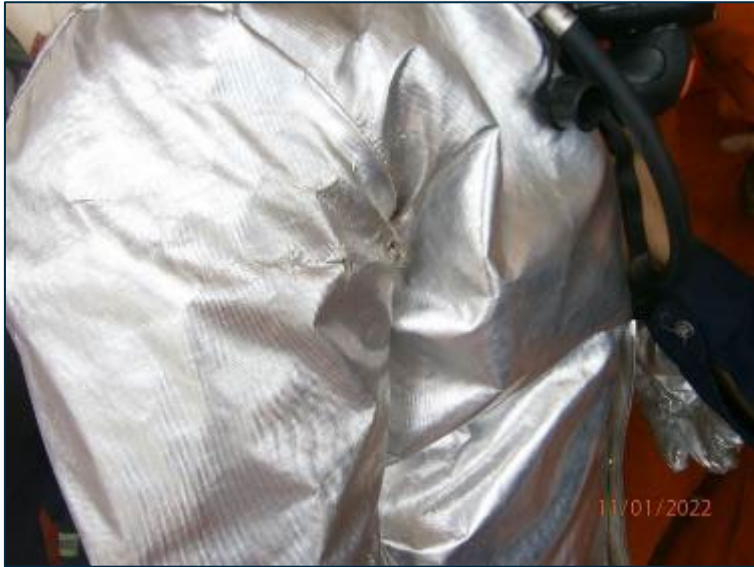
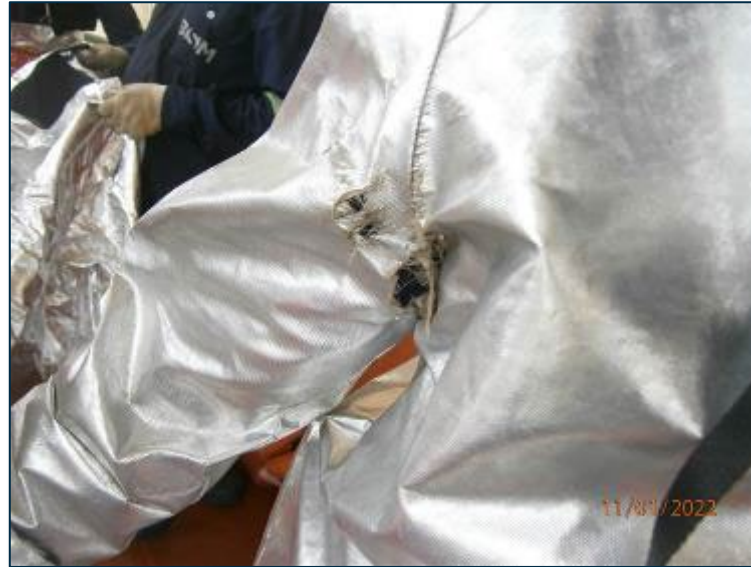
FIREFIGHTER'S OUTFIT

Damaged firefighter's outfit

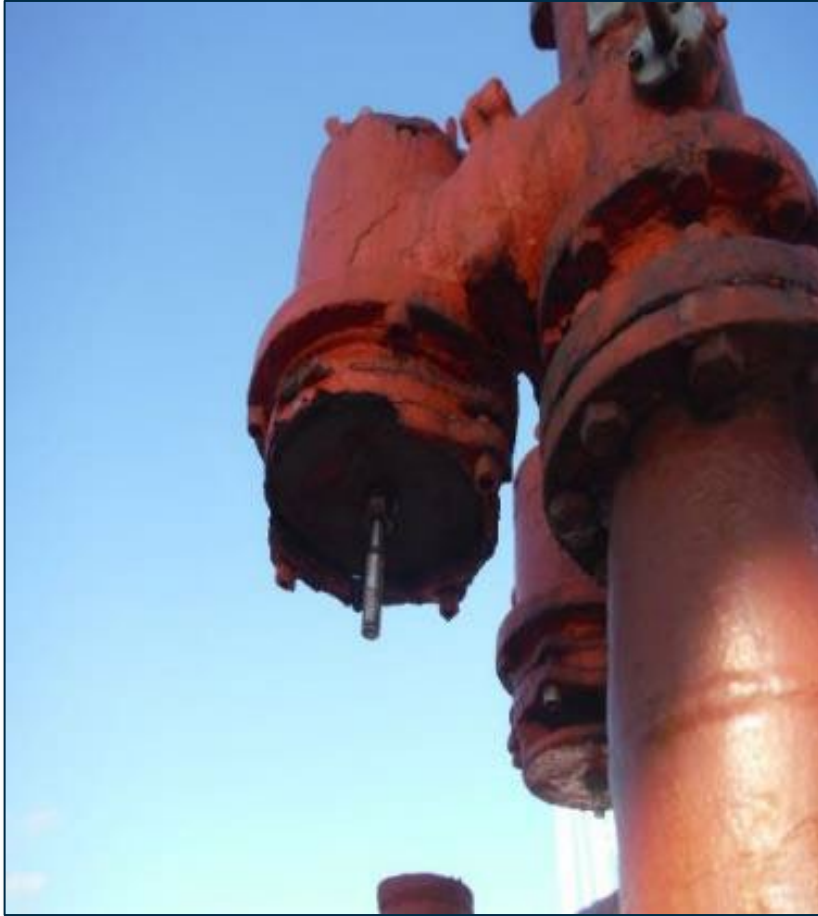
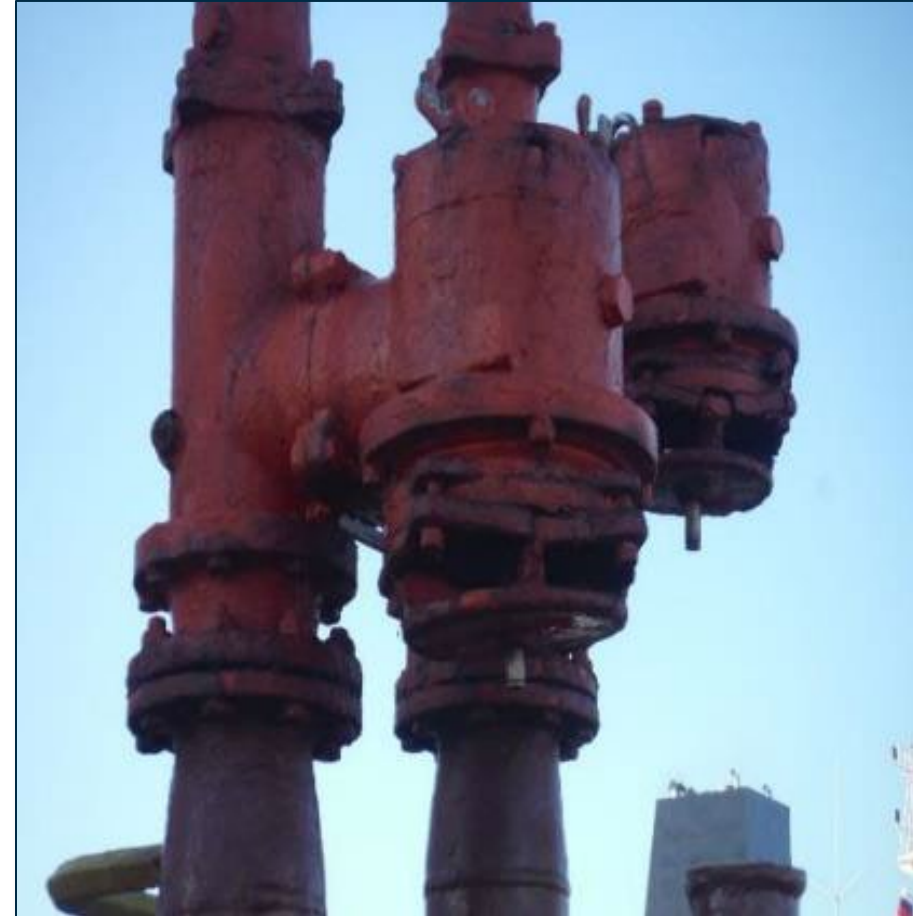
PRESSURE VACUUM (PV) VALVE CONDITION

PV valves
